The Crash of Air Florida Flight 90

What Happened?

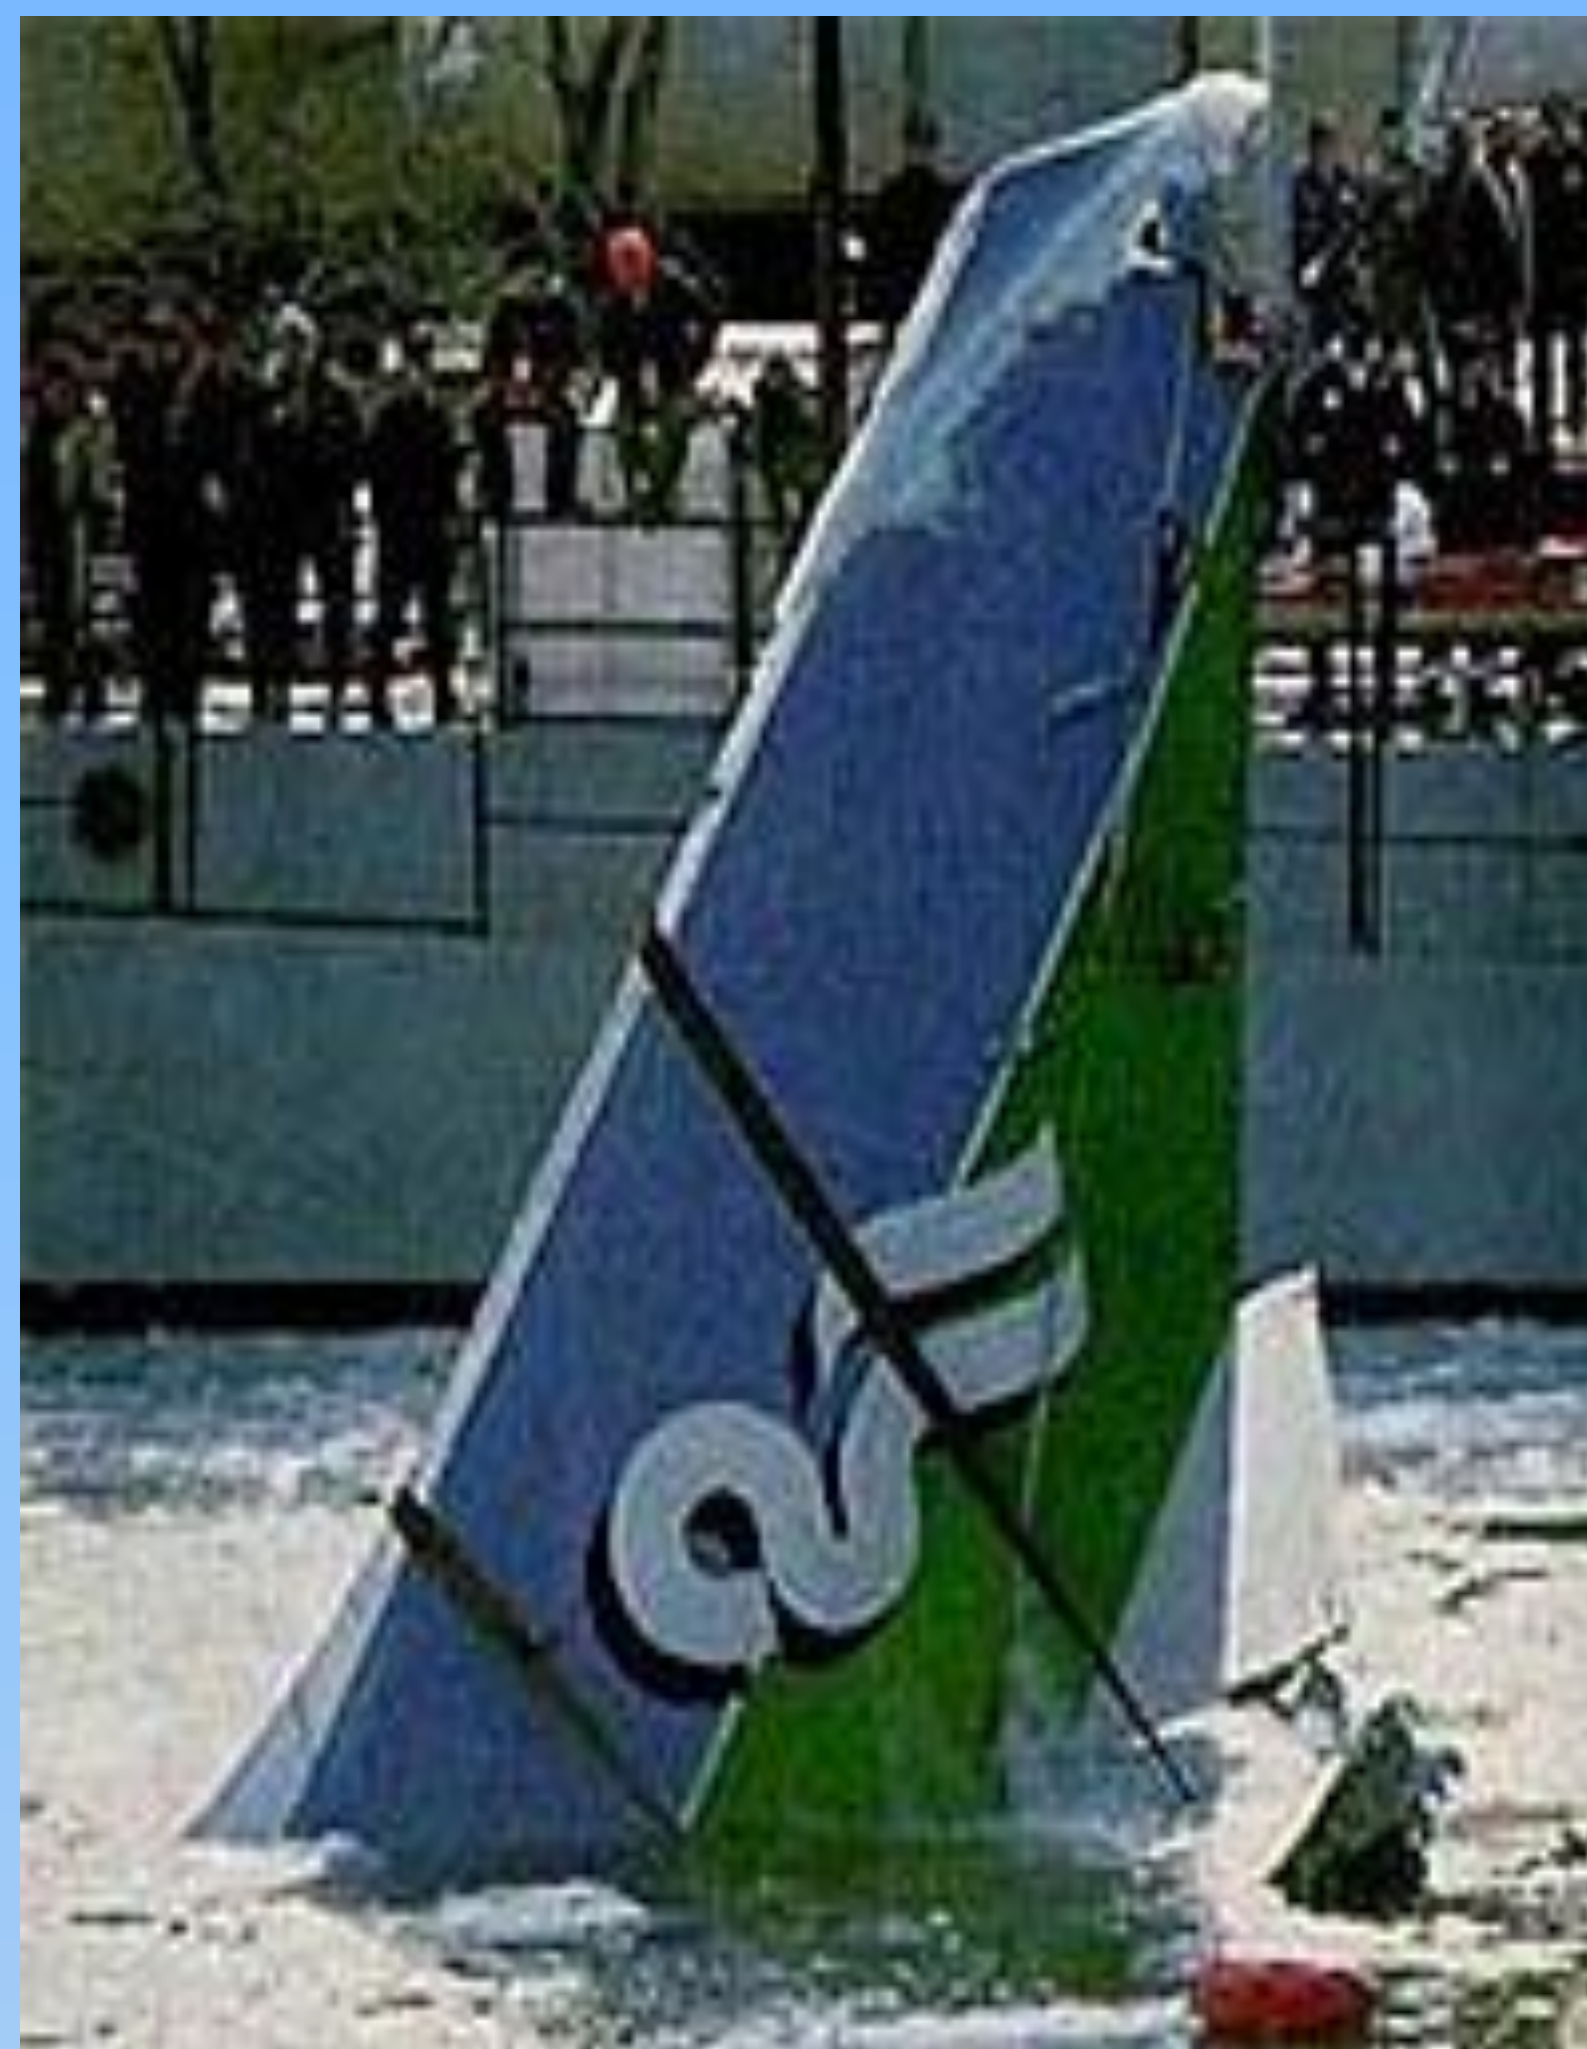
Salvage operations on January 19, 1982.
Photograph courtesy of airdisaster.com.

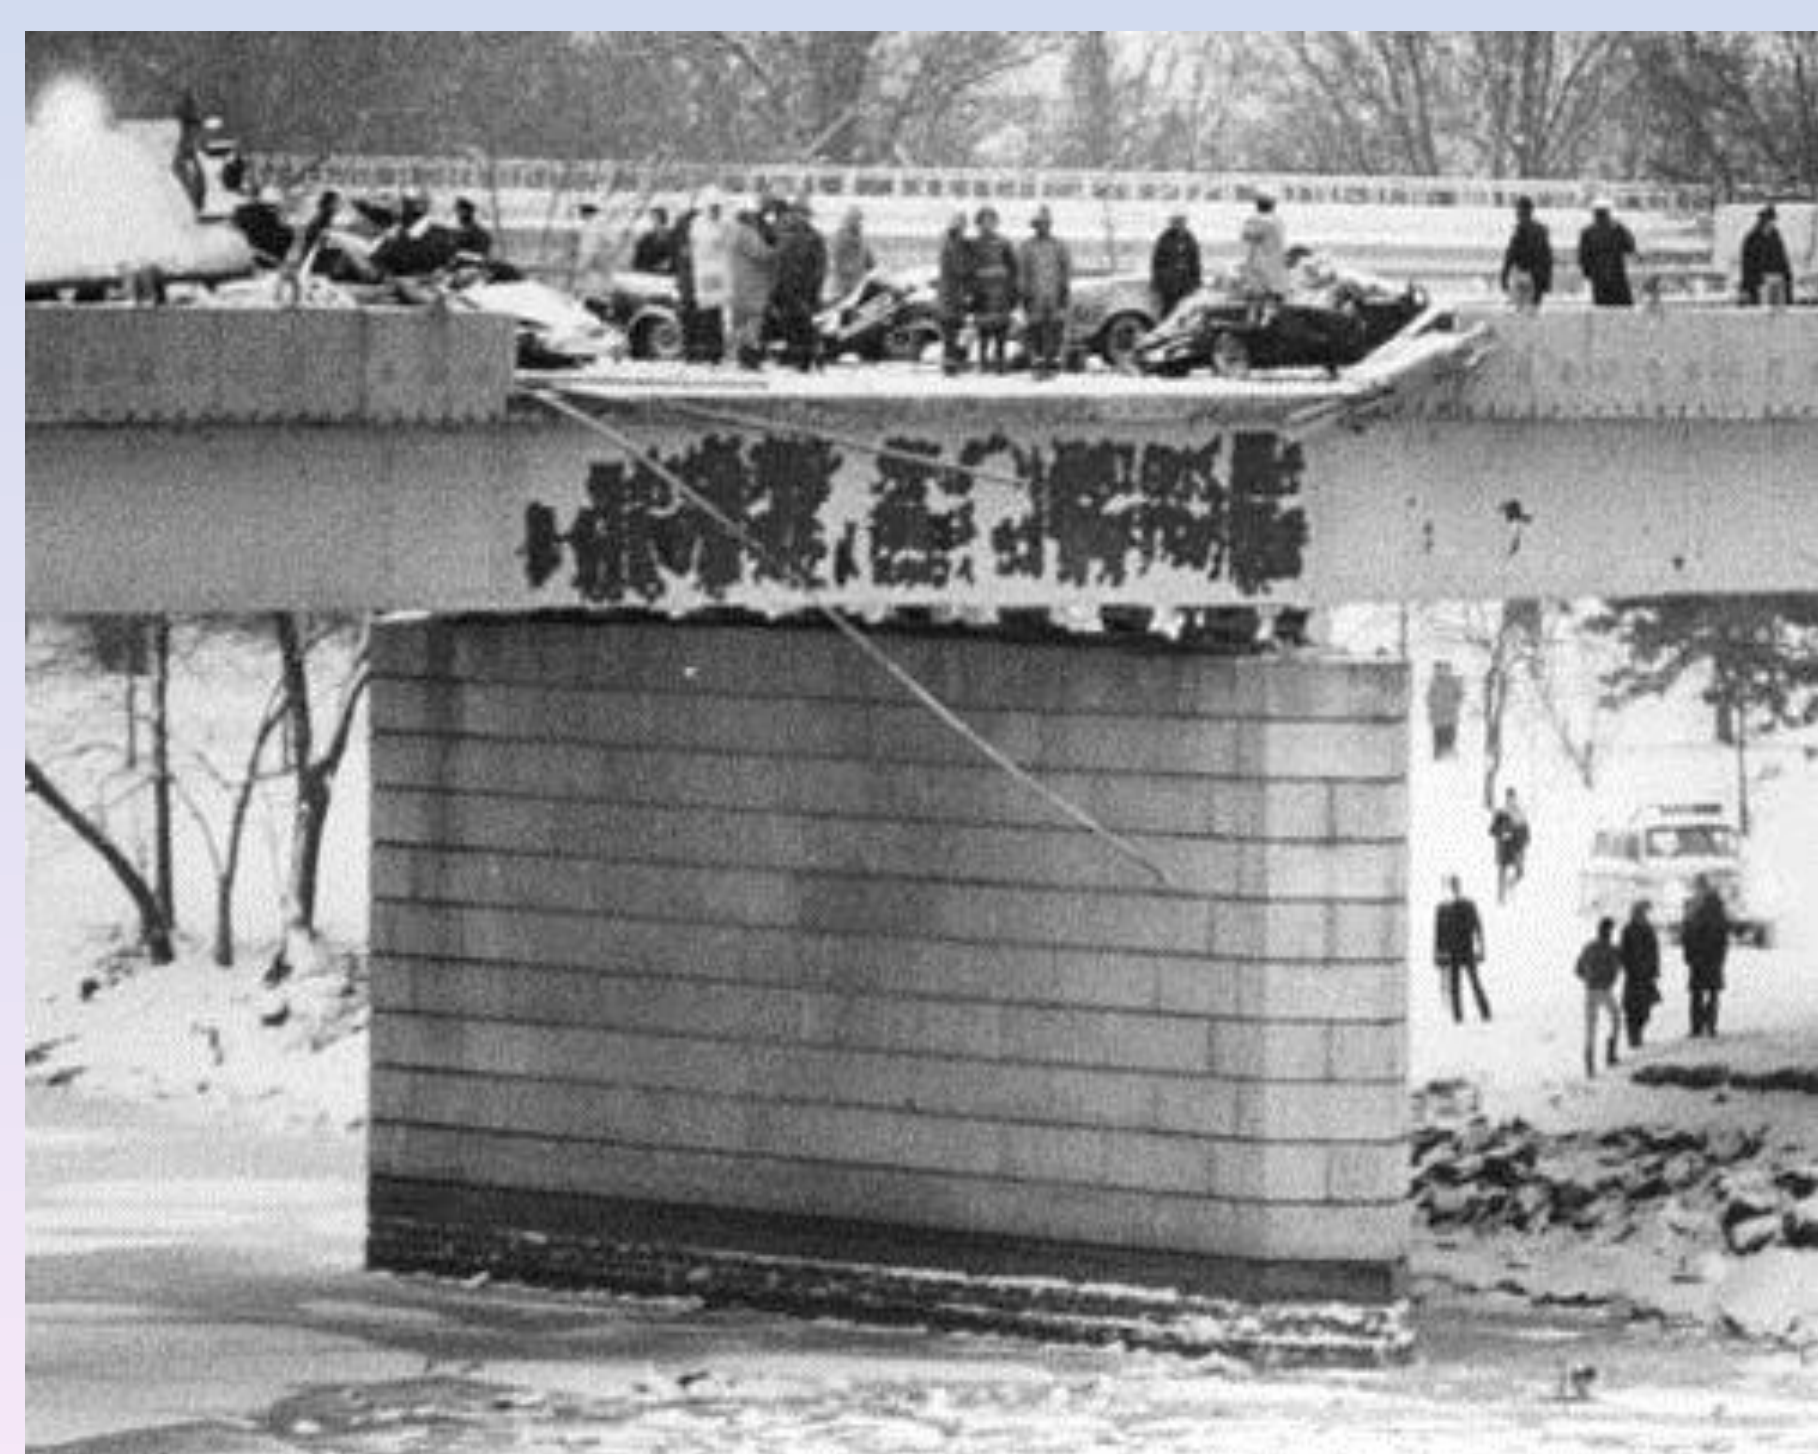
Photograph showing the section of the 14th Street Bridge damaged by the crash. Photograph courtesy of The Washington Post.
