JEFFERSONVILLE HOUSING INVENTORY STUDY

JEFFERSONVILLE, INDIANA

**Center for Environmental Policy and Management
School of Urban and Public Affairs
The University of Louisville**

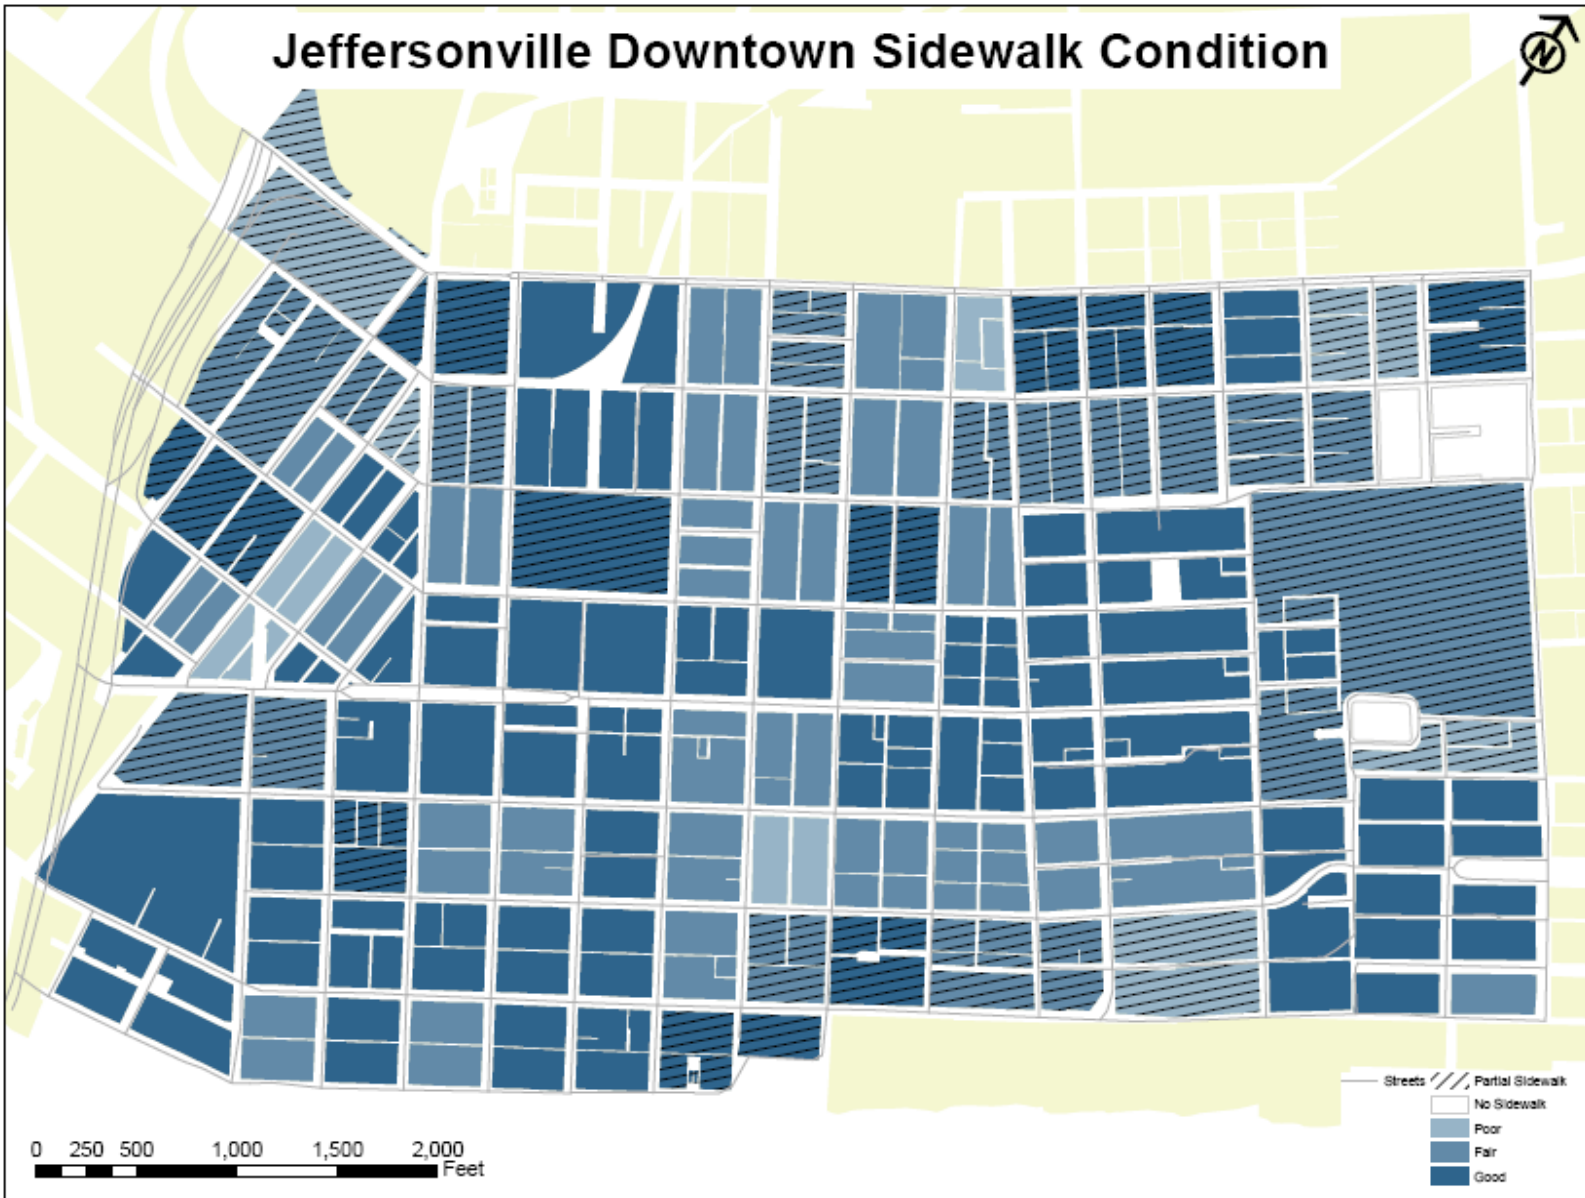
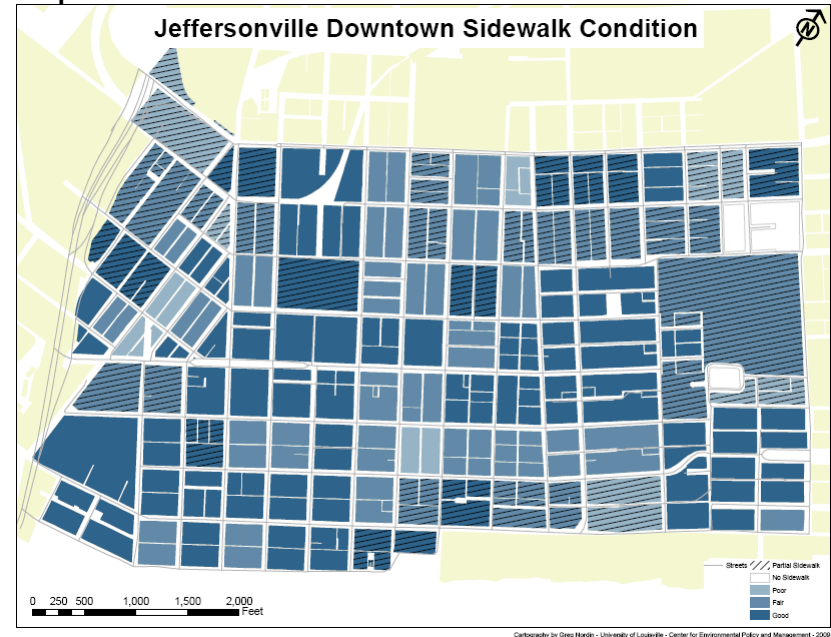
Map 2: Block Level Sidewalk Condition

About half of the sidewalks in the study area are in good condition (48%), while most others are fair condition (42%). Only 10 blocks (8%) had sidewalks in poor condition, and 3 blocks (2%) had no sidewalks at all. As with the presence of sidewalks, the condition of sidewalks appears to be evenly distributed across the study area. There are no apparent concentrations of good, fair, or poor conditions in any part of the area.

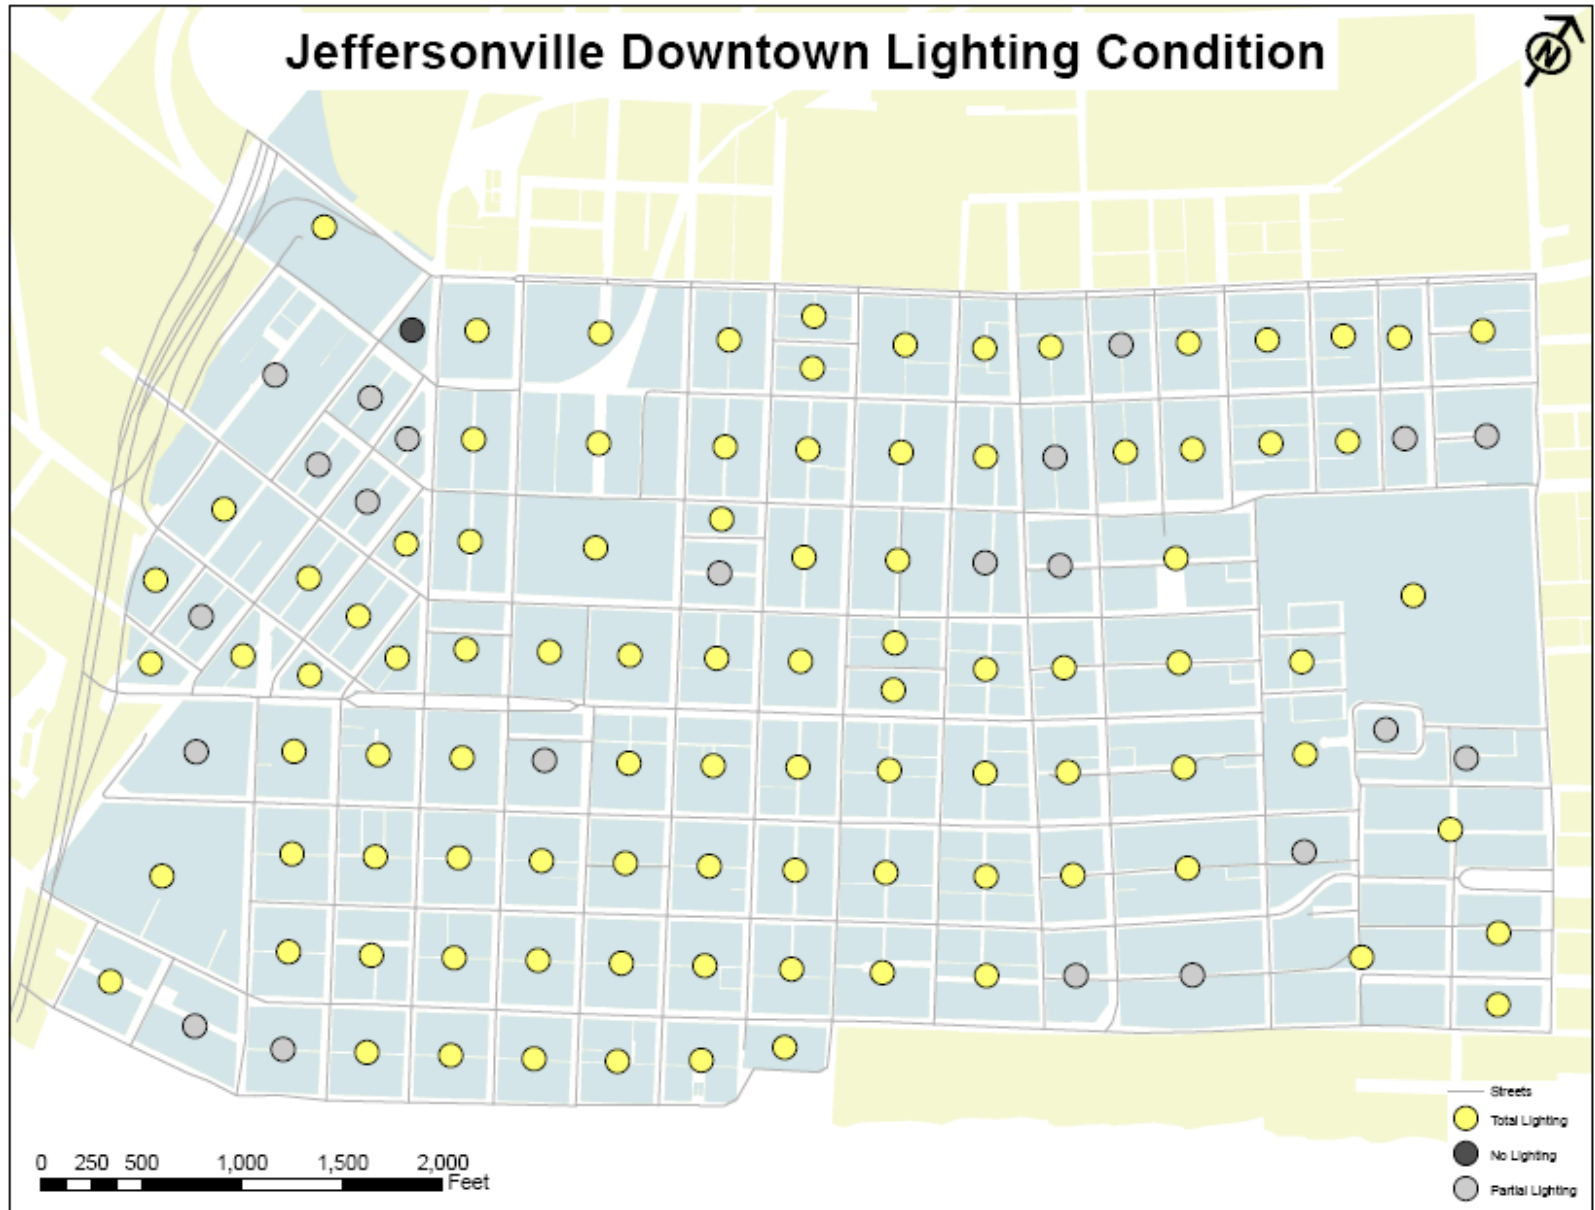
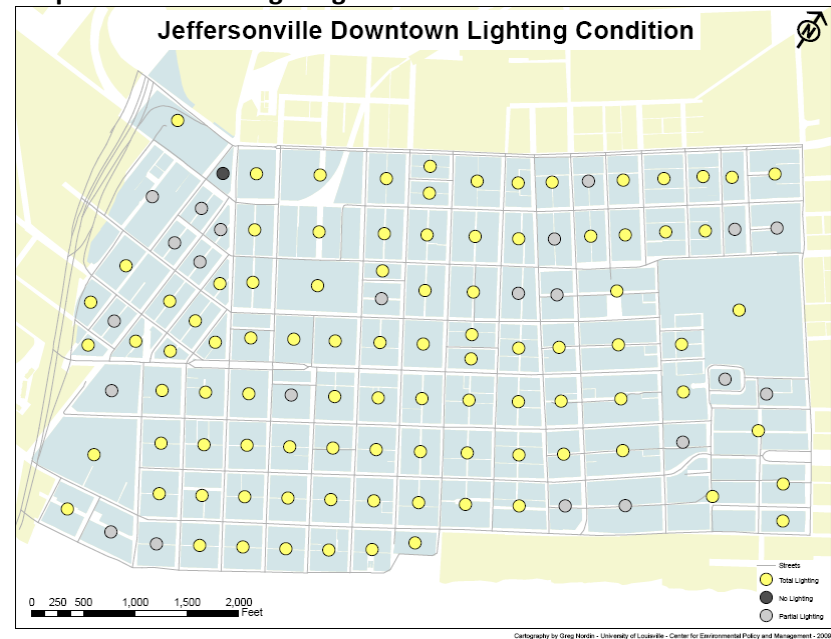
Map 3: Block Level Lighting Condition

Most blocks in the study area have street lighting present on every side of the block (81%). Only a few (18%) have partial lighting, and only one (1%) has no street lighting at all. There appears to be a small concentration of blocks in the Northwest corner of the study area with partial or no lighting, as well as a general trend of partially-lit blocks on the periphery of the study area.

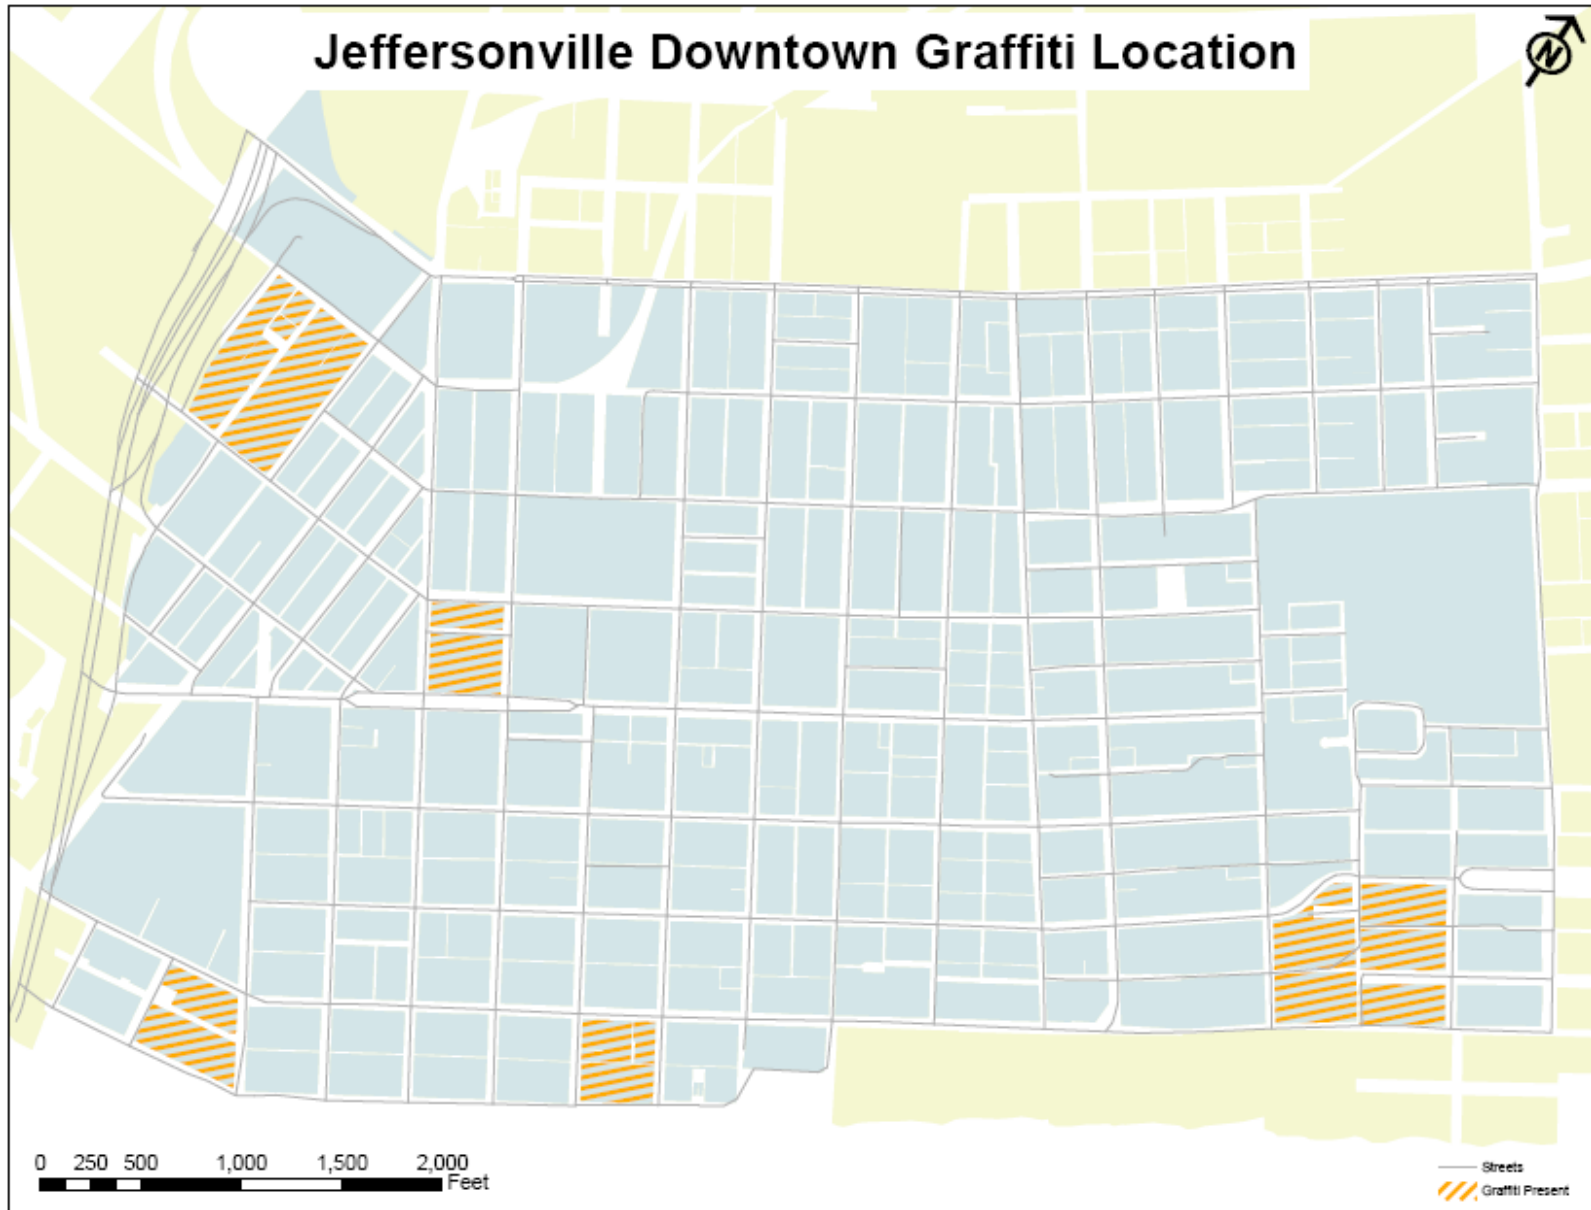
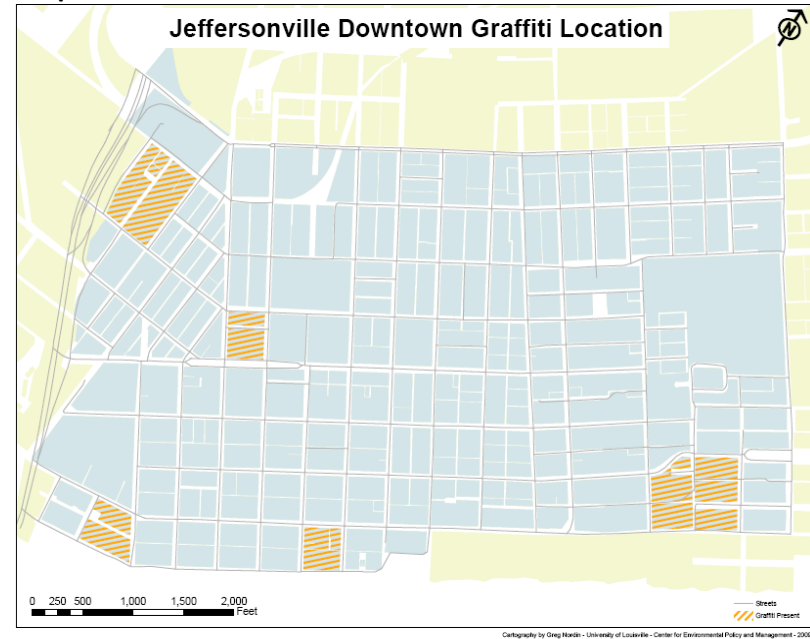
Map 4: Block Level Presence of Graffiti

There were very few instances of graffiti found on public property in the study area. Graffiti was only found on 5 blocks (4%), while 96% of the study area had no graffiti. The instances of graffiti tended to be on the periphery of the study area, particularly the corners. Descriptions of the location of each instance of graffiti can be found in the electronic housing inventory database.

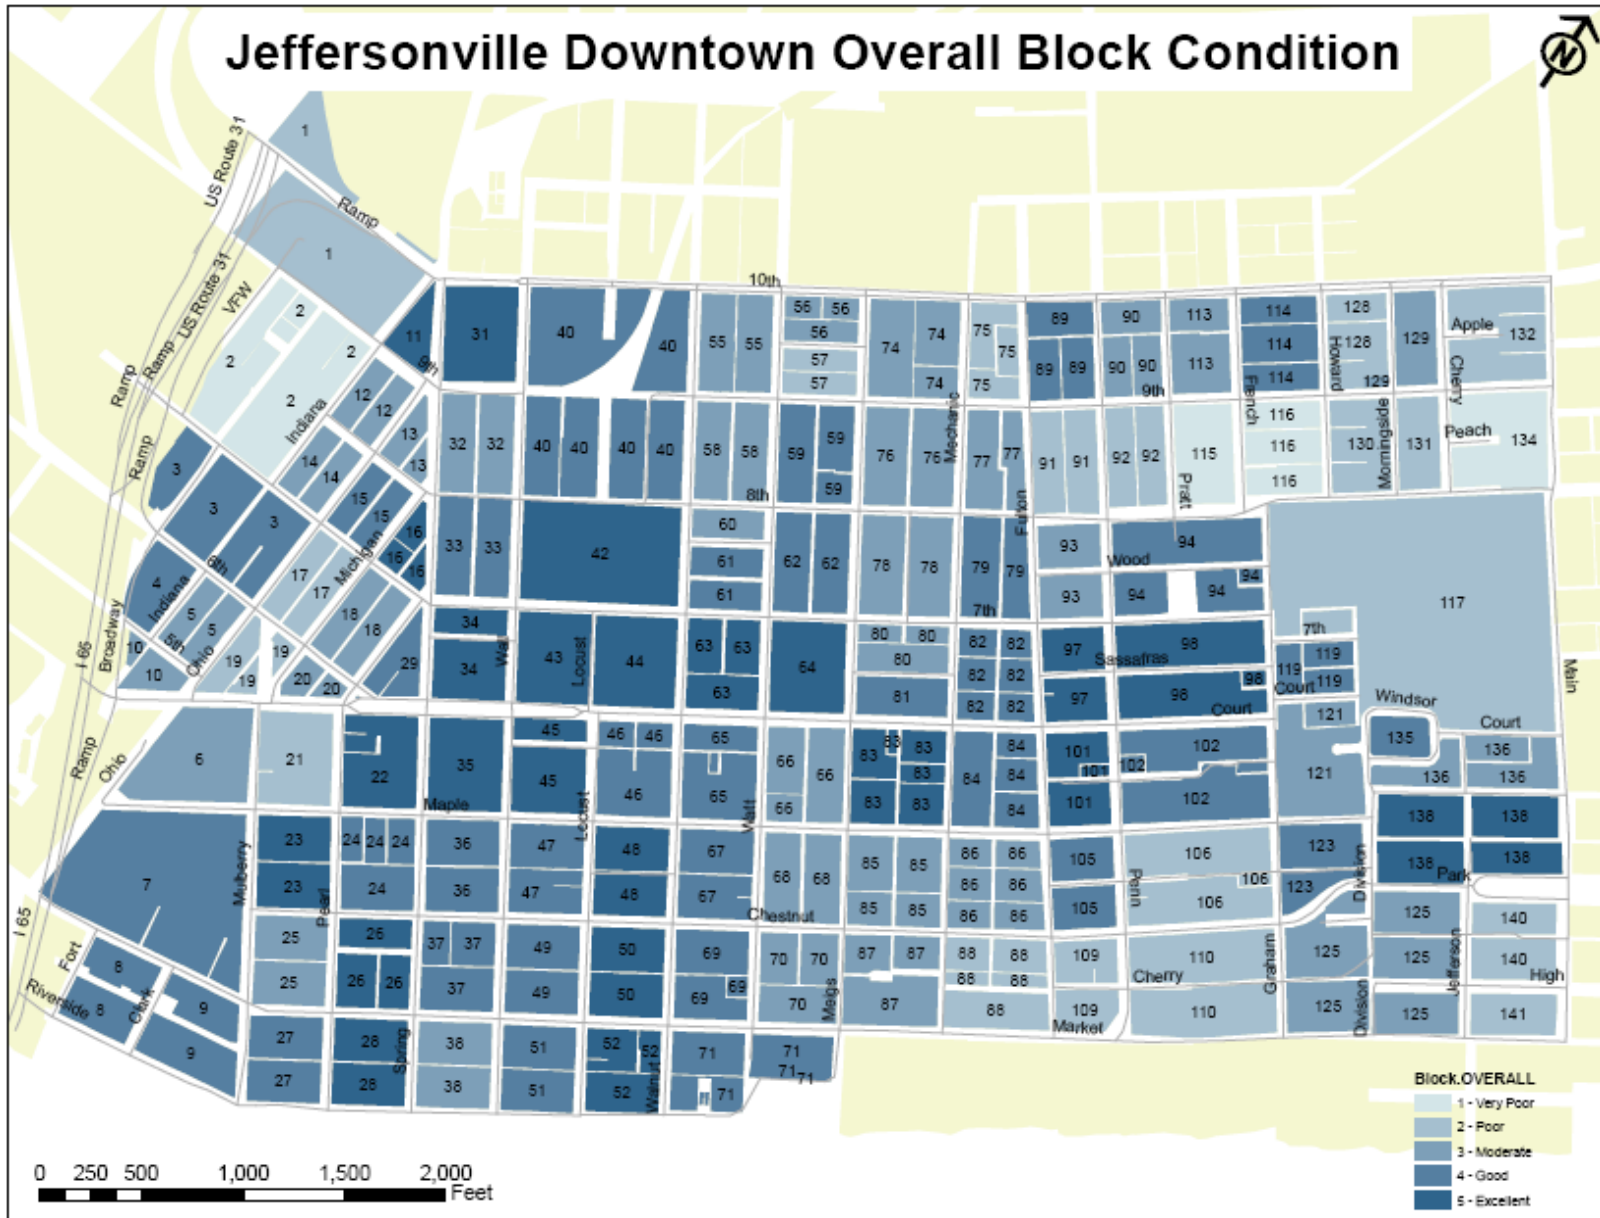
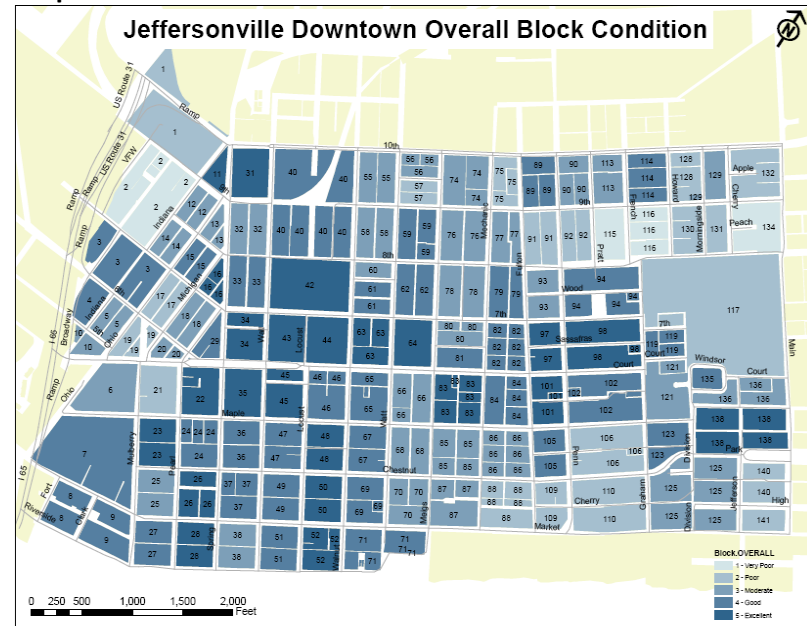
Map 5: Block Level Overall Block Condition

The majority of blocks in the study area are in “good” or “fair” condition (62%), followed by “excellent” (18%) and “somewhat poor” (16%). Only 3 blocks (2%) are considered in “poor” condition. Most of the blocks in excellent condition are located on the interior of the study area and are typically clustered together with other excellent blocks. This trend holds true for other conditions as well. There are very few “isolated” blocks in terms of condition. Blocks tend to gradually fade from one condition to another.

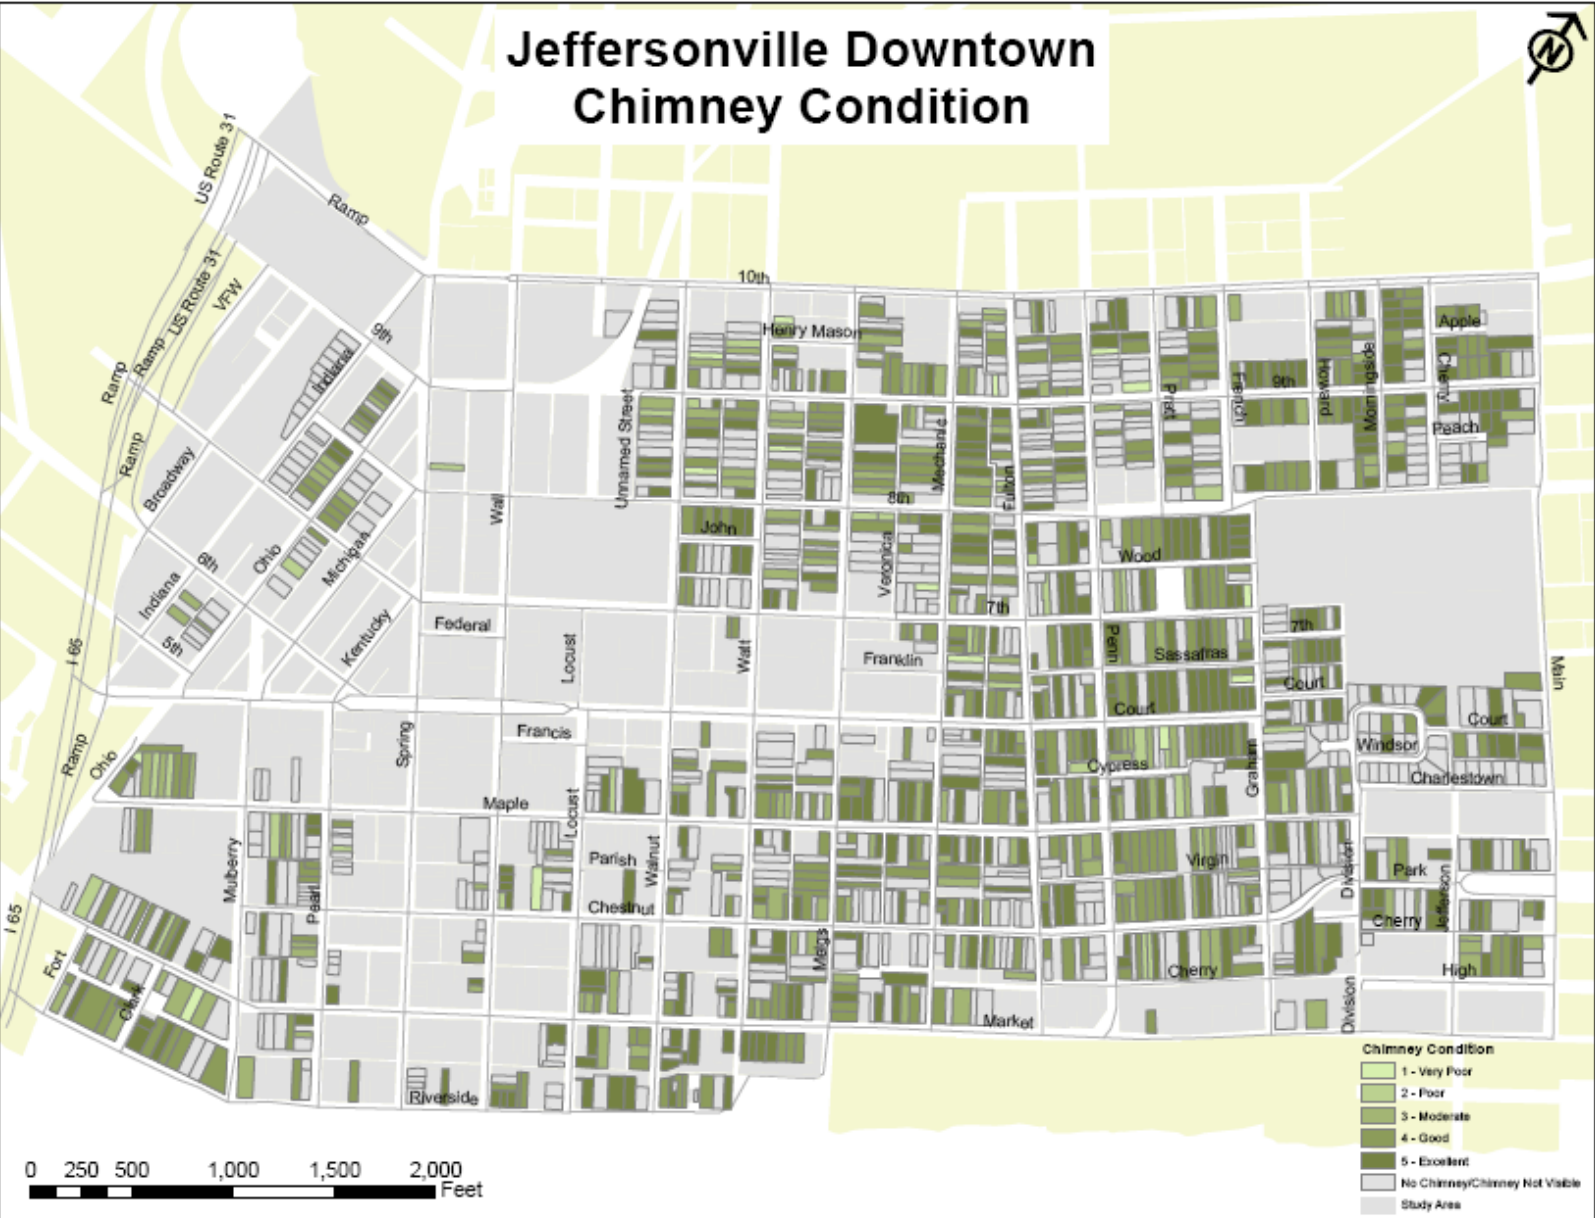
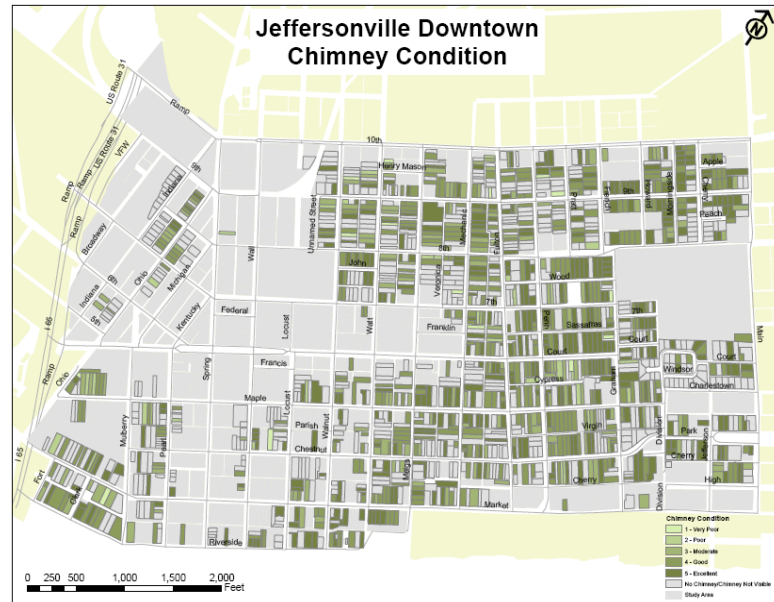
Map 10: Individual Property Chimney Condition

About half of the chimneys in the study area are either in excellent (24%) or good condition (23%). 41% of houses did not have a visible chimney, and 12% of chimneys were in fair to very poor condition. Chimneys in the northern portion of the study area are generally in better condition.

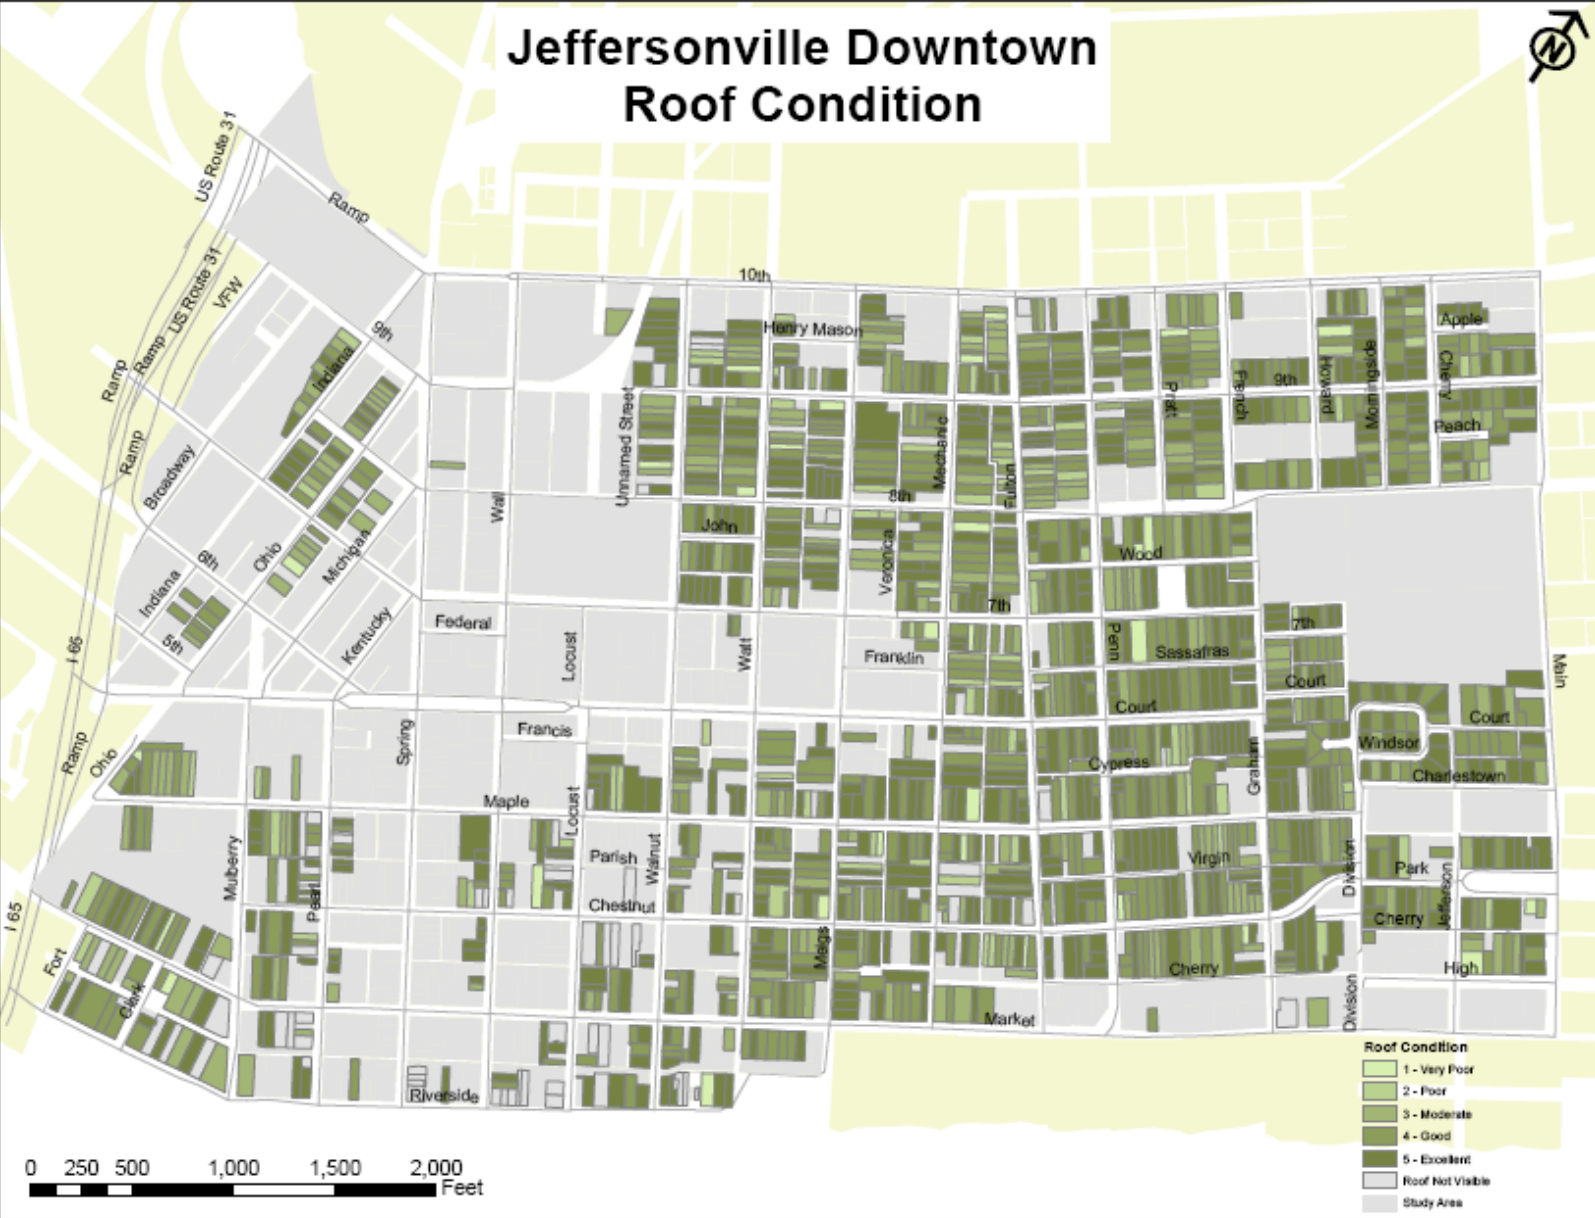
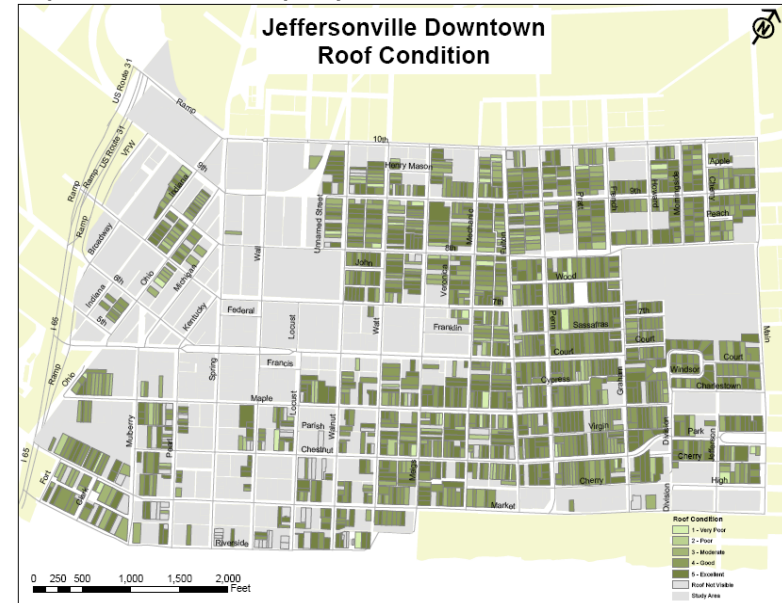
Map 11: Individual Property Roof Condition

Most of the roofs in the study area are in either excellent (39%) or good (34%) condition, followed by 15% in fair condition. The remaining 7% are in poor or very poor condition. 5% of the houses in the study area had roofs that were not visible from the street, typically because of the height or elevation of the house. The condition of roofs appears to be evenly distributed across the study area.

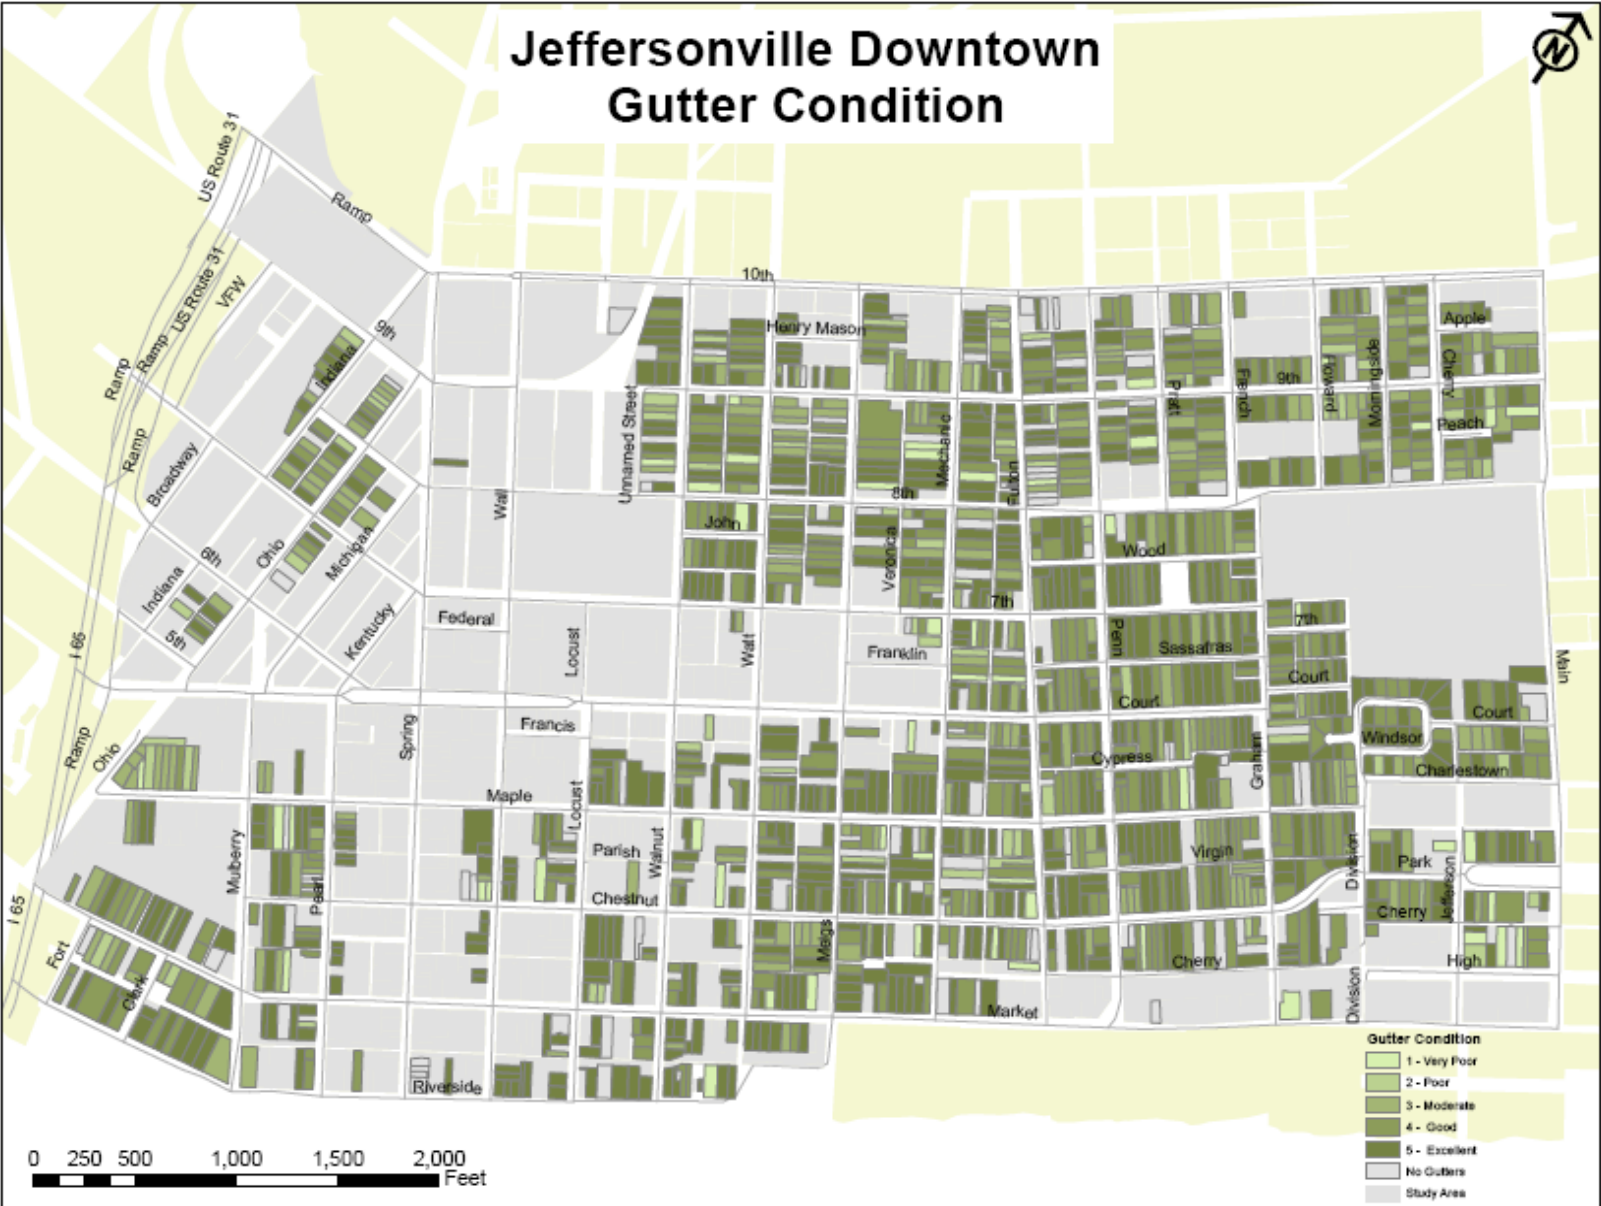
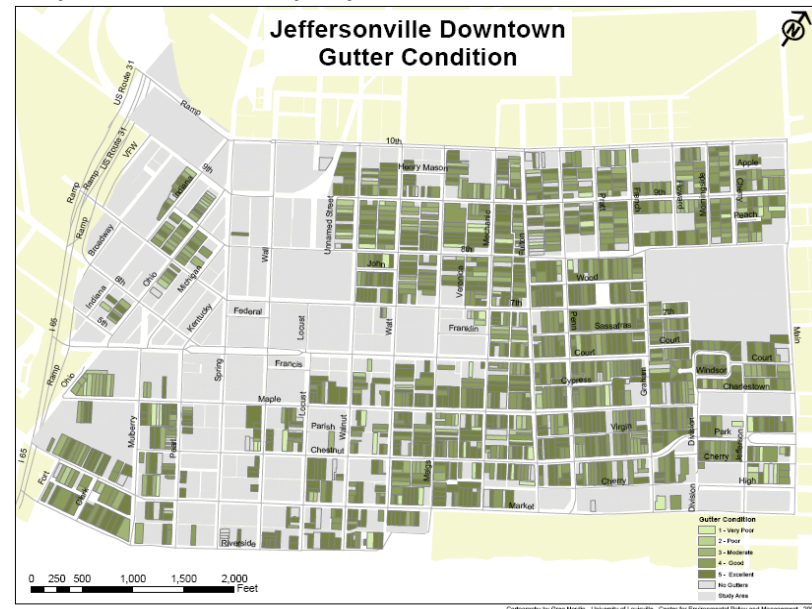
Map 12: Individual Property Gutter Condition

Nearly half of the gutters in the study area are in excellent condition (43%), followed by 30% in good condition and 14% in fair condition. 8% are in poor or very poor condition. 5% of houses had no evidence of gutters ever being present on the structure. The gutter condition appears to be evenly distributed across the study area.

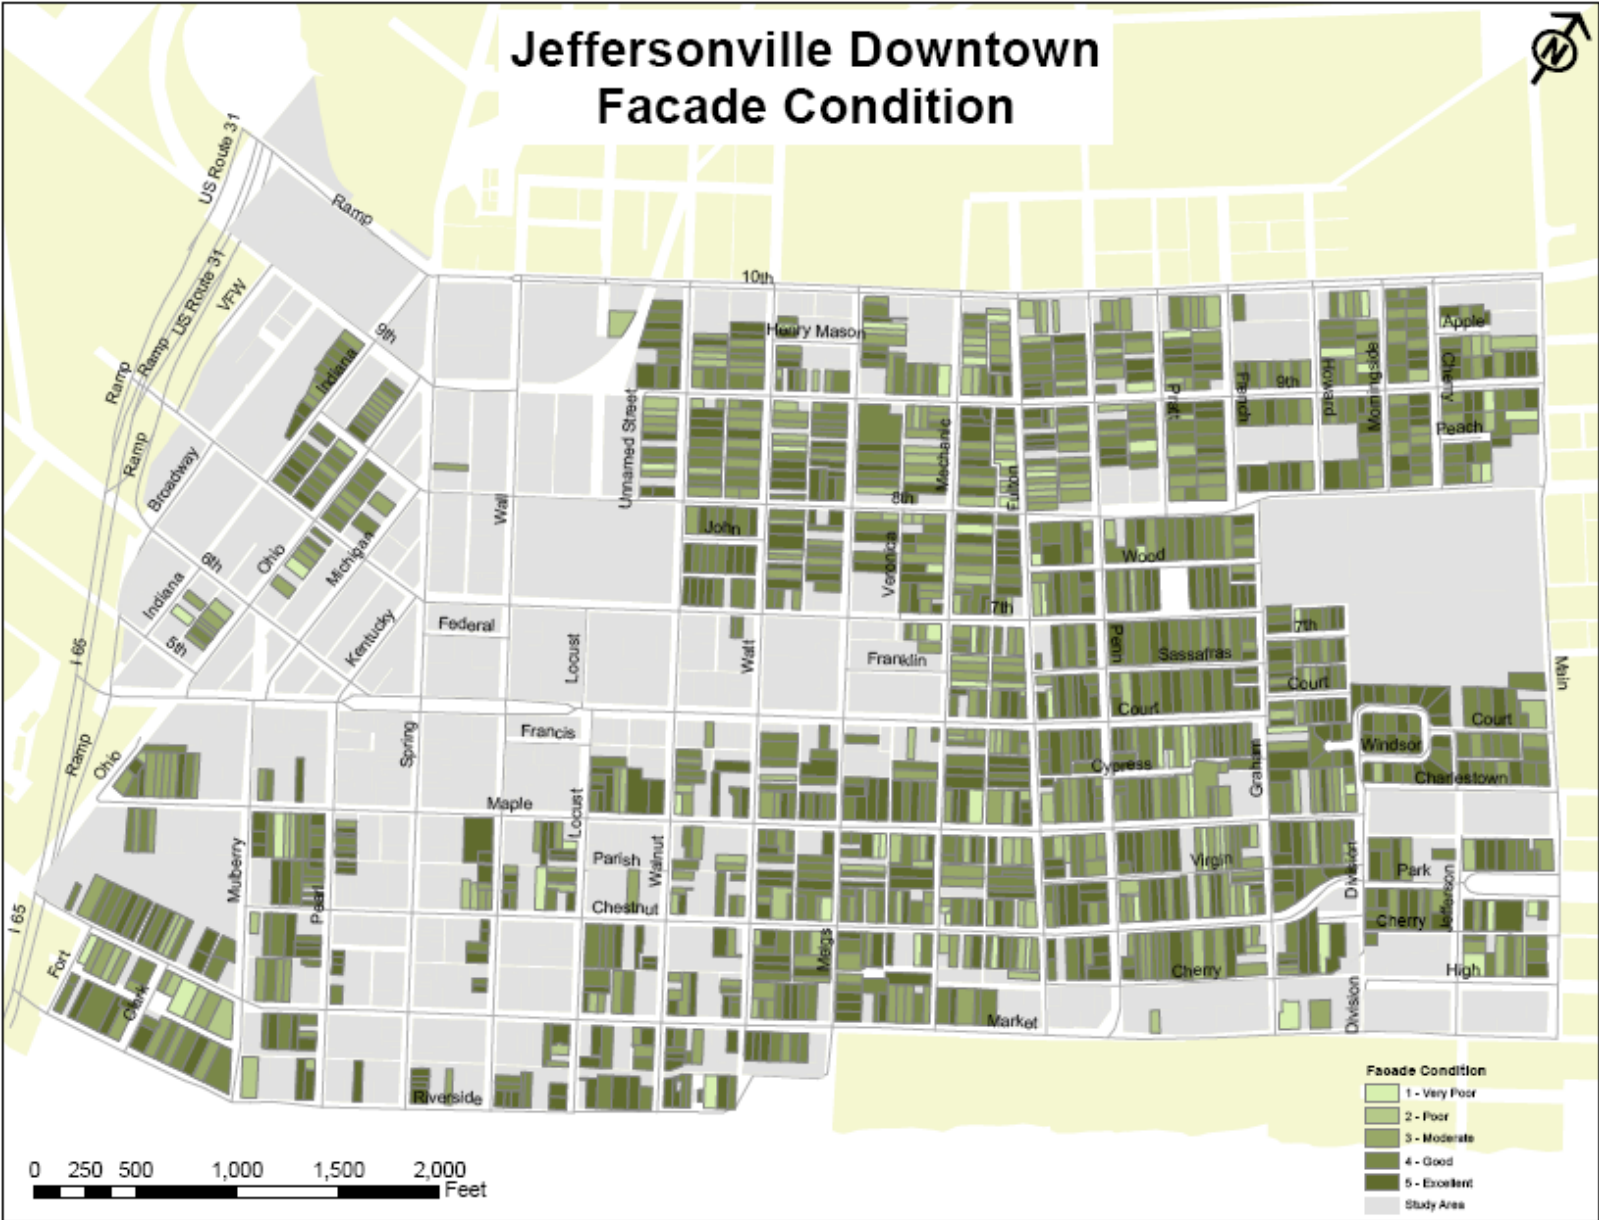
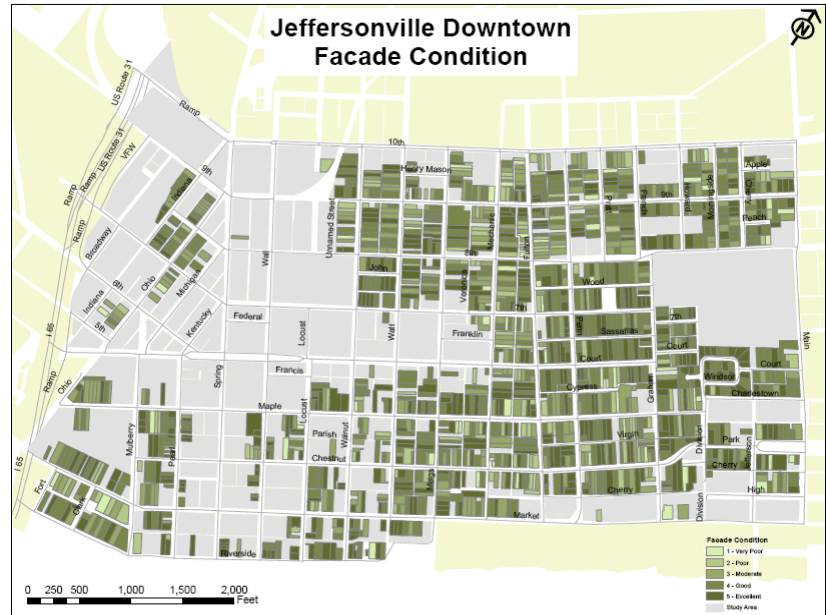
Map 13: Individual Property Façade Condition

About one-third of the houses in the study area had façades in good condition (37%), followed by 29% in excellent condition, 20% in fair condition, and 13% in poor or very poor condition. Houses in the northern and eastern portions appear to have a somewhat better façade condition than other portions of the study area. Houses with good or excellent façades also appear to be somewhat clustered together (i.e. adjoining other properties with the same façade condition).

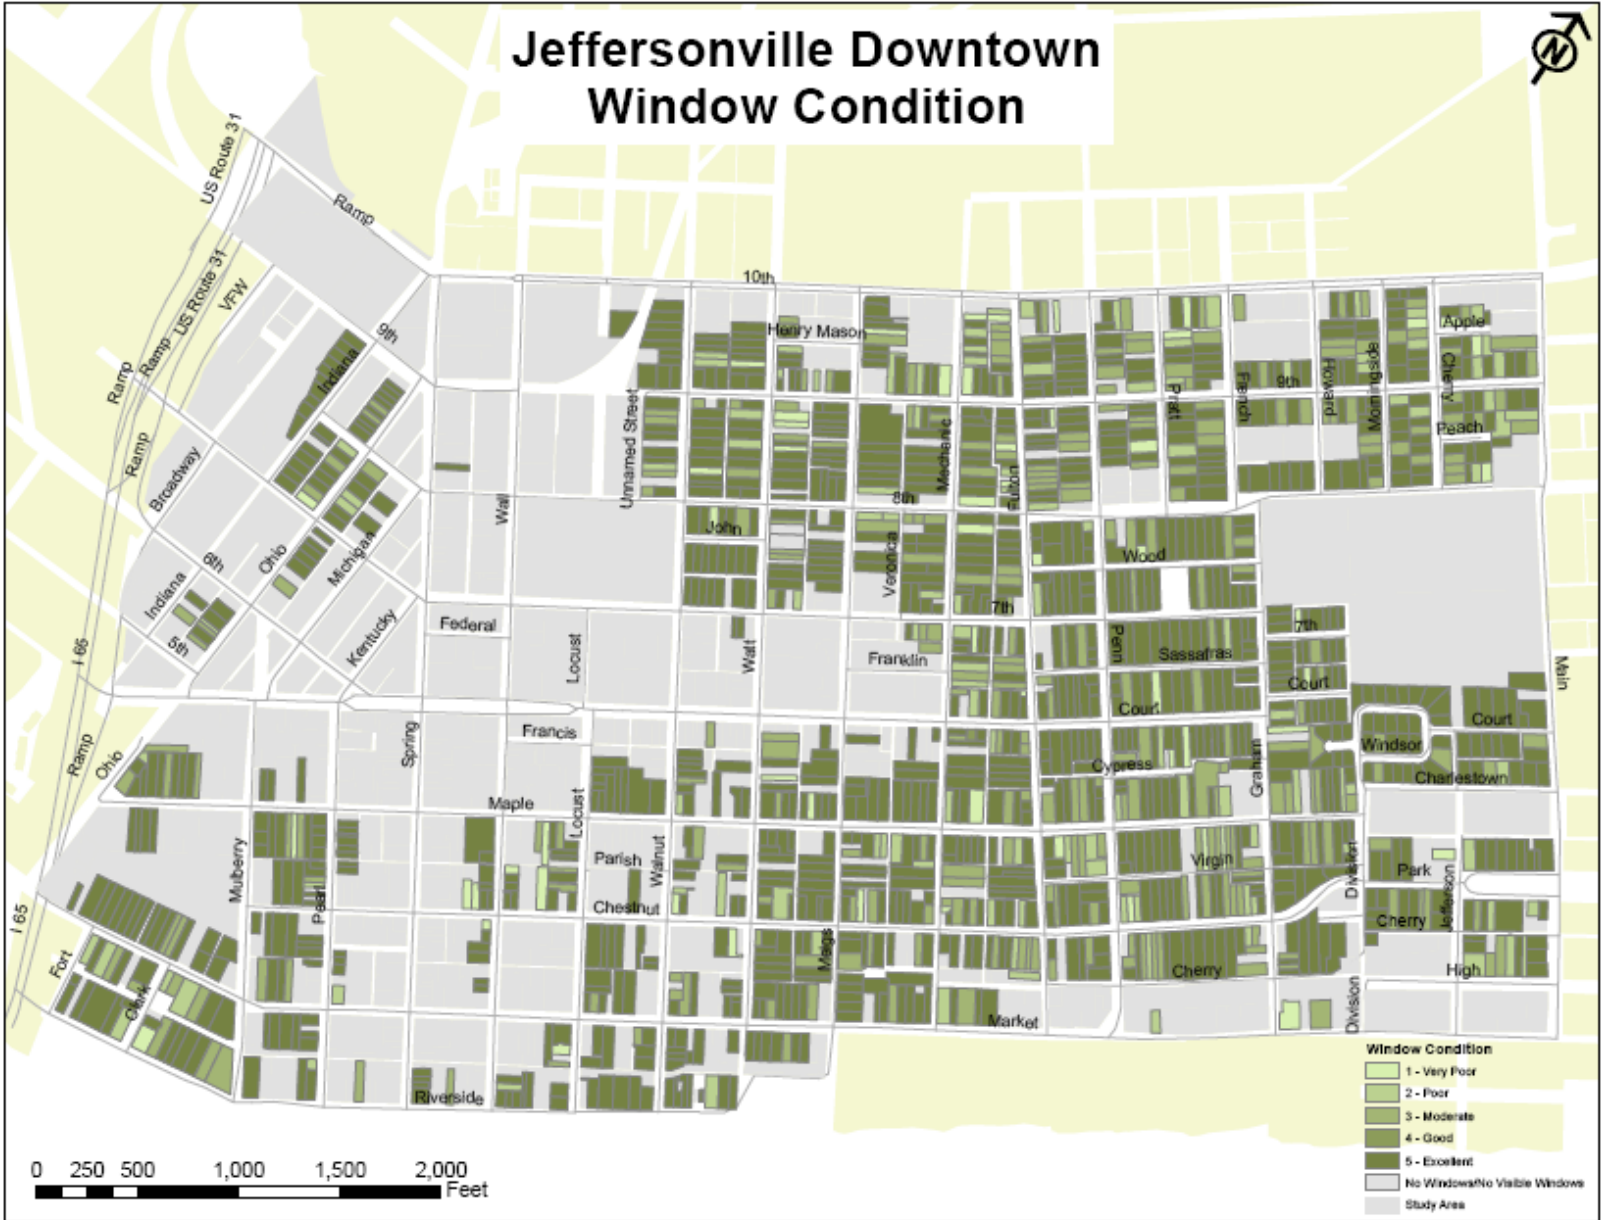
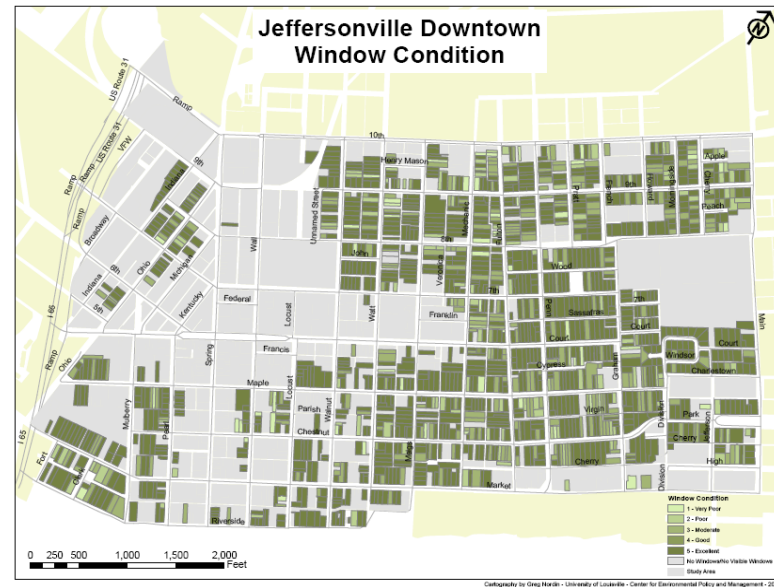
Map 14: Individual Property Window Condition

About half (48%) of the houses in the study area had windows in excellent condition, followed by 22% in good condition, 18% in fair condition, and the remaining 11% in poor or very poor condition. Two houses had no visible windows from the street. There are several blocks where all of the houses have excellent window condition, and few blocks where there is a majority of houses with poor window condition. Windows in poor condition appear to be somewhat isolated rather than clustered together in specific areas.
