JEFFERSONVILLE HOUSING INVENTORY STUDY

JEFFERSONVILLE, INDIANA

**Center for Environmental Policy and Management
School of Urban and Public Affairs
The University of Louisville**

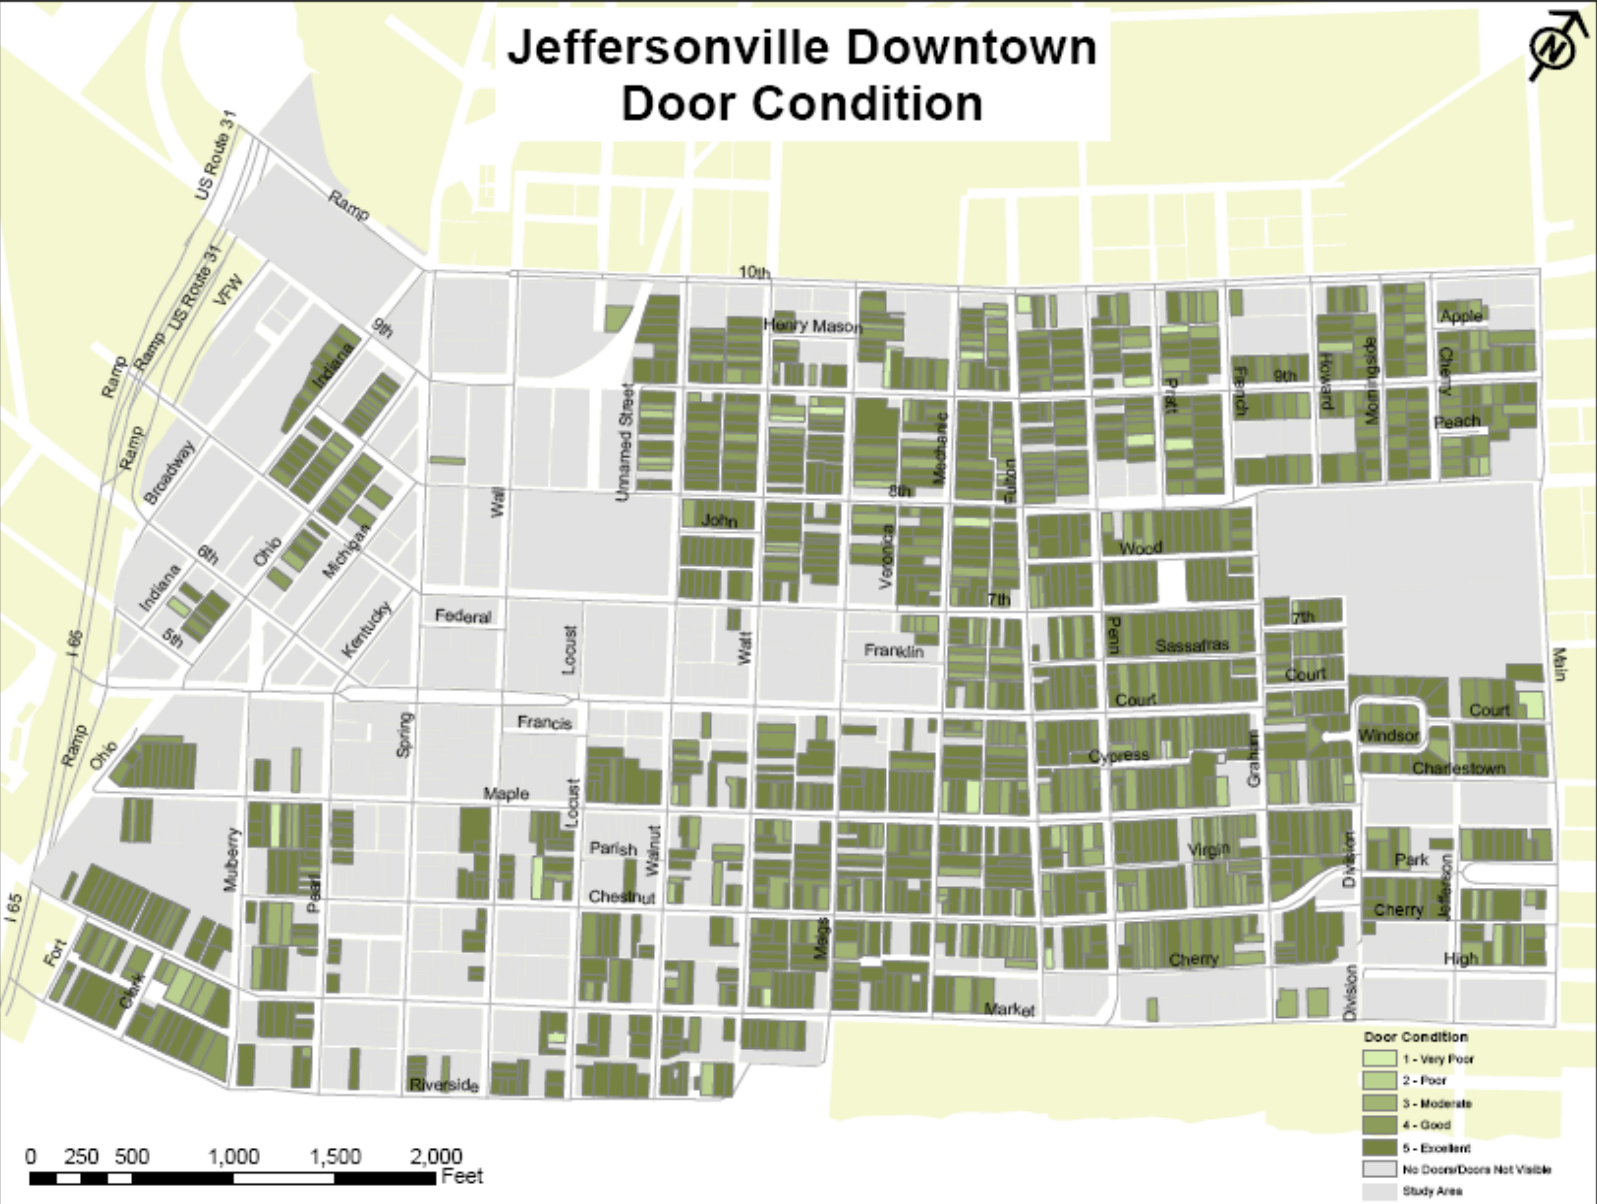
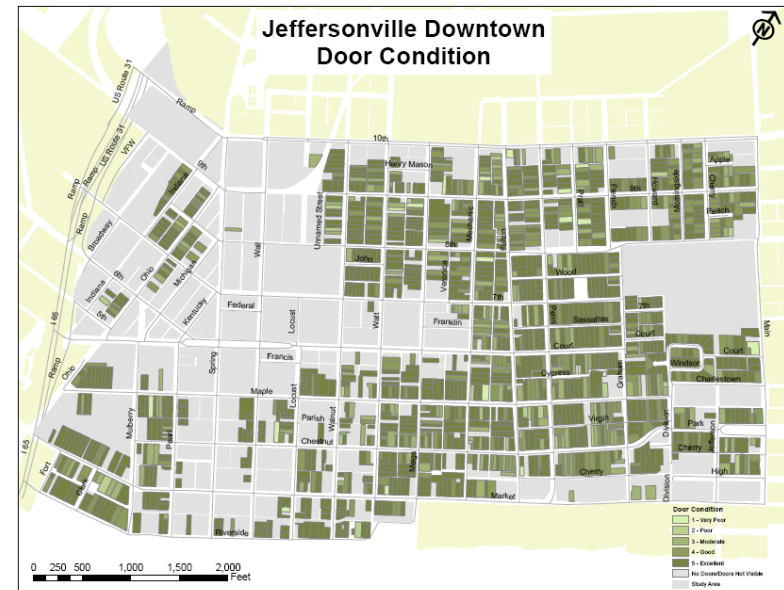
Map 15: Individual Property Door Condition

The majority of houses in the study area have doors in excellent condition (65%), followed by 20% in good condition and the remaining 14% in fair to very poor condition. Two houses had no visible doors from the street. Houses with doors in poor or very poor condition appear to be isolated and not clustered together in specific areas.

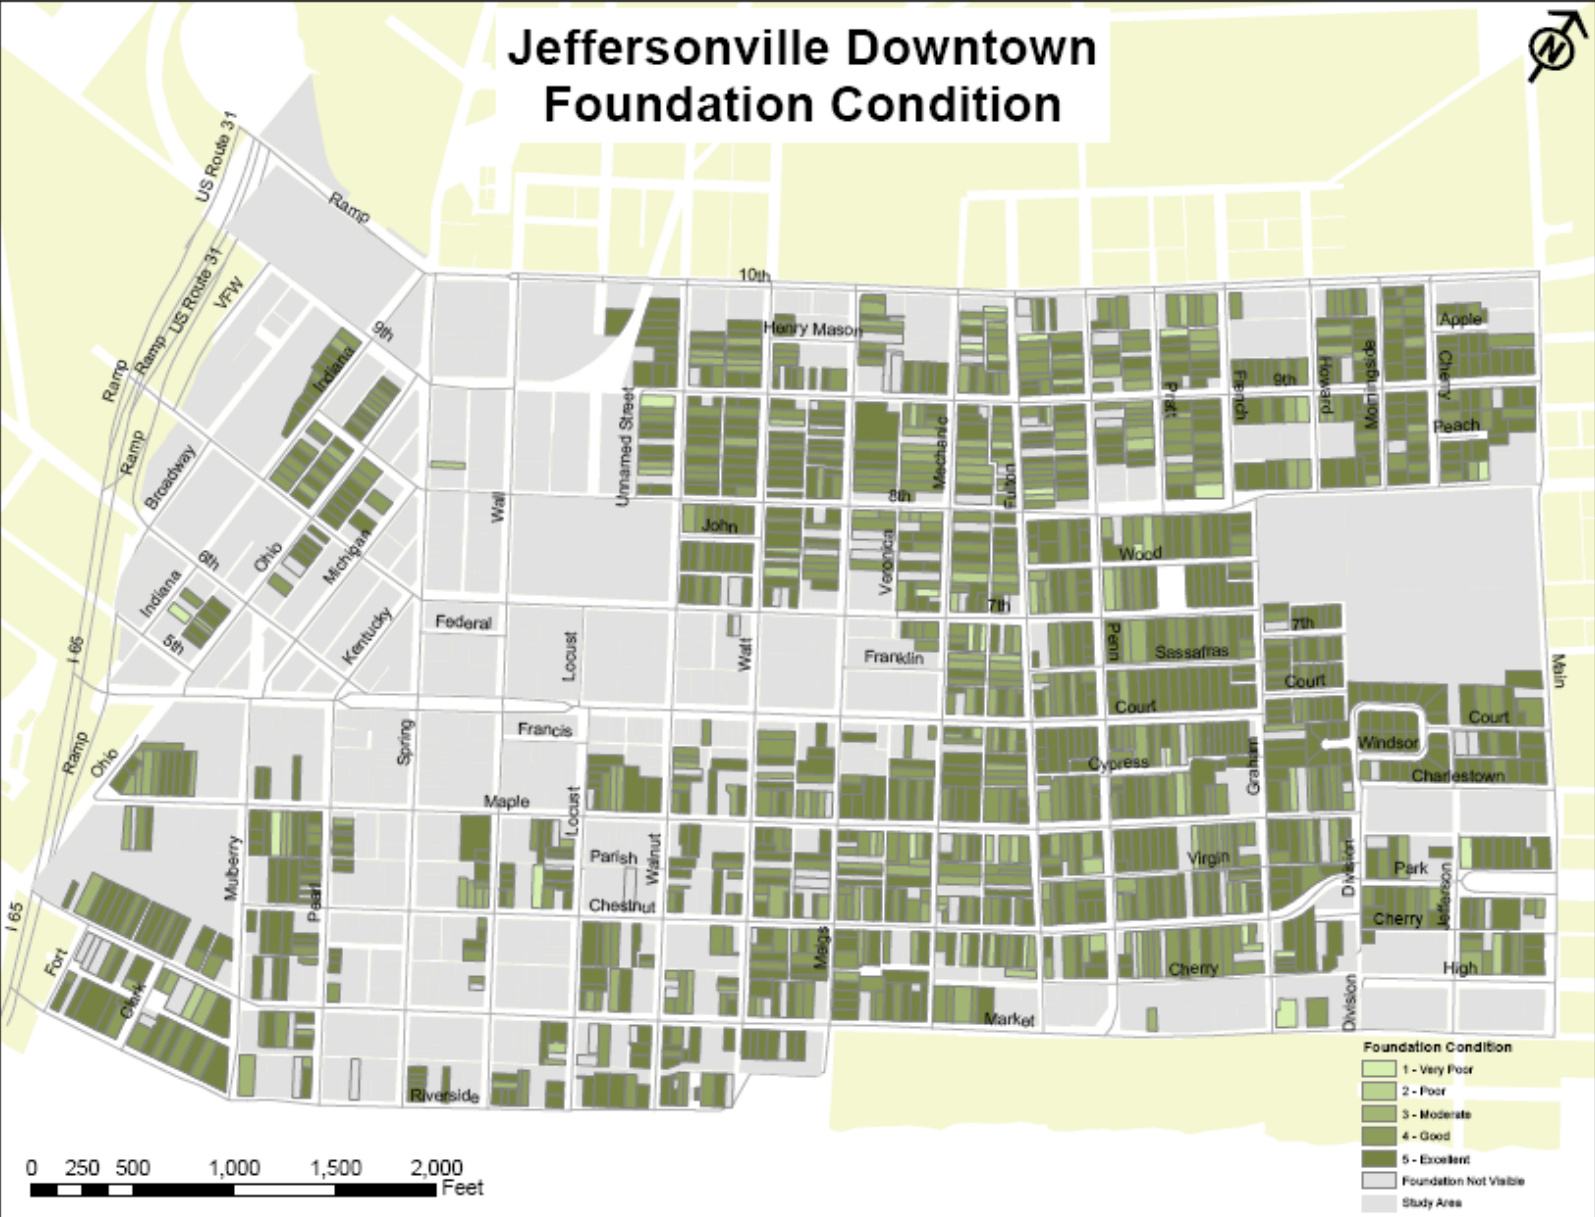
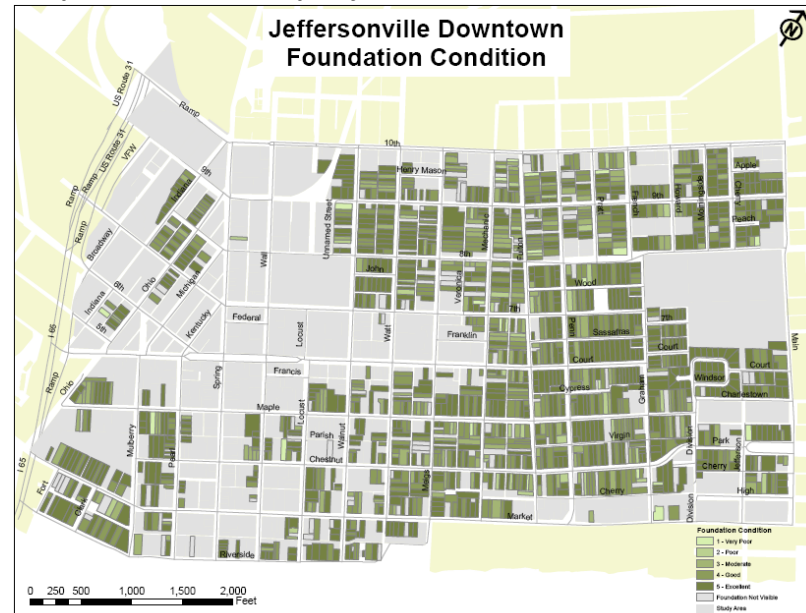
Map 16: Individual Property Foundation Condition

Note: Brick foundations consistently received more low ratings than stone foundations.

About half (53%) of the houses in the study area have foundations in excellent condition, followed by 27% in good condition, 11% in fair condition, and 4% in poor or very poor condition. Of the houses in the study area, 5% have foundations that are not visible due to dense shrubbery and landscaping. Foundation condition appears to be evenly distributed across the study area.

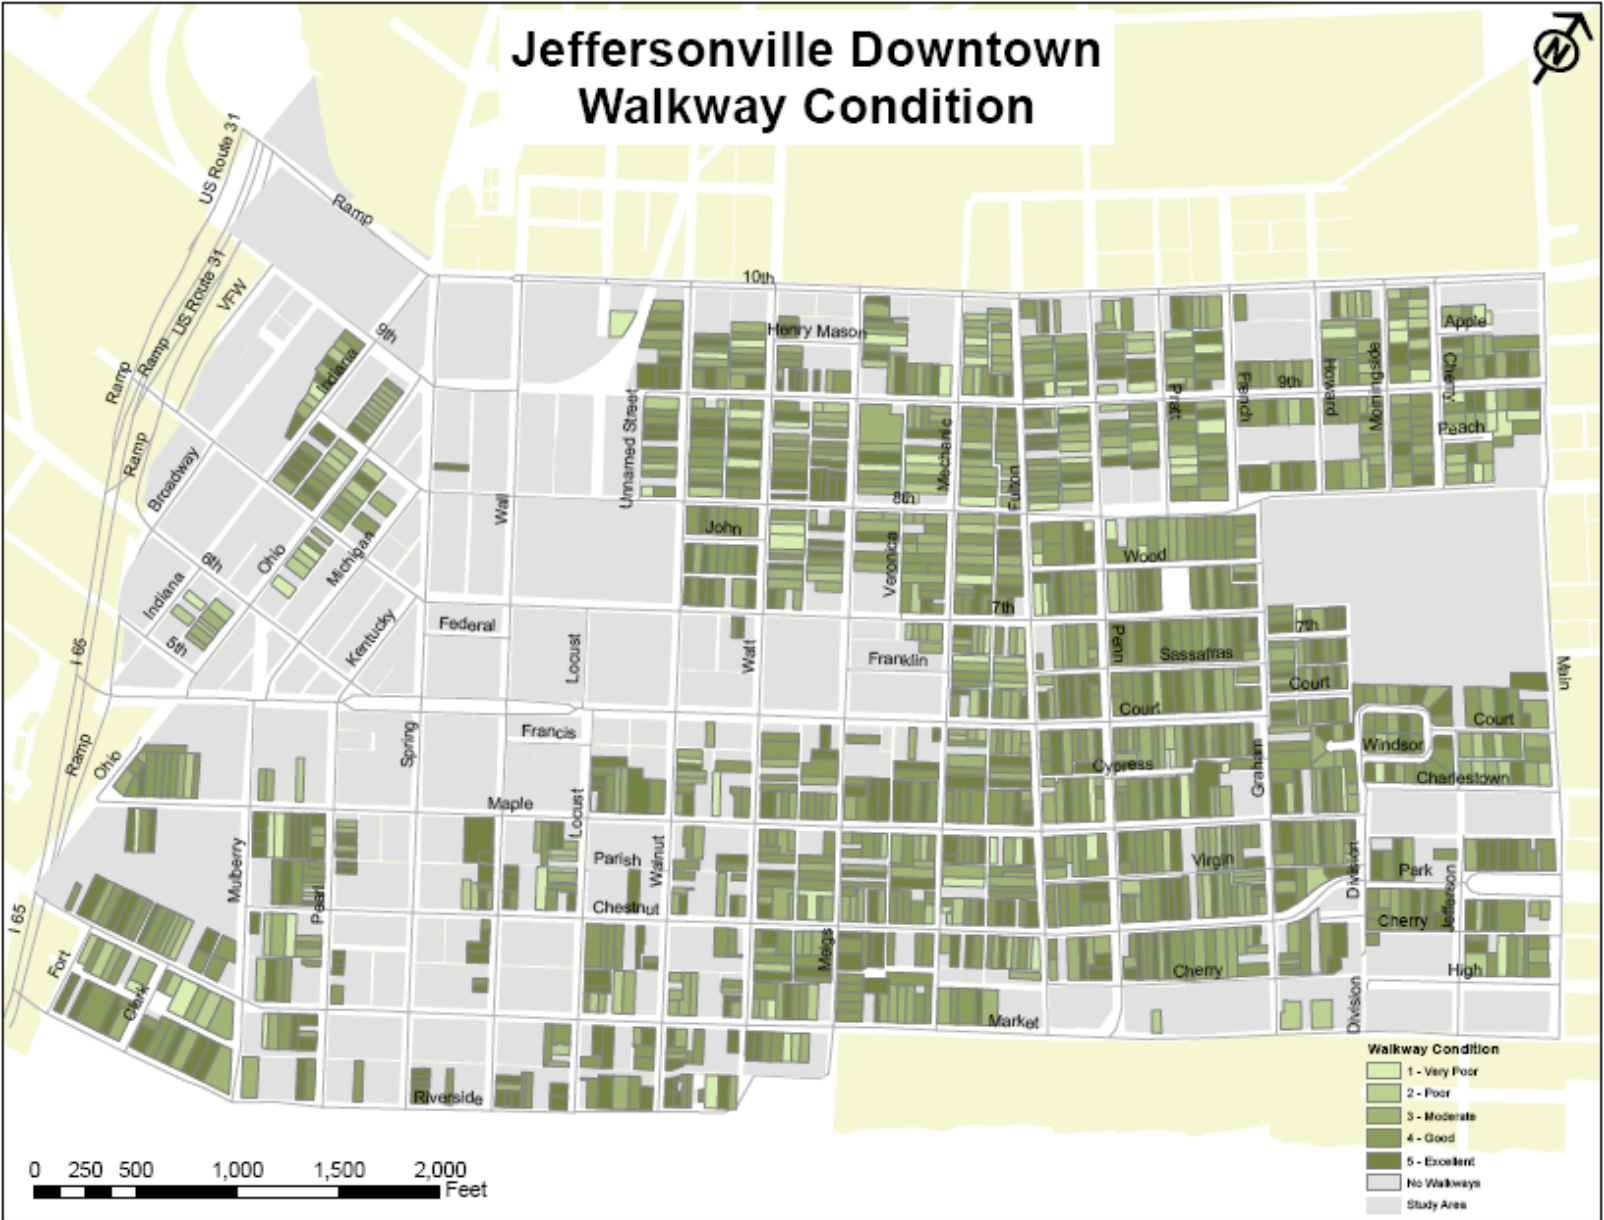
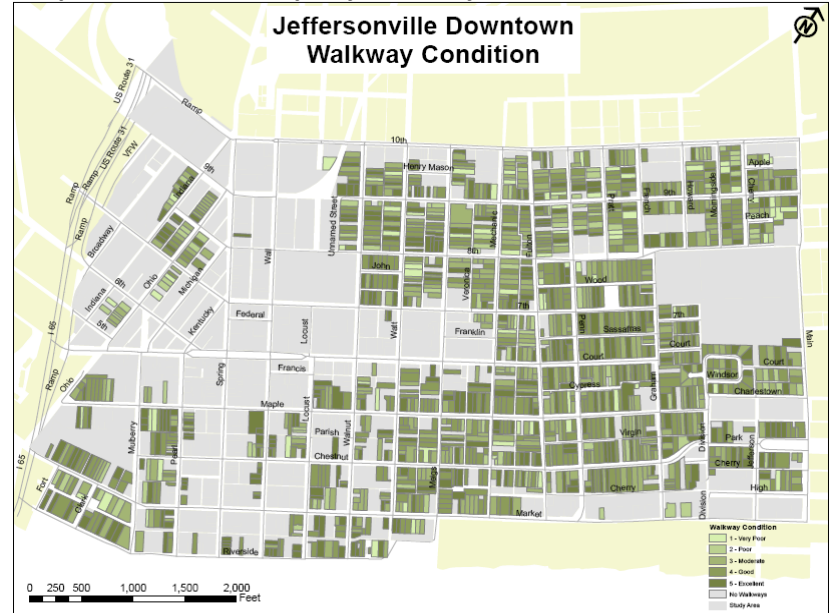
Map 17: Individual Property Walkway Condition

Walkways include any steps, paths, or other hard-surface areas intended for walking, as well as paved or gravel driveways. Most of the walkways in the study area are in good condition (36%), fair condition (26%), or excellent condition (25%), with a few in poor (7%) or very poor (5%) condition. Three houses in the study area had no walkways visible on the property. Walkway condition appears to be evenly distributed across the study area.

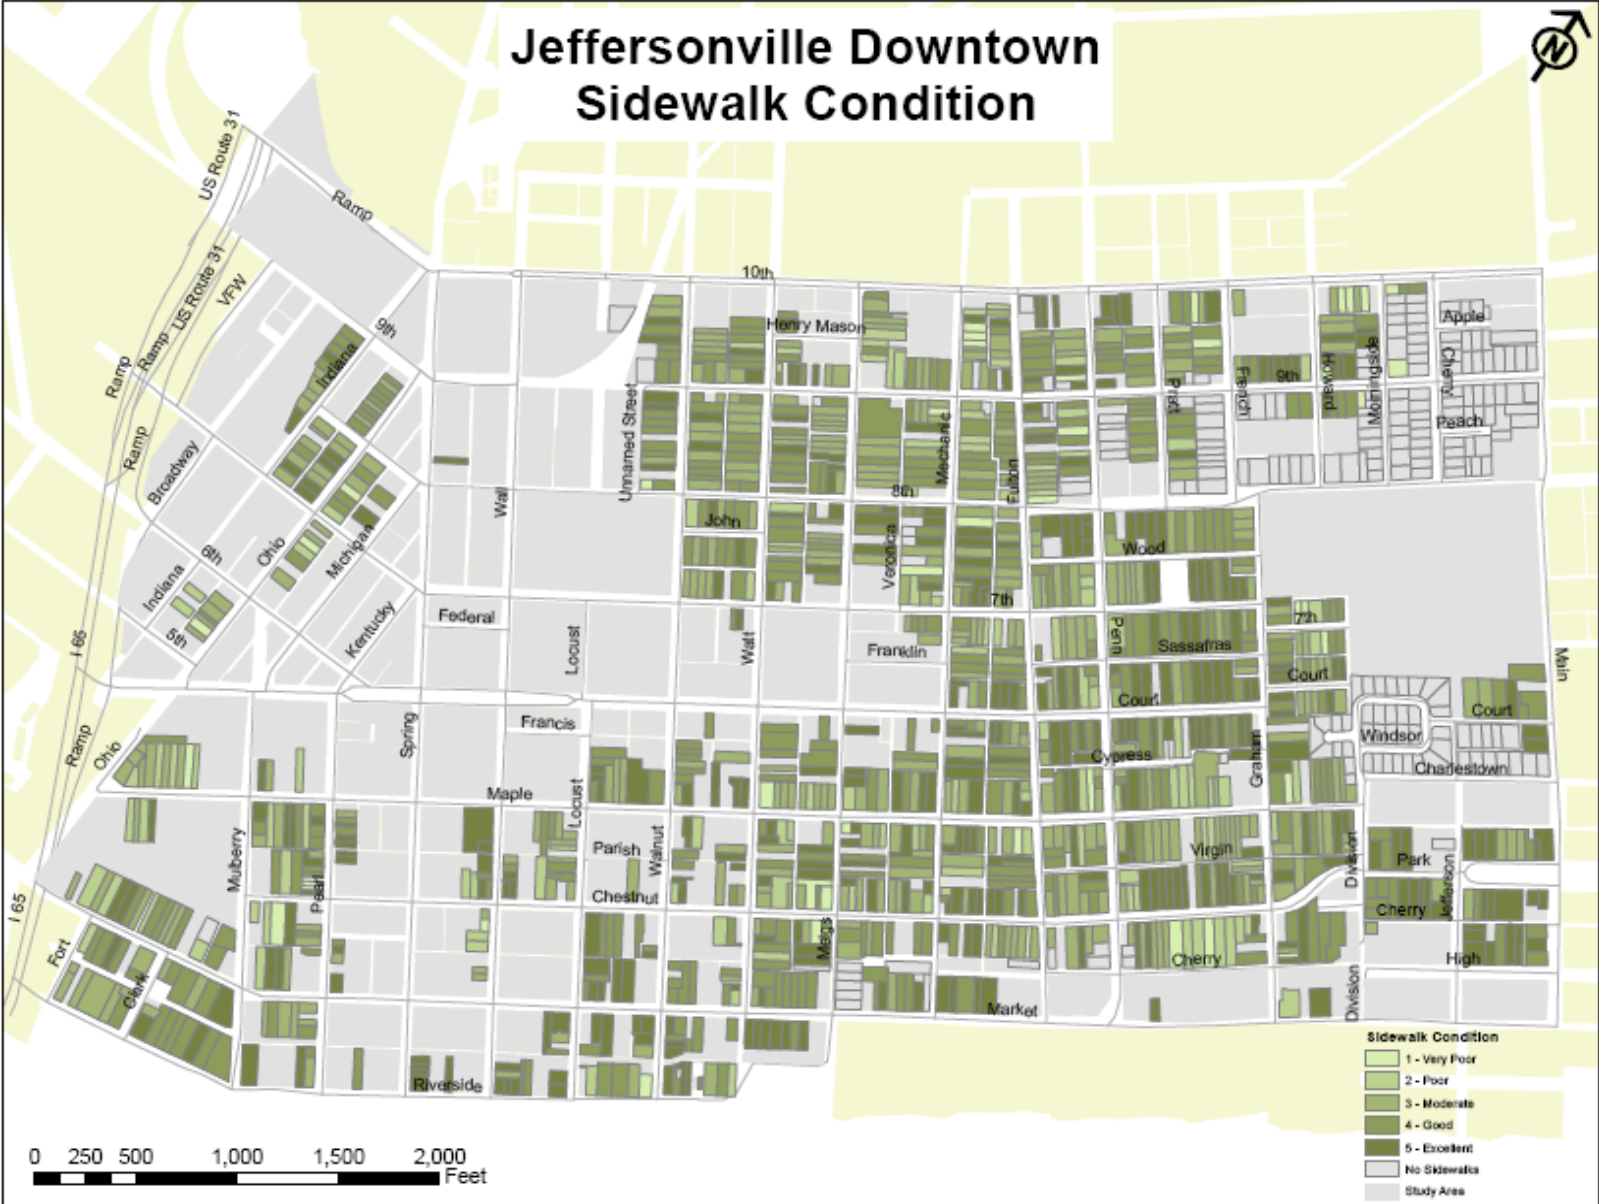
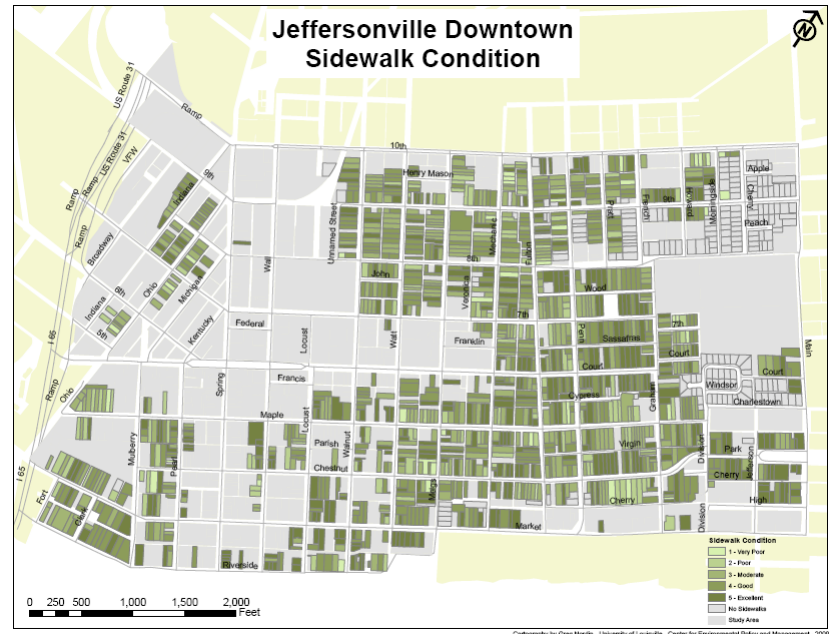
Map 18: Individual Property Sidewalk Condition

The condition of sidewalks on each individual property (in the public right of way) is rated. Most sidewalks were either in excellent (24%), good (28%), or fair (25%) condition, with only 11% in poor or very poor condition. 211 properties, or 13% of the total number of houses in the study area, did not have sidewalks on the property. Sidewalks on a block that were not on a residential property (in front of parking lots, commercial, etc.) were not rated here but are included in the block level sidewalk ratings in this report. Sidewalk condition does appear to vary, sometimes considerably, within blocks.

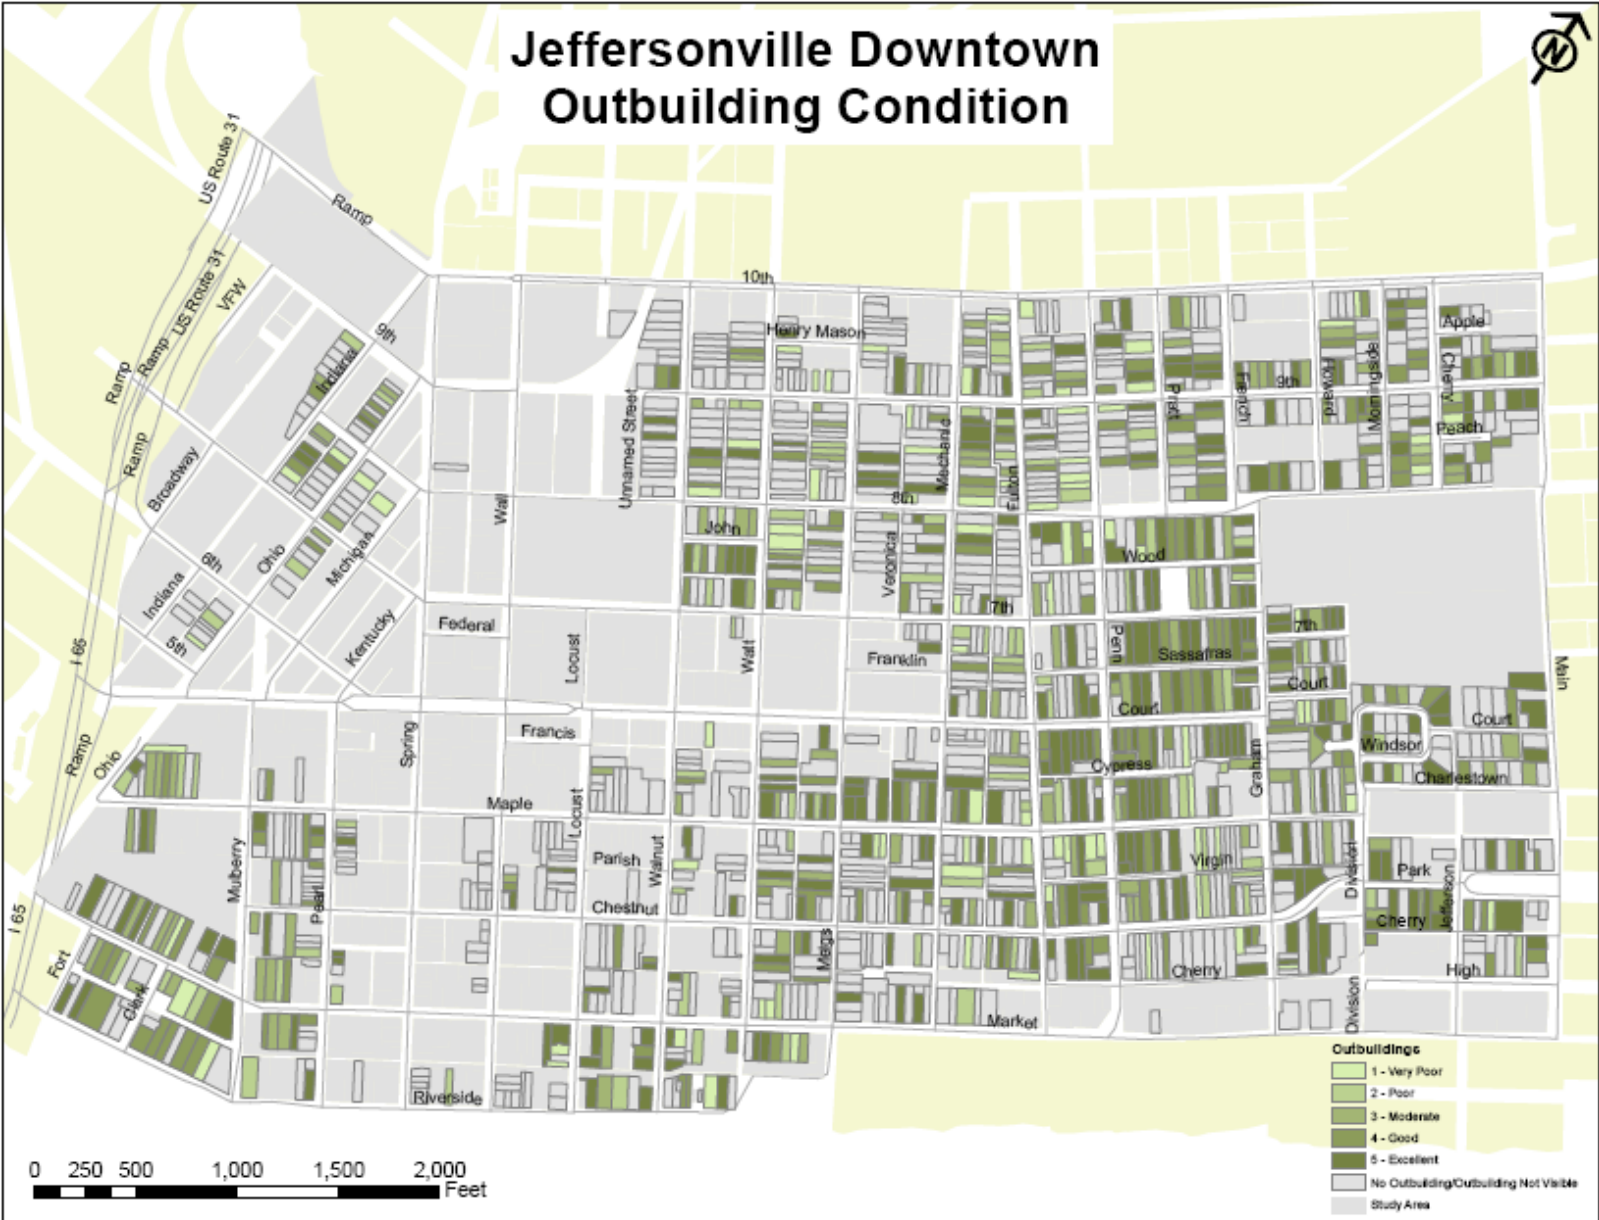
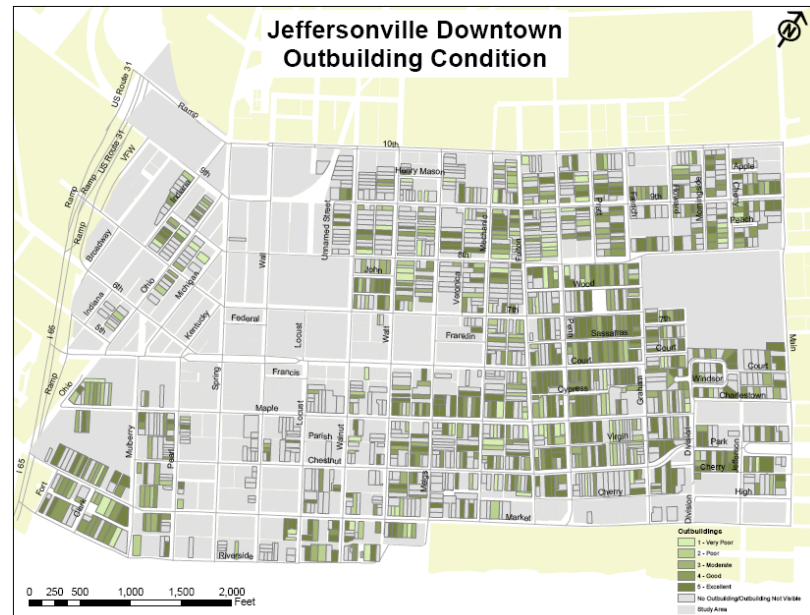
Map 19: Individual Property Outbuilding Condition

About half of the buildings in the study area have outbuildings (48%). Of the houses with outbuildings, 18% are in excellent condition, followed by 11% in good condition, and the remaining 19% are in fair to very poor condition. There appears to be a high concentration of outbuildings just west of the cemetery and in the southwest corner of the study area. The outbuildings west of the cemetery appear to be in the best condition.

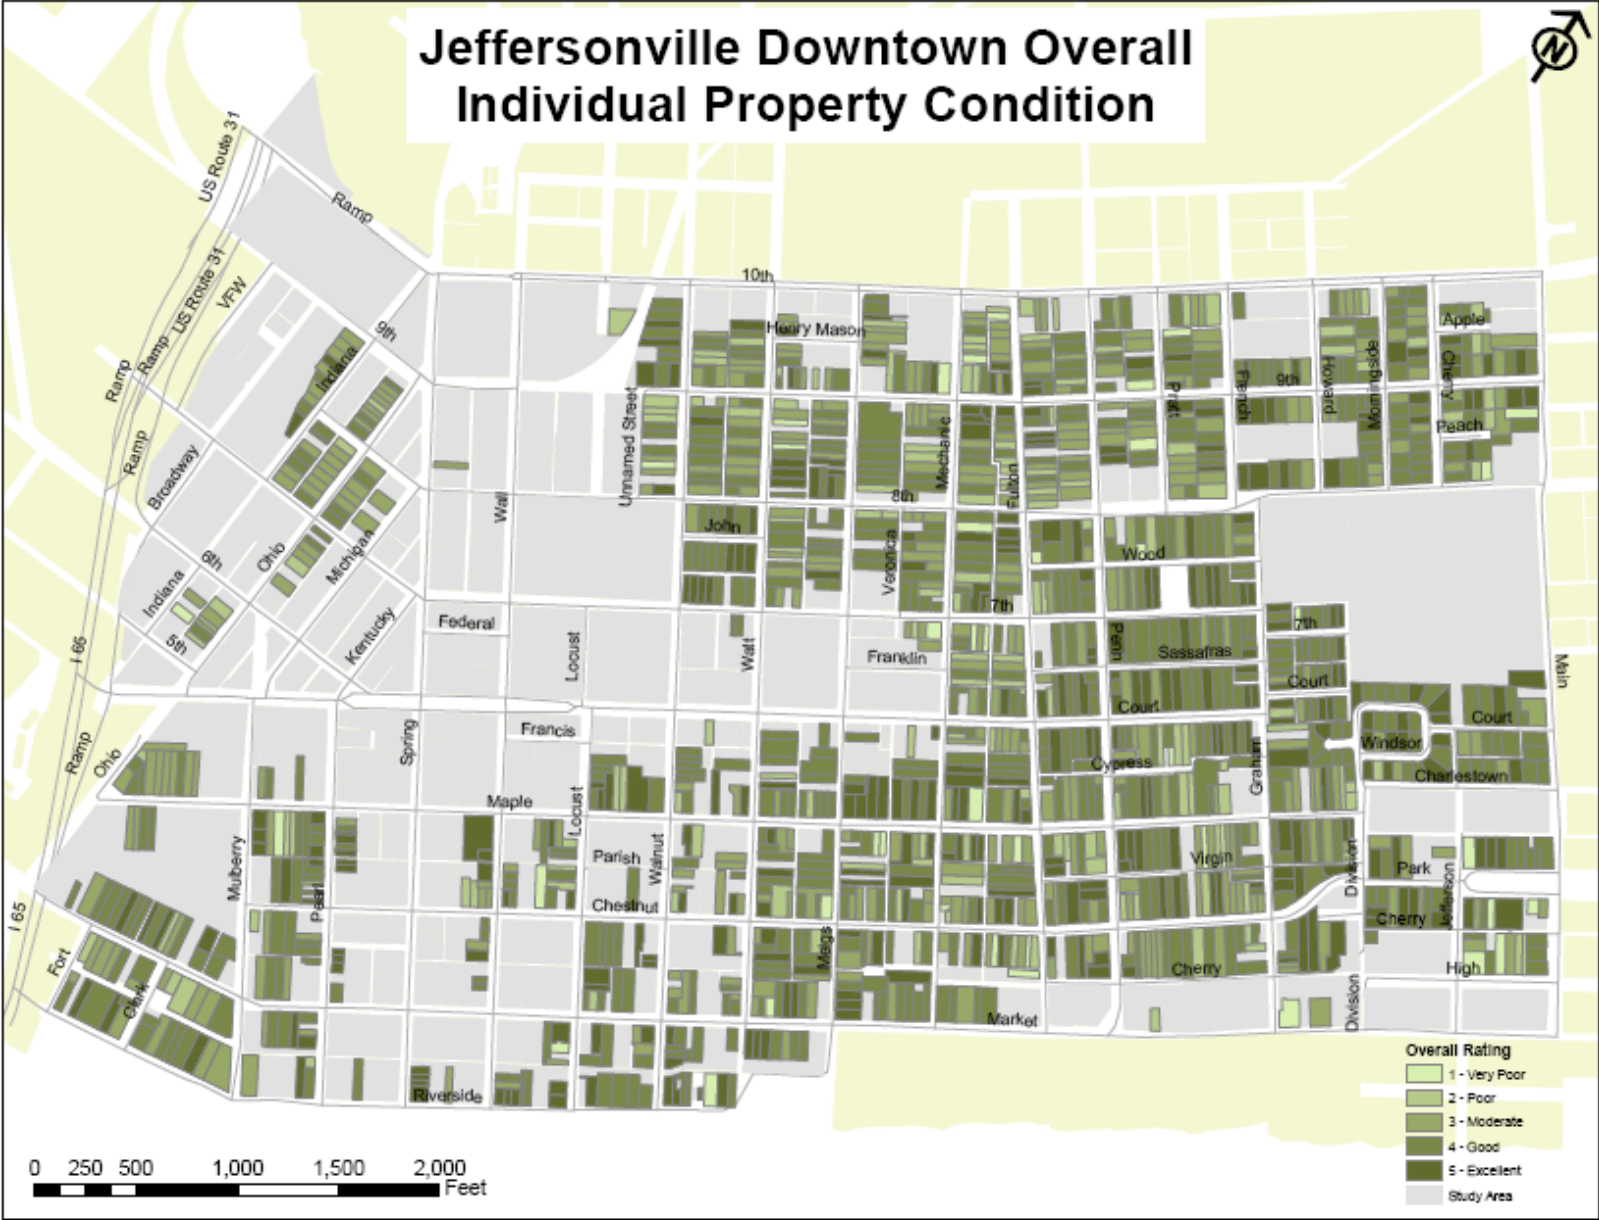
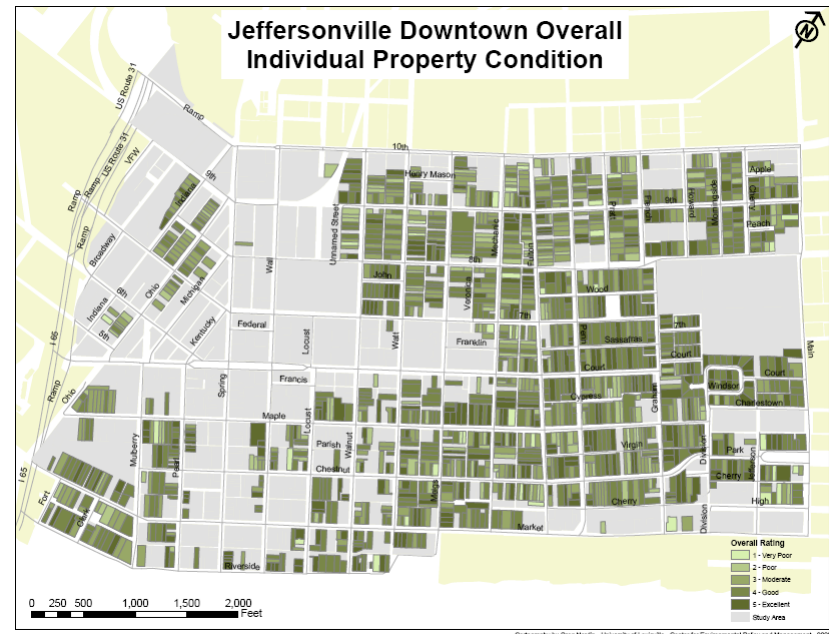
Map 22: Individual Overall Property Condition

Most of the houses in the study area are in good overall condition (42%), followed by 25% in fair condition and 21% in excellent condition. There are 10% of the houses in poor condition and 44 houses (3%) are in very poor condition. Overall housing condition appears to be evenly distributed across the study area. There are no blocks or portions of the study area with high concentrations of houses in poor or very poor condition.
