SIXTH FIVE-YEAR REVIEW REPORT FOR LEE'S LANE LANDFILL SUPERFUND SITE JEFFERSON COUNTY, KENTUCKY

AUGUST 2018

U.S. Environmental Protection Agency Region 4 Atlanta, Georgia

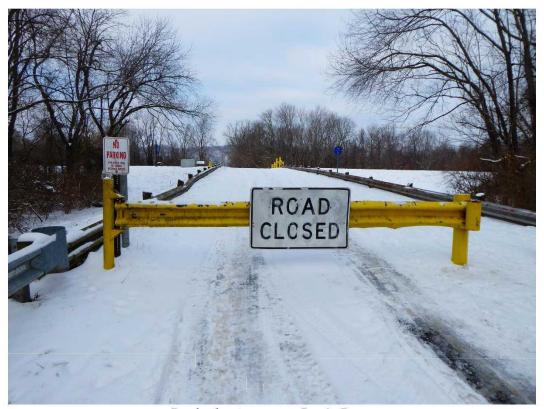
Locked entrance on Lee's Lane

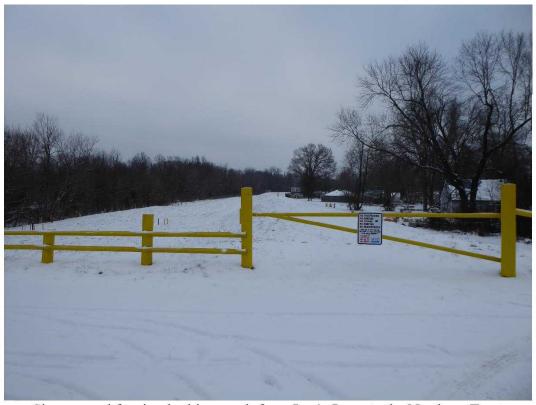
Signage and fencing looking north from Lee's Lane to the Northern Tract

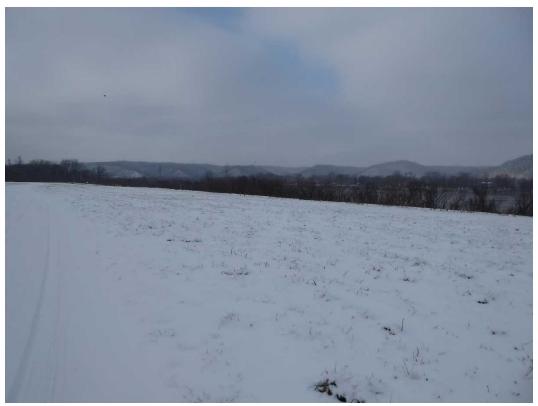
Capped area with Ohio River beyond rip-rap and tree line

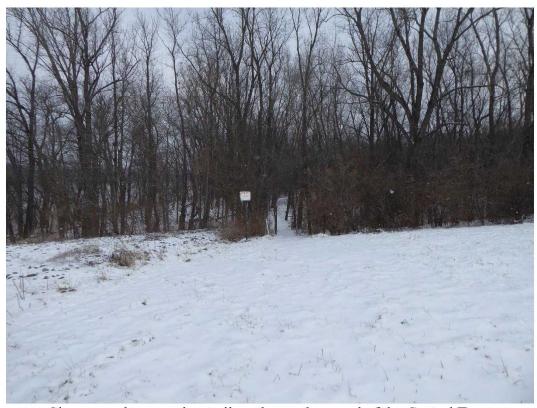
Signage and trespassing trail on the northern end of the Central Tract

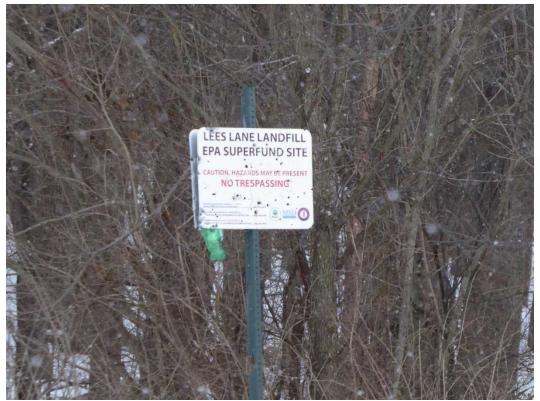
Example of site signage

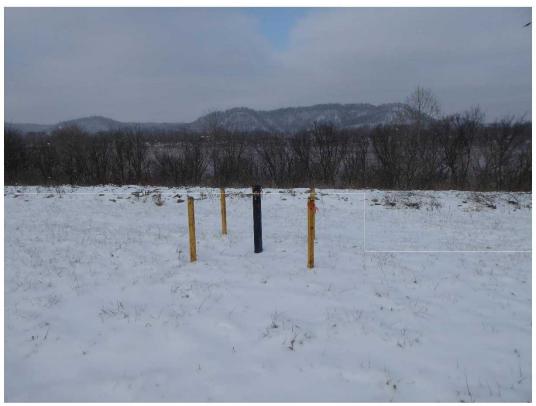
Monitoring well on capped area with Ohio River beyond the tree line

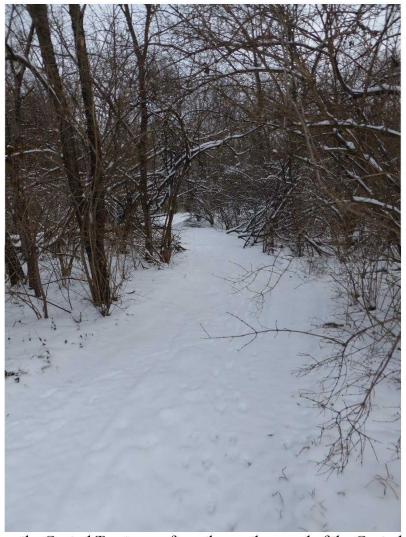
Trail on the Central Tract, seen from the southern end of the Central Tract

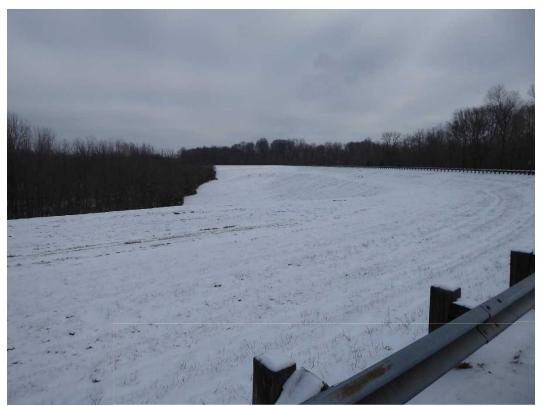
Eastern side of the Southern Tract, seen from the levee

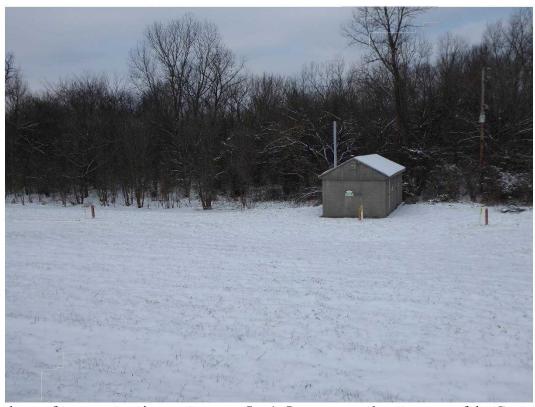
Blower house for gas extraction system near Lee's Lane, on northeast corner of the Central Tract

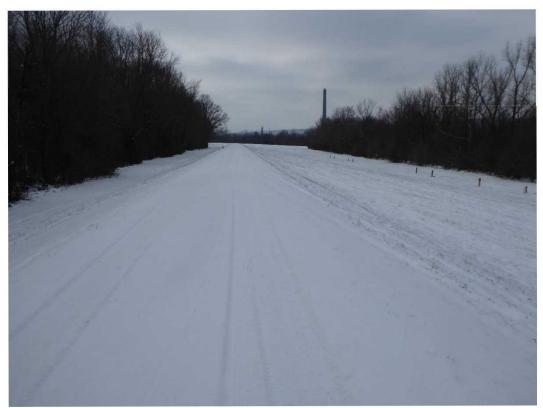
Louisville Loop on levee looking south from Lee's Lane; Site on right with Louisville Gas & Electric stack in background
