The Crash of Air Florida Flight 90

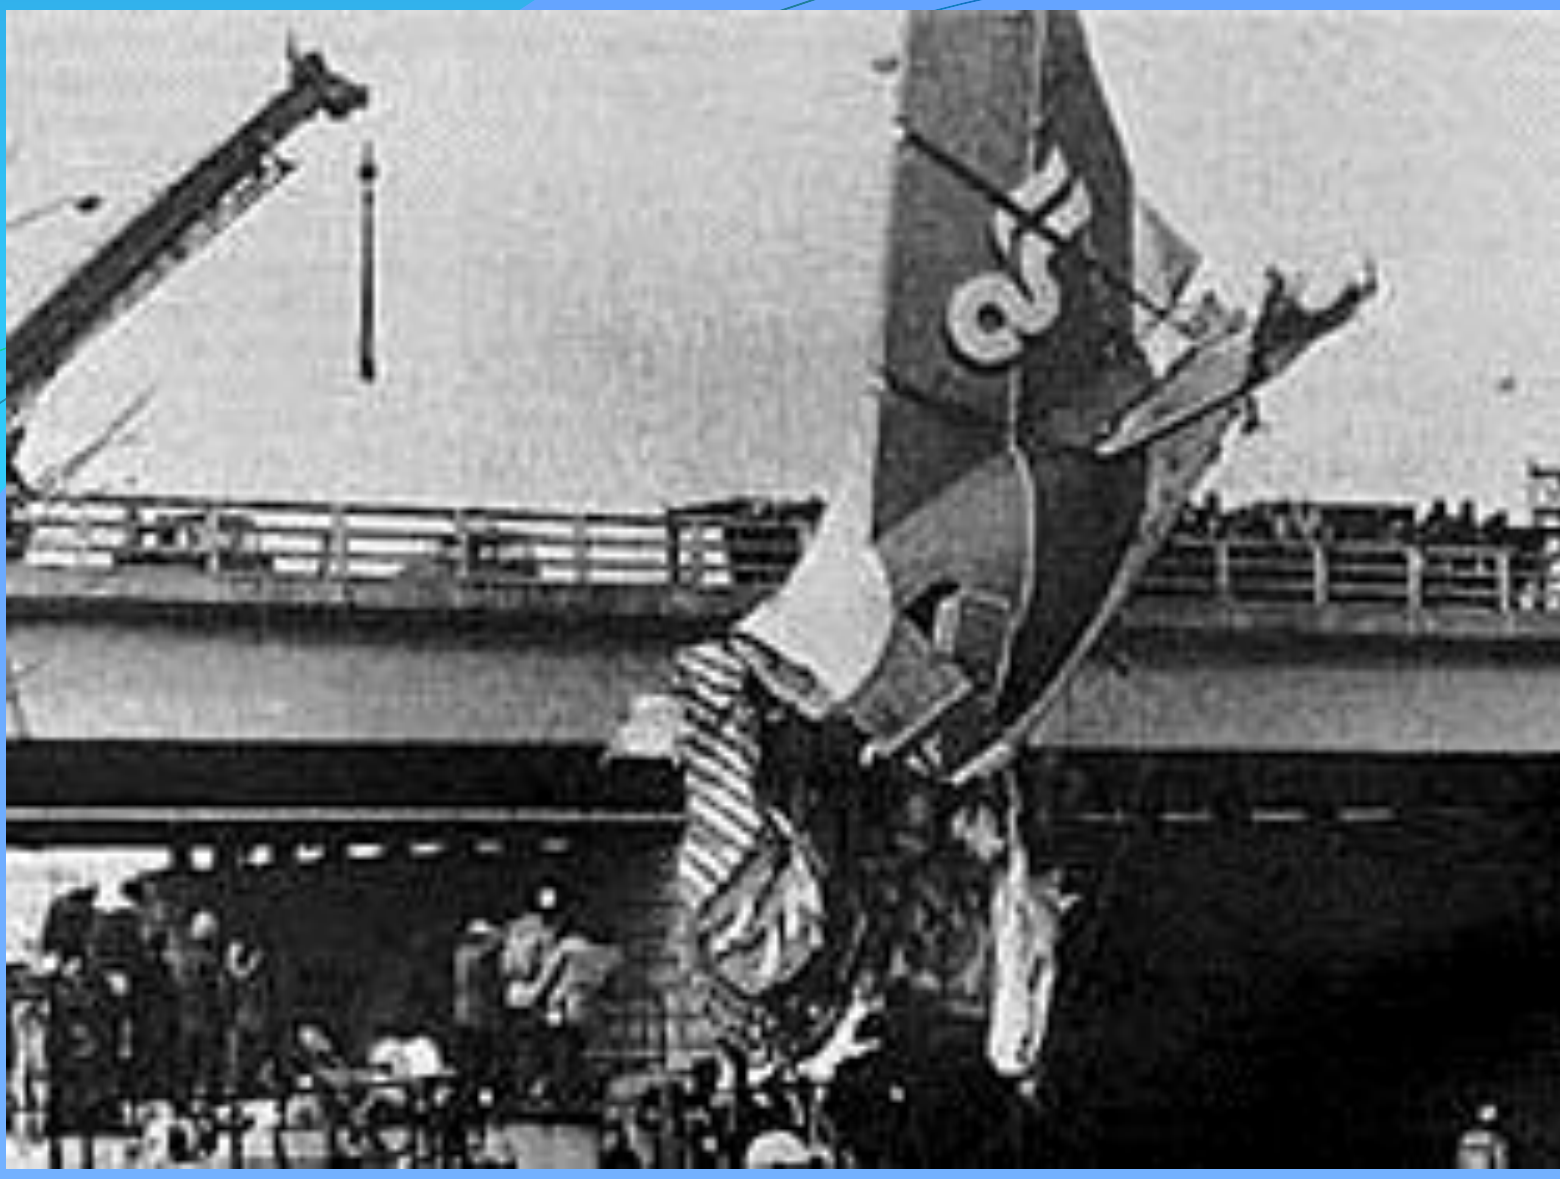
Salvage operations on January 19, 1982.
Photograph courtesy of airdisaster.com.

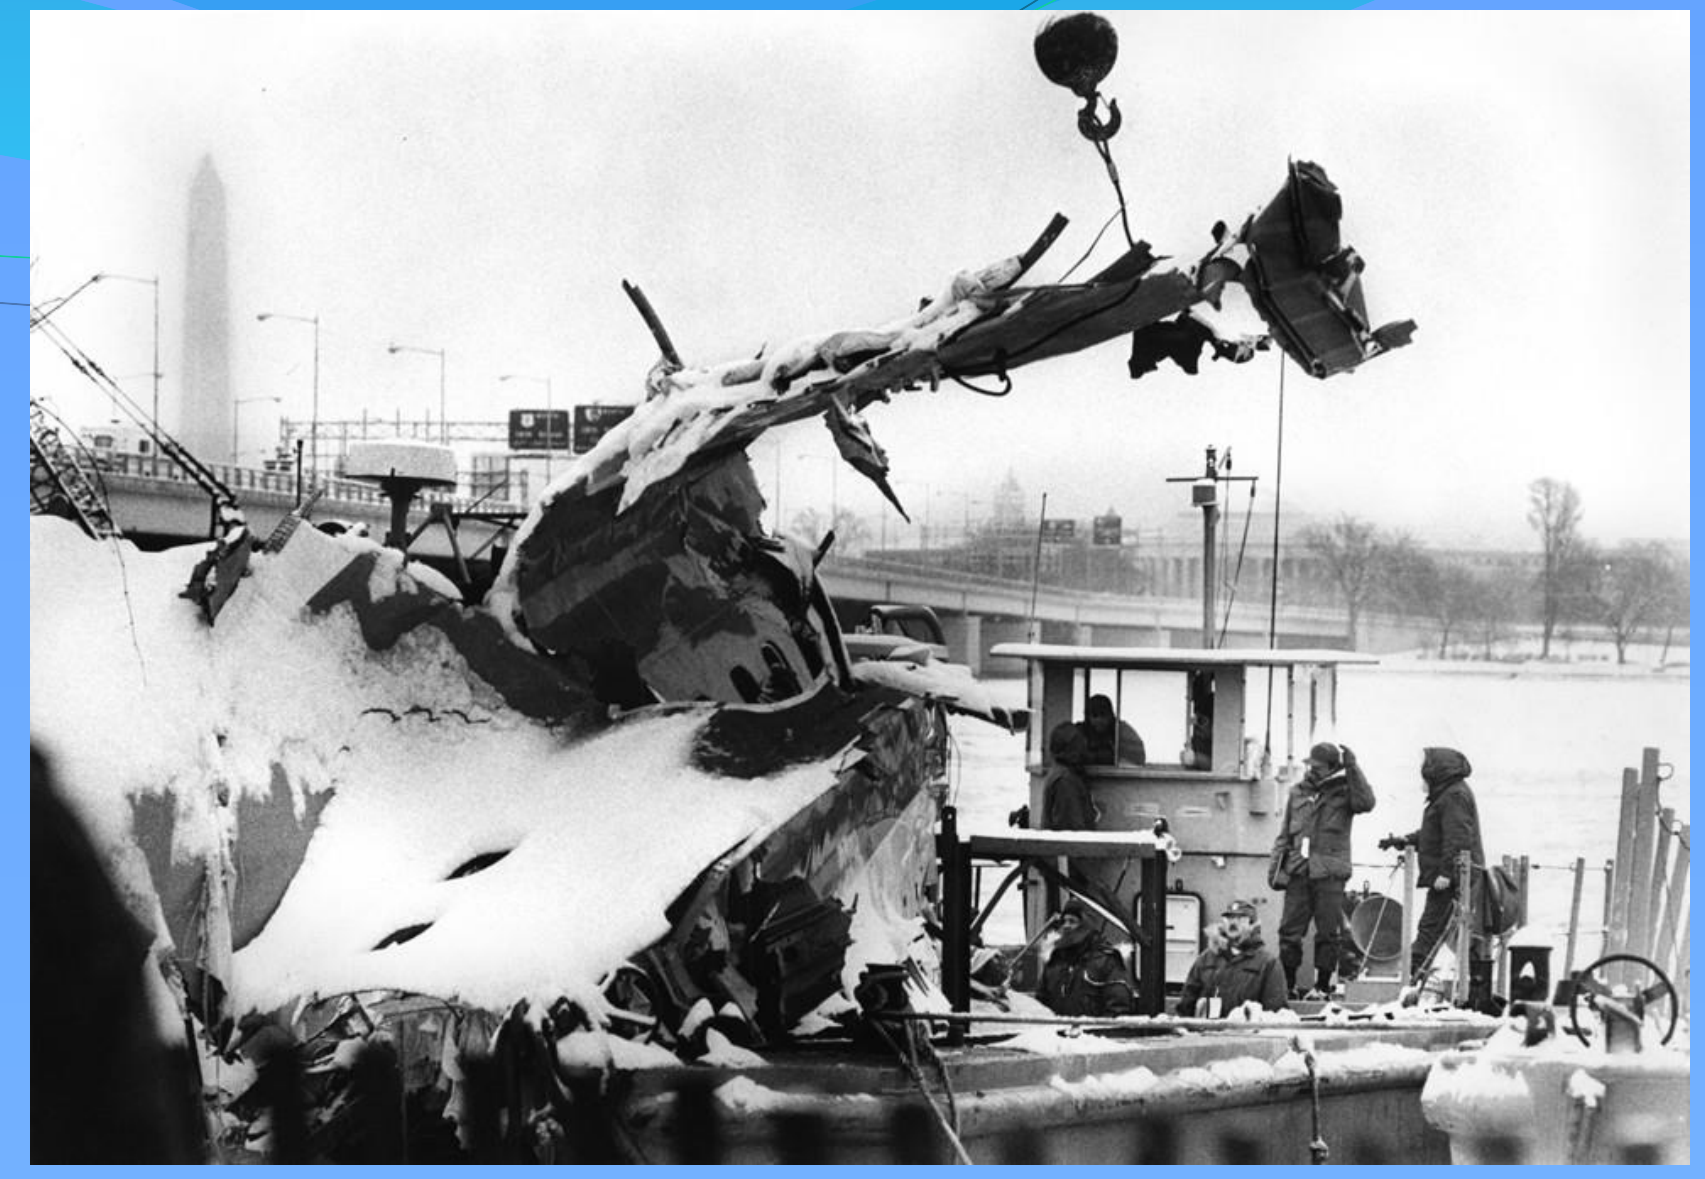
Salvage operations on January 19, 1982.
Photograph courtesy of The Washington Post.

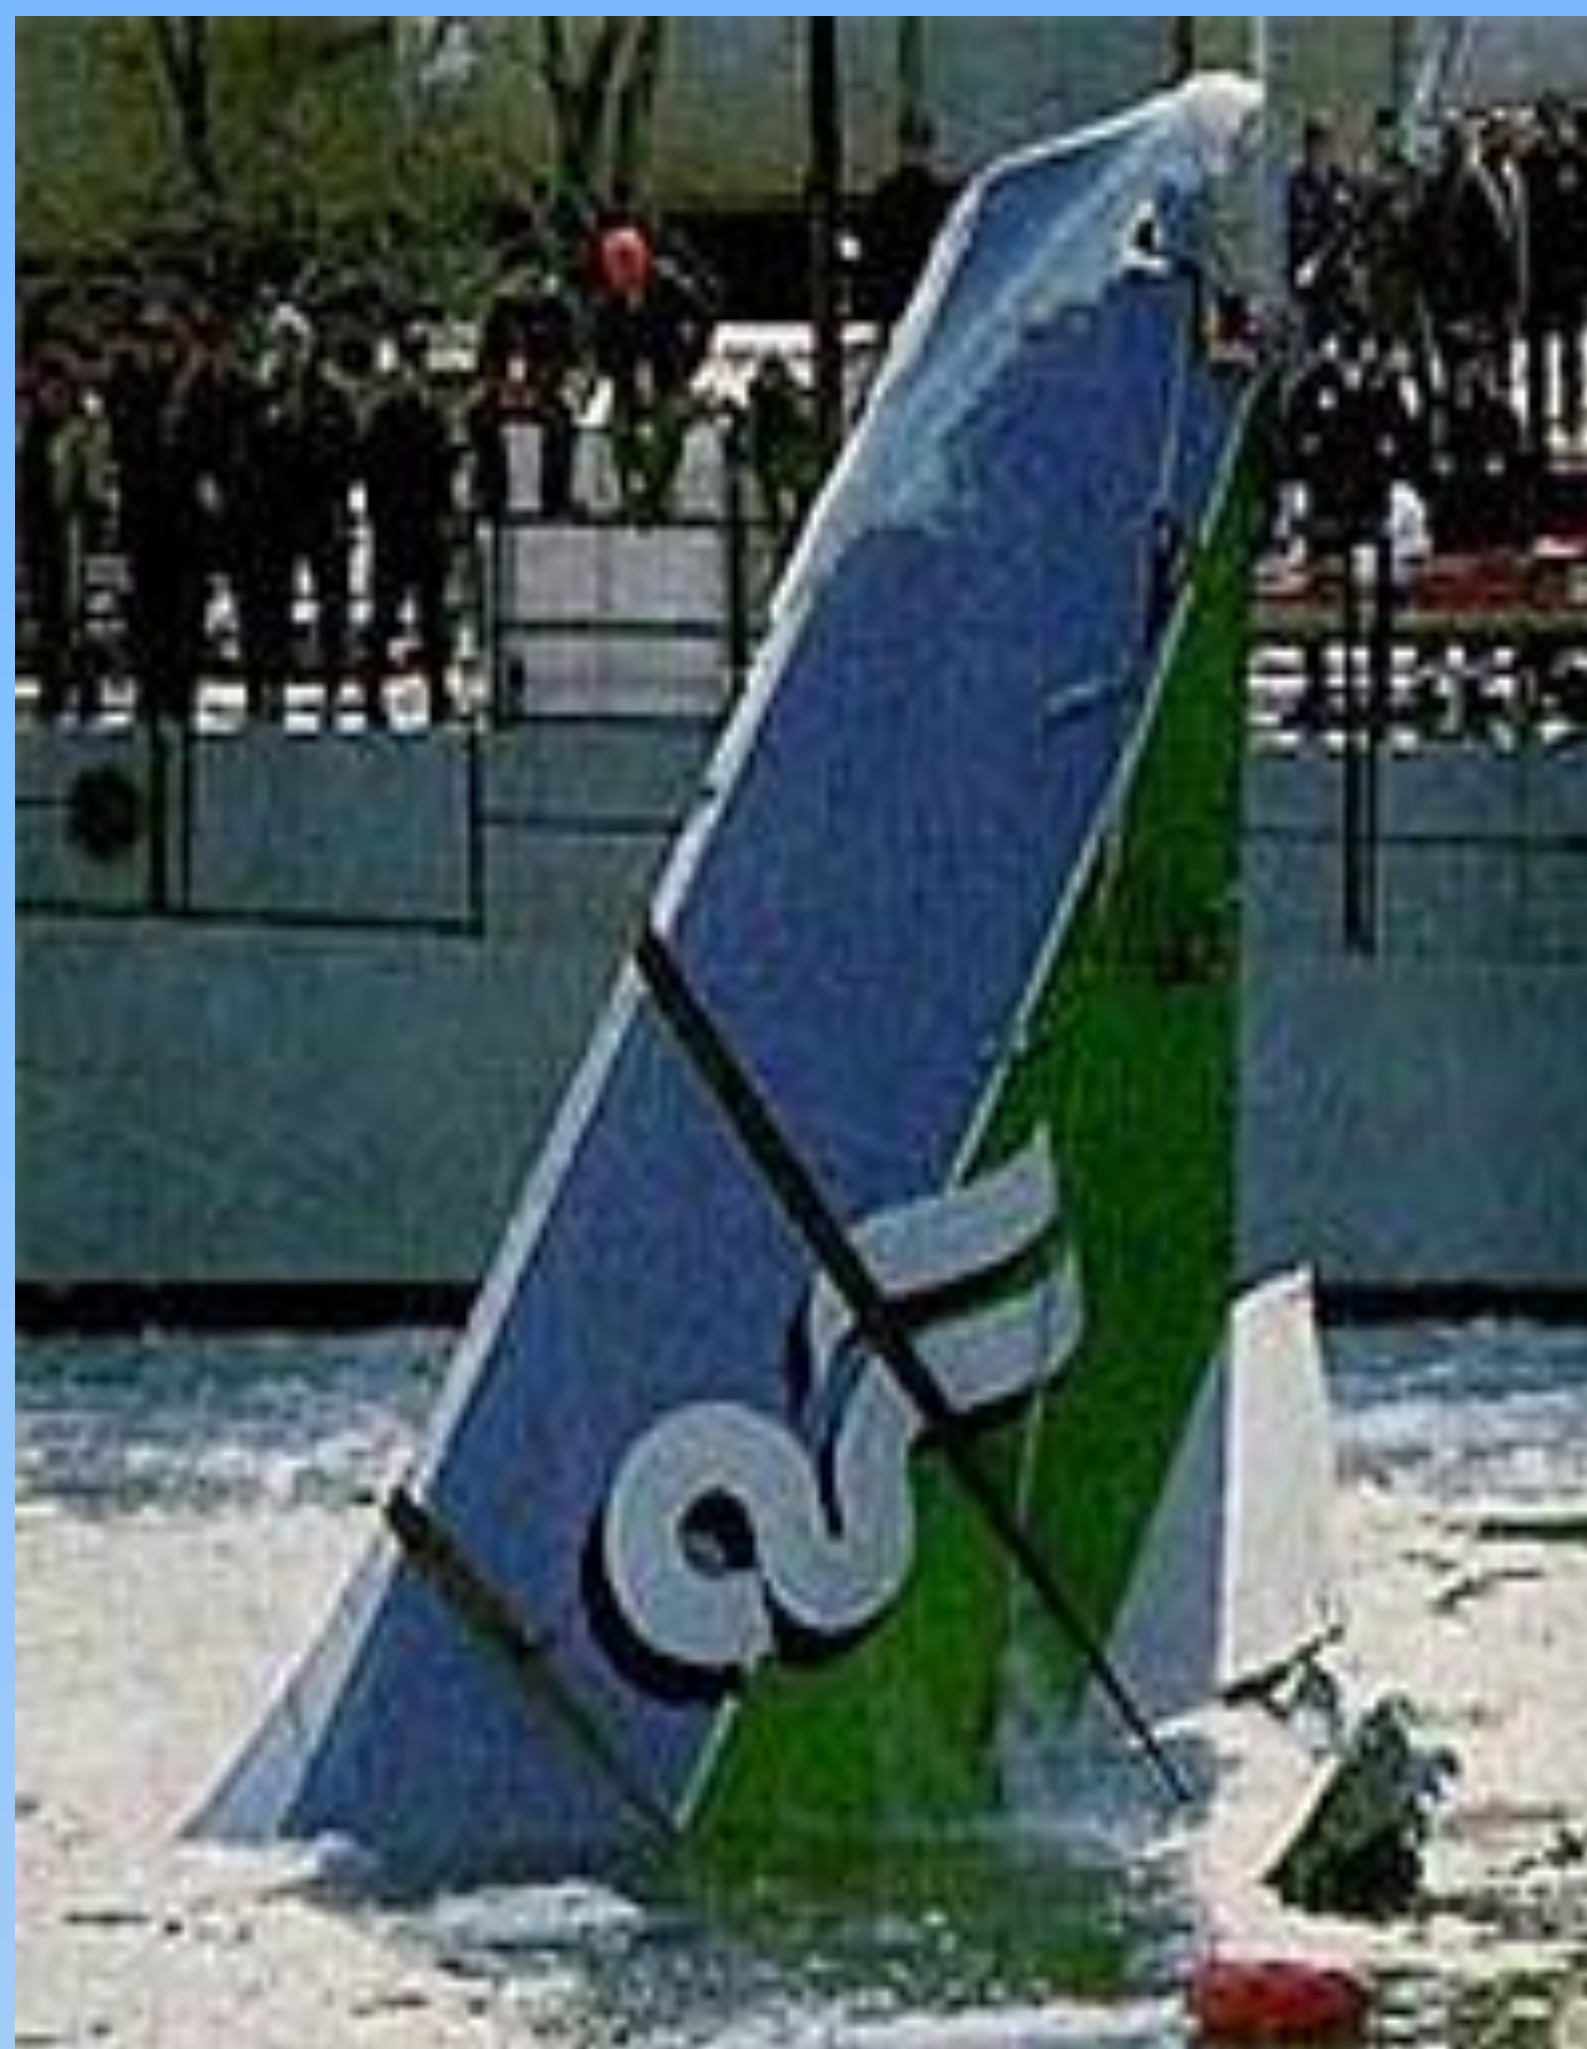
Salvage operations on January 19, 1982.
Photograph courtesy of airdisaster.com.
