Conceptual Site Model

Lee's Lane Landfill Site
Louisville, Kentucky

Report Prepared by Lee's Lane Landfill Group and The
Louisville and Jefferson County Metropolitan Sewer
District

089257 | Report No 3

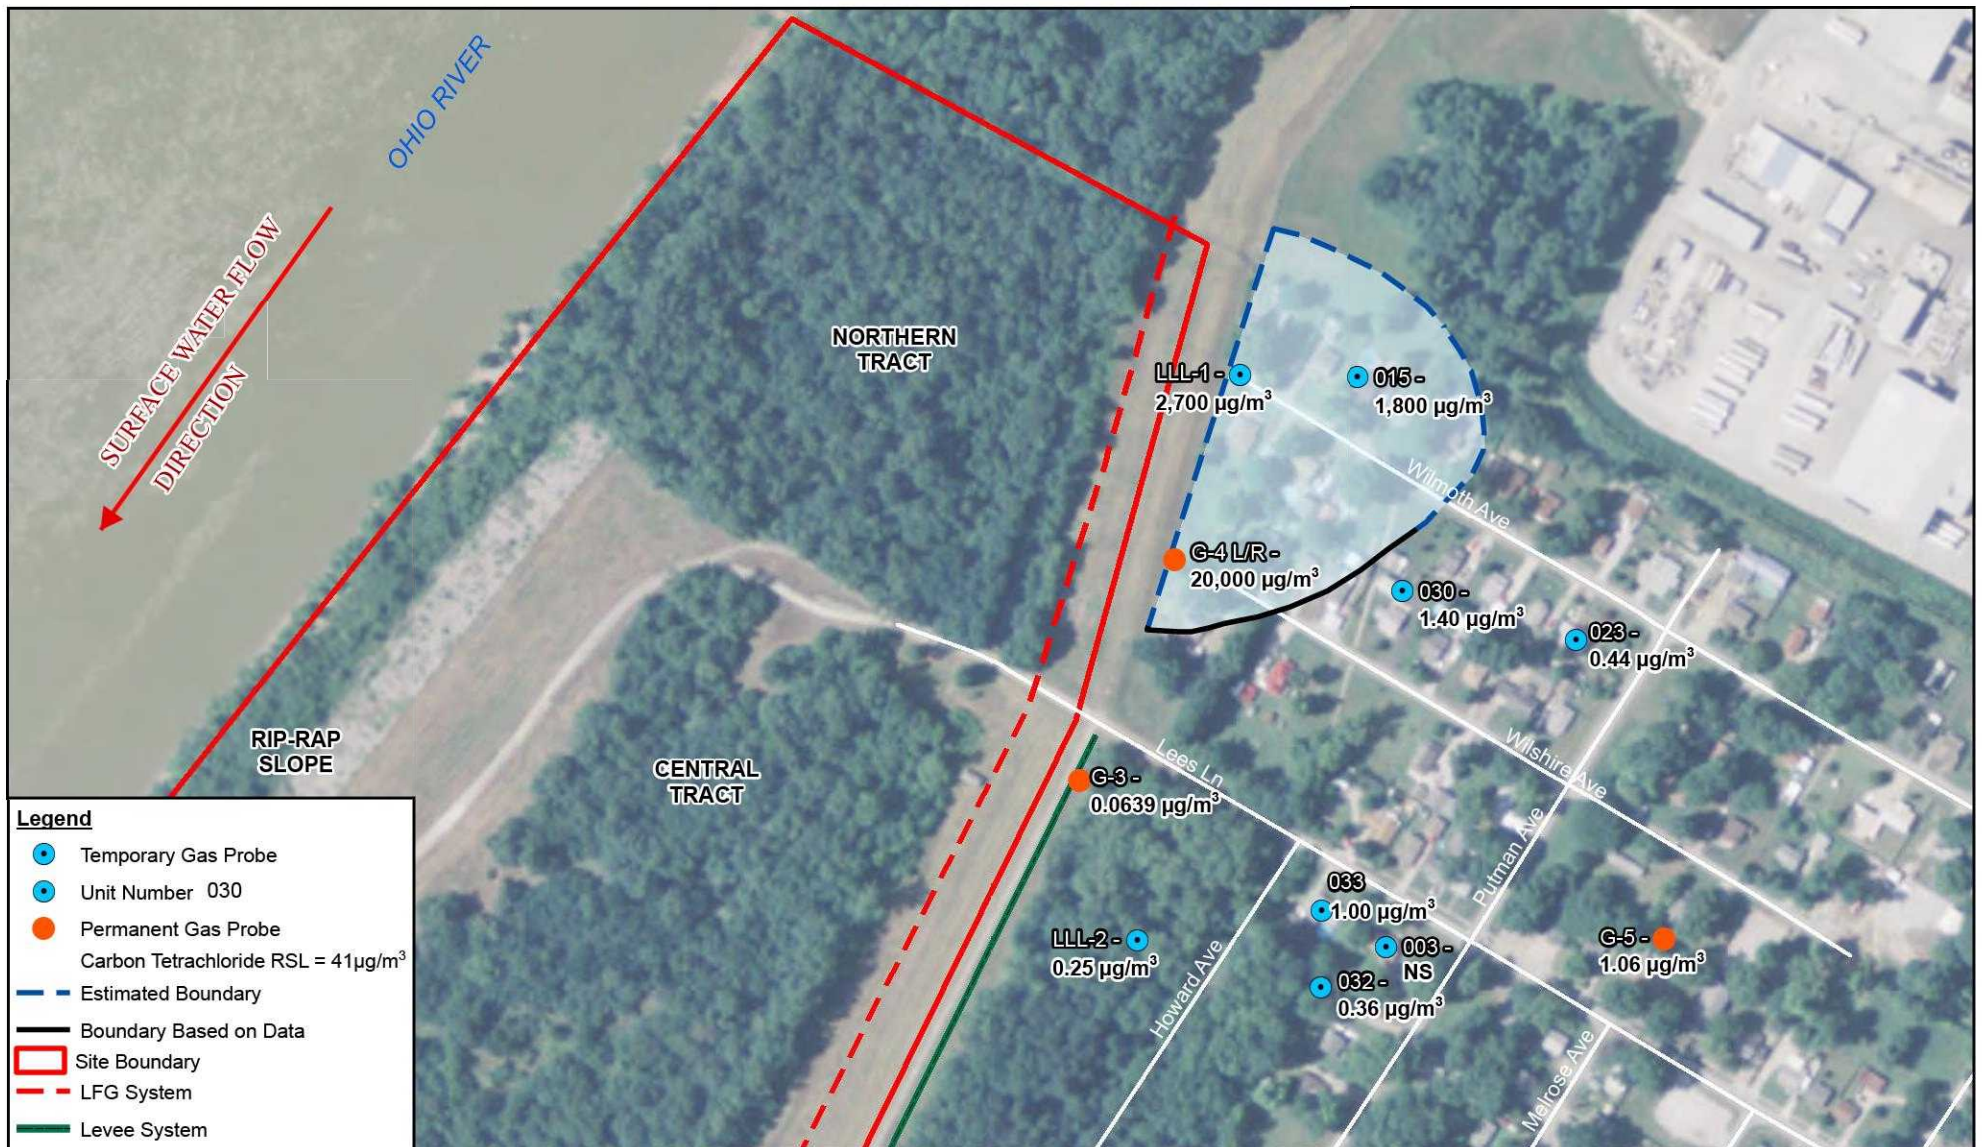
FIGURE 6.3

CARBON TETRACHLORIDE RSL MAXIMUM VALUES
