## Chapter 4 Iroquois Park

Prepared by Andropogon Associates, Philadelphia PA

### Renewal Strategy

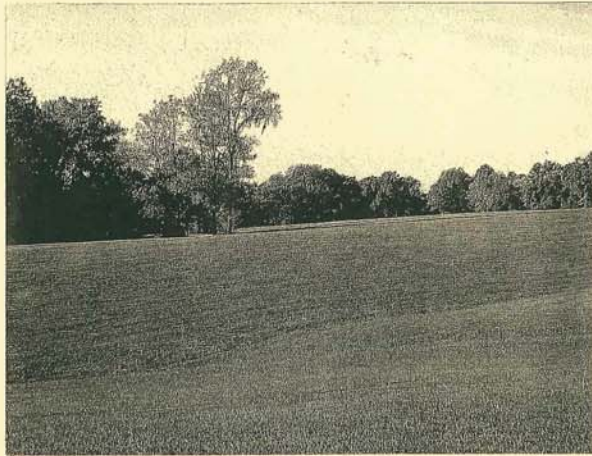
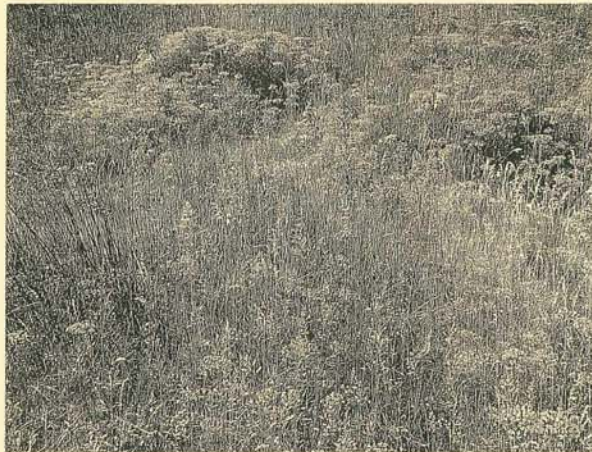
(Top) View of existing Summit Field, with its great expanse of poorly established turf, which contributes to increased stormwater runoff in the downslope gullies. (Andropogon Associates, 1993)

(Bottom) View of enriched savannah/meadow. Such enrichment of Summit Field and the marginal areas along the forested slopes would mitigate stormwater runoff and be evocative of the original oak savannah proposed by Olmsted. (Andropogon Associates, 1993)

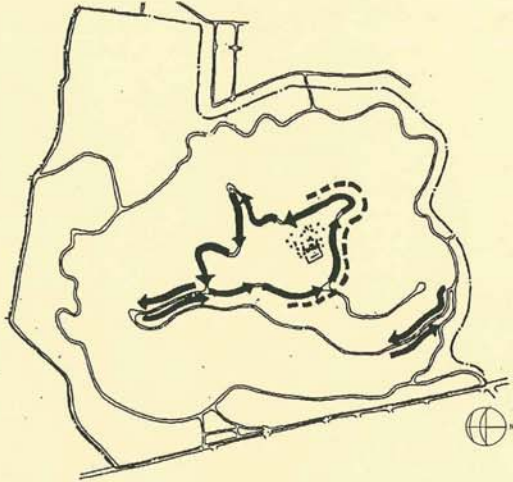
For vehicular access to the hilltop, Toppill Road around Summit Field would be one-way, counterclockwise, with designated parking areas at the overlooks and near Jacob's Lodge. For special events, parallel parking would be permitted on Toppill Road.

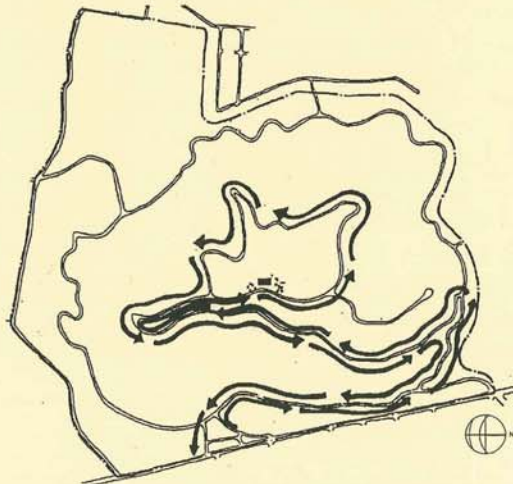
For Winterfest, buses would pick-up passengers at the amphitheater parking lot and go around Summit Field with a stop at Jacob's Lodge. No vehicular access would be permitted.

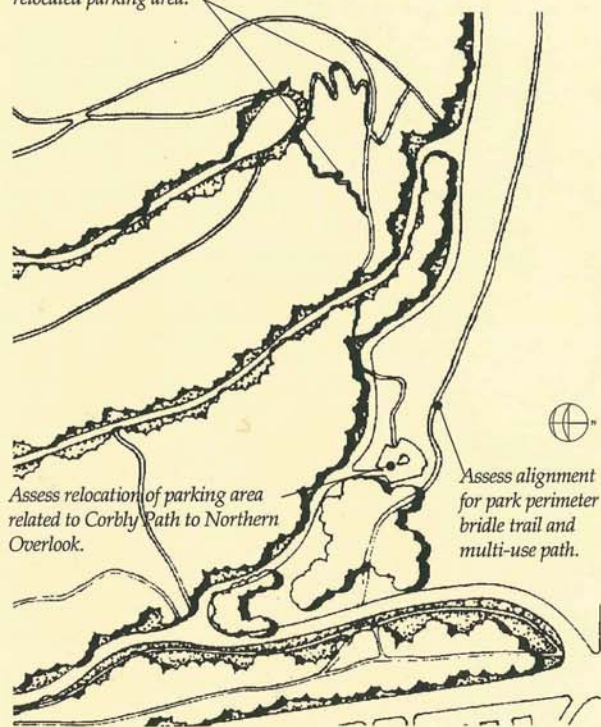
Illustrative Master Plan for Iroquois Park, showing Northern Overlook, with existing switchback trail and steps in need of repair, along with a proposed alternate alignment—the Corbly Path described on the 1897 General Plan—to a new parking area off Rundill Road.

The steps to the Northern Overlook pose another serious drainage and erosion problem, which should be addressed in a comprehensive way. To construct a functional drainage system for these steps, which are deteriorated, settled wood railroad ties, it appears likely that the entire length of steps would have to be dismantled in order to install an underdrainage system of inlets and culverts. The cost of this reconstruction and repair should be evaluated against an alternative alignment. Both the master planning team and historians Charles Beveridge and Arleyn Levee recommend this approach. Alternative path alignments should evaluate the benefits of the Corbly Path on the 1897 plan, which starts south of the Southern Parkway entrance, crossing Rundill Road and Uppill Road, to the overlook with steep areas requiring steps. The steps "should be constructed using appropriate materials and in a style suitable to a scenic reservation."—from Charles E. Beveridge and Arleyn A. Levee, "Louisville's Olmsted Legacy: Cherokee, Iroquois and Shawnee Parks, A History," (1992), p. 103. If this alternative proves feasible, the parking area at the base of Uppill Road should be removed and the entire slope stabilization area of the old switchback route should be temporarily protected by fencing while the new plantings are taking hold. A new parking area is proposed off Rundill Road, with a new path link to the Corbly Path alignment.

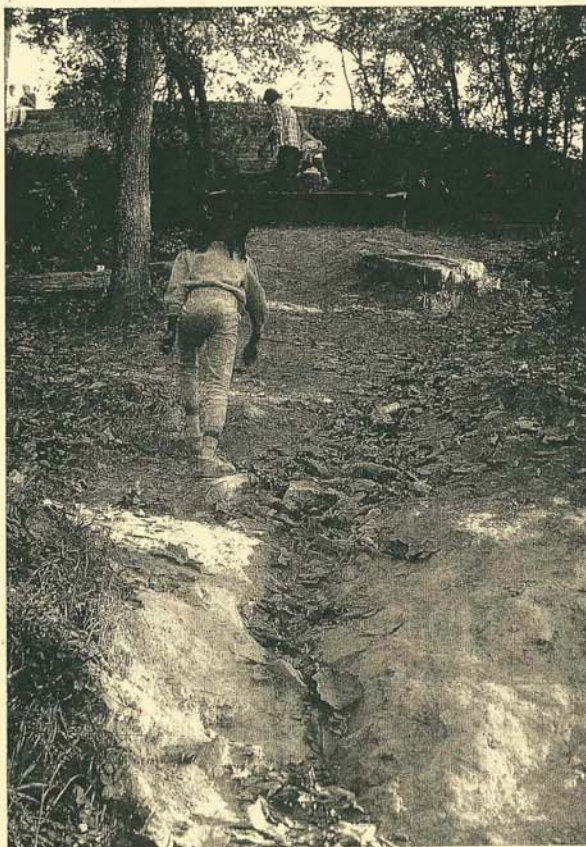
View of existing switchback trail to the Northern Overlook. Unfortunately, most visitors do not use the switchback trail, but prefer to go directly up hill, causing trampling and further erosion of the area. (Andropogon Associates, 1992)

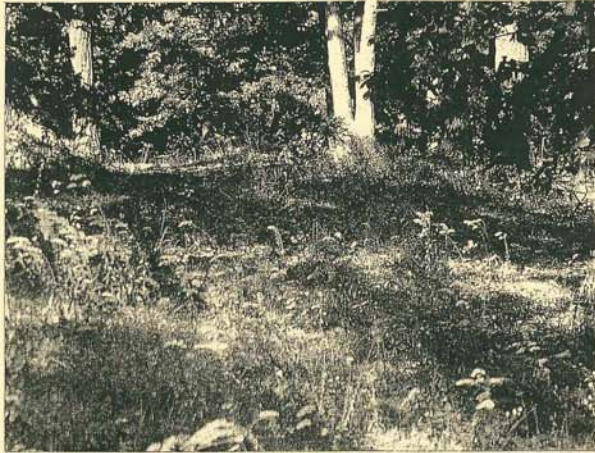
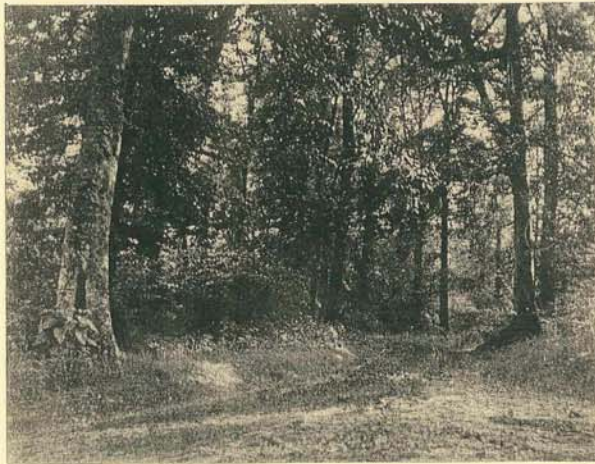
*Illustrative Master Plan for Iroquois Park, showing proposed renewal of Summit Field.*

Summit Field, existing conditions.

The installation of detention basins on the hilltop will mitigate flooding in adjacent communities, reduce erosion and improve wildlife habitats. These detention basins and woody swales (with meadow and prairie edges) will not limit open space use and drainage gullies down the hillside will be stabilized. This will slow the runoff of stormwater and downhill flooding problems, and it will recreate the original prairie habitat of Burnt Knob, creating unique beauty in the Louisville area and providing educational opportunities. New paths through the Summit Field meadows will extend out from Jacob's Lodge and into the large open greensward in the center of the field. Two new picnic pavilions will replace existing shelters, along with observation and interpretation areas in the prairie. Handicapped access and lay-by parking would be introduced adjacent to Jacob's Lodge.

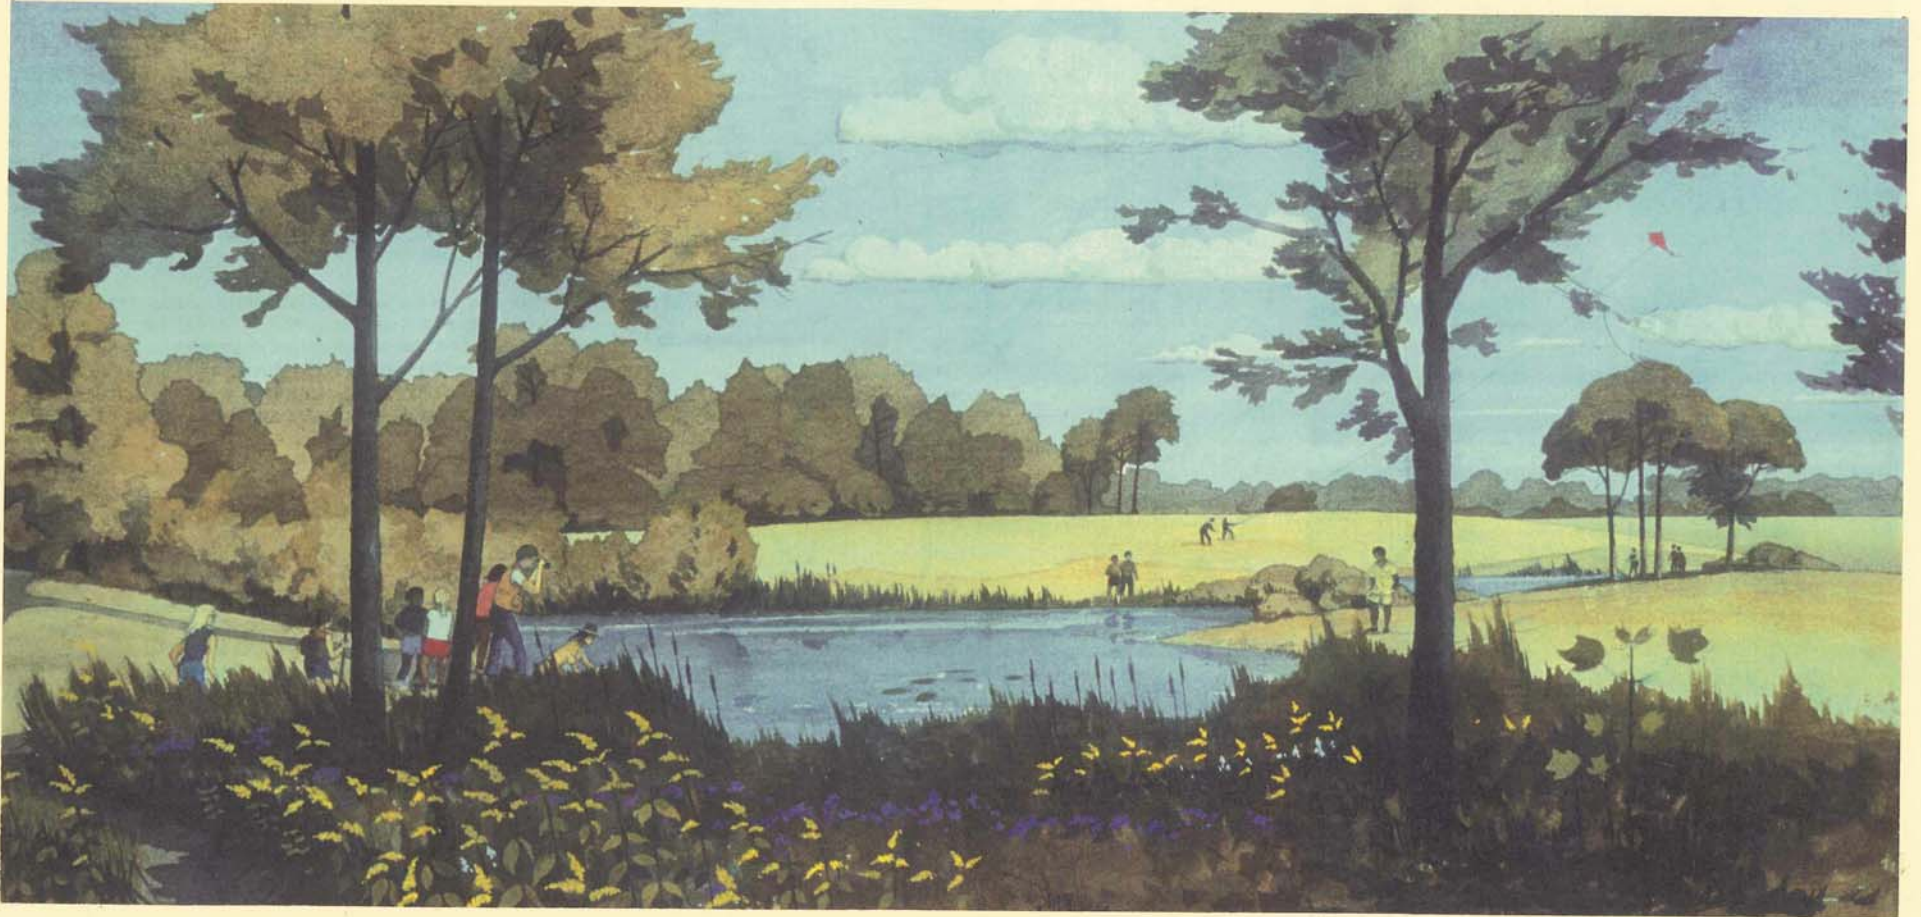
*Panorama of proposed oak savannah at Summit Field, with detention basins and stormwater swales stabilized in woody vegetation. Enriched margins of prairie can be experienced along new paths, which connect to other park features and the large open greensward for passive recreation and special events. (Rendering by Colin Franklin, Andropogon Associates)*

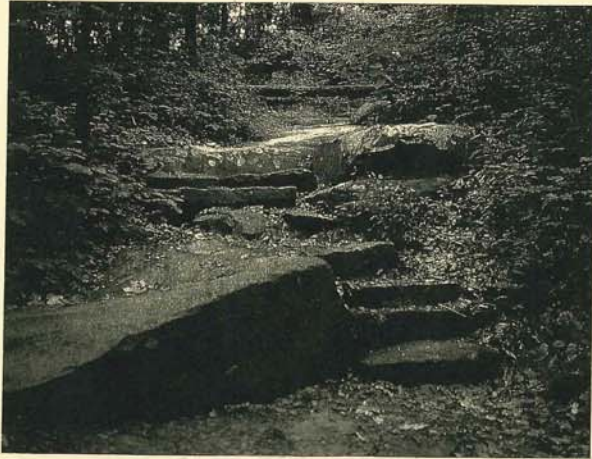
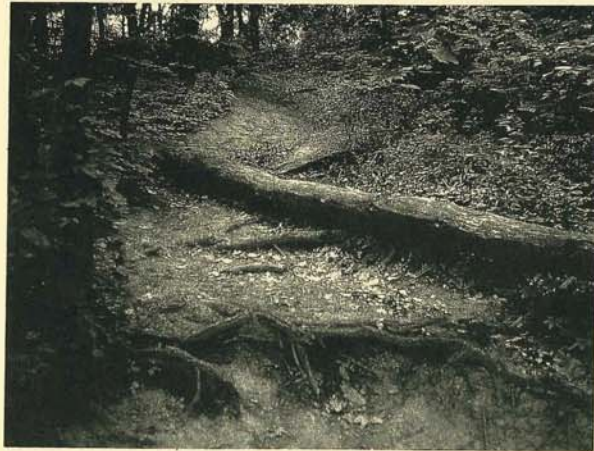
*Illustrative Master Plan for Iroquois Park's Olmsted Woodland Trail.*

(Top) Historic Olmsted path to hilltop, connecting the amphitheater area to Jacob's Lodge, with artistically laid stonework in need of artistic masons to properly restore them. (Andropogon Associates, 1992)

The main historic woodland trail connecting the hilltop to the amphitheater area will be reconstructed, with stone steps relaid according to time-honored craft traditions, and drainage infrastructure installed. At key points along the paths there will be places to sit and learn from interpretive signage about the rare ecology of this place. Pending the implementation of trail repair programs, other original trails could be reclaimed and reestablished to take visitors from park perimeters uphill to Summit Field and the magnificent overlooks of the surrounding countryside and downtown Louisville as well as around the hill.

- Initiate infrastructure crew to evaluate and repair stone steps, pathwork and related drainage; stabilize eroded areas; replant herbaceous ground layer and woodland vegetation; and provide wayside shelters and interpretive overlooks on Olmsted Woodland Trail from amphitheater to Jacob's Lodge.

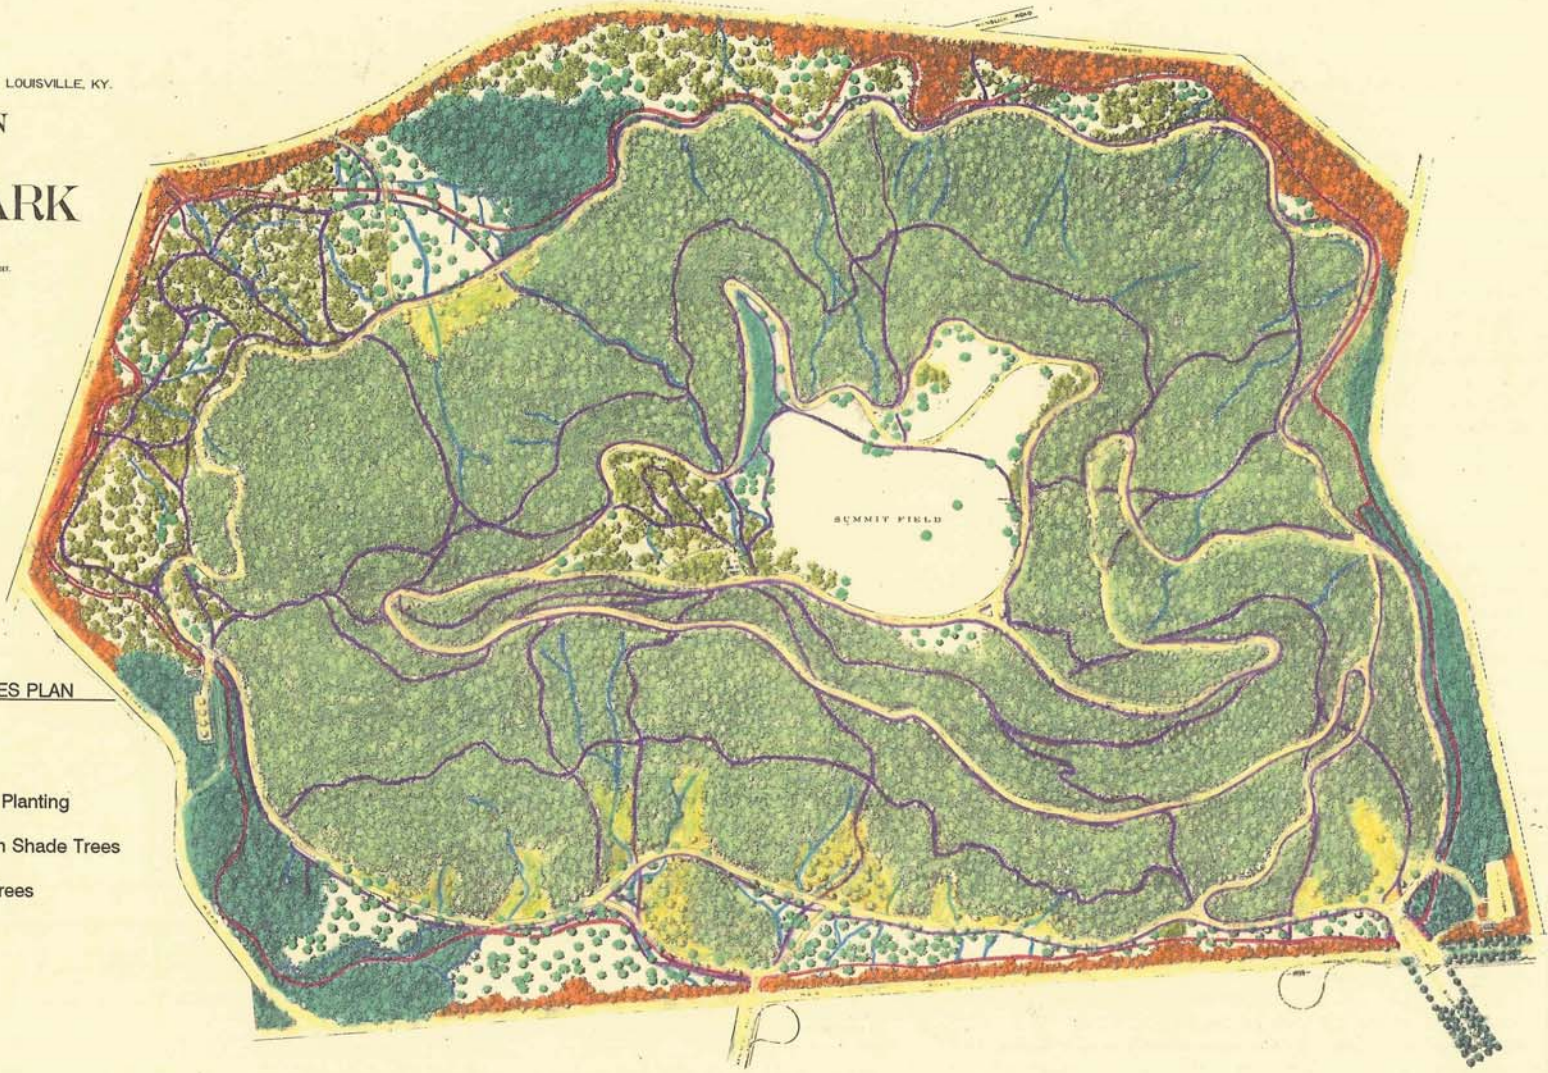
IROQUOIS PARK LANDSCAPE TYPES PLAN

1. Iroquois Park Historic Landscape Types Plan, color coding of vegetation types and circulation, prepared by Landscapes, 1993, overlaid on General Plan for Iroquois Park, Louisville, Kentucky, December 1, 1897 by F.L. and J.C. Olmsted, Landscape Architects. (FLONHS)

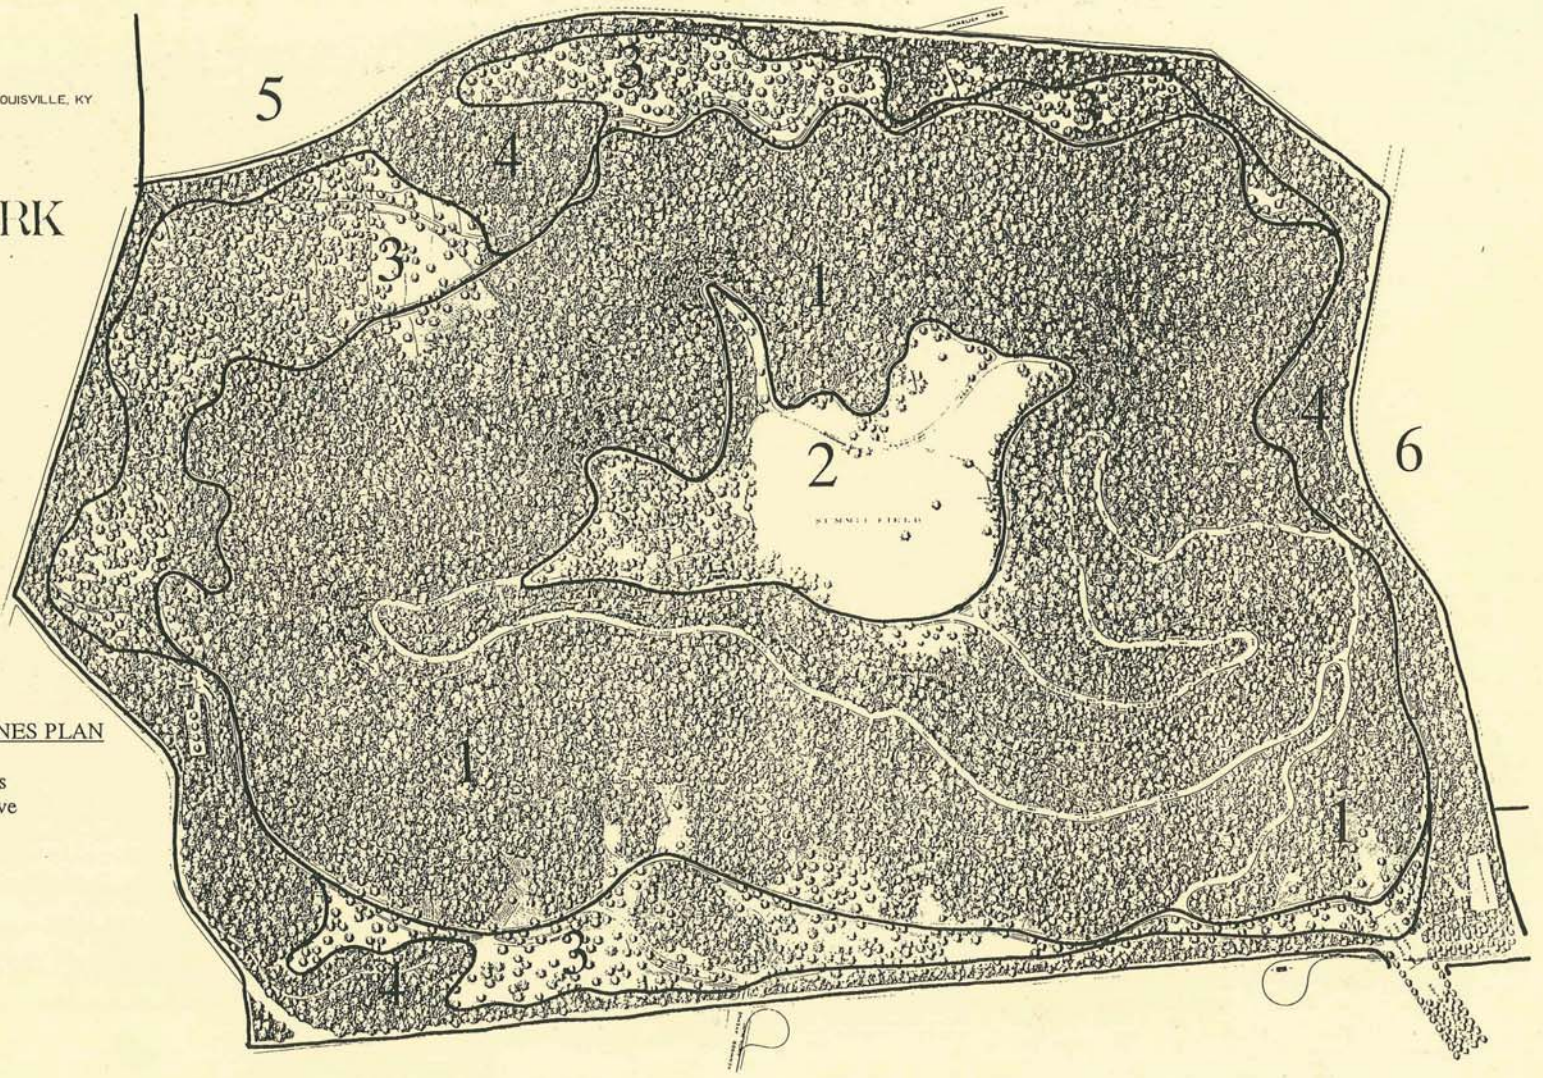
IROQUOIS PARK HISTORIC ZONES PLAN

- 1 • Sloping Forest & Outlooks
- 2 • Summit Field & Oak Grove
- 3 • Park Perimeter
- 4 • Woodland Edge
- 5 • Beech Woods
- 6 • Golf Course

3. Iroquois Park Historic Zones Plan, prepared by Landscapes, 1993, overlaid on General Plan for Iroquois Park. (FLONHS)

The essential character of Iroquois Park is defined by six zones, four of which were incorporated in the F.L. & J.C. Olmsted General Plan. These zones are shown on the Iroquois Park Historic Zones Plan [3] and are described as follows: (1.) the sloping forest that covers the hillsides of Burnt Knob is a unique woodland experience for an urban environment, through this forest the Uppill Road winds providing access to the four dramatic overlooks at South Lookout or Panther Point, West Lookout or Observation Point, Krupps Point, and North Lookout; (2.) the Summit Field at the top of the hill is a large open space at the top of the city; (3.) the perimeter of the park on level to rolling topography was intended for bicycle riding and walking in both open areas and woodland. This area now contains active recreation facilities, parking and a large amphitheater; (4.) the woodland edge, narrow in some places and wide in others, was a visual buffer separating the park from the city surround; little edge buffer remains today; (5.) the Beech Woods was added to the park boundaries and contains the Riding Stable and related parking and riding ring today as well as the remaining woods; (6.) the Golf Course area was also added to the park along the north side extending the park boundary and providing an open, rolling area of landscape.

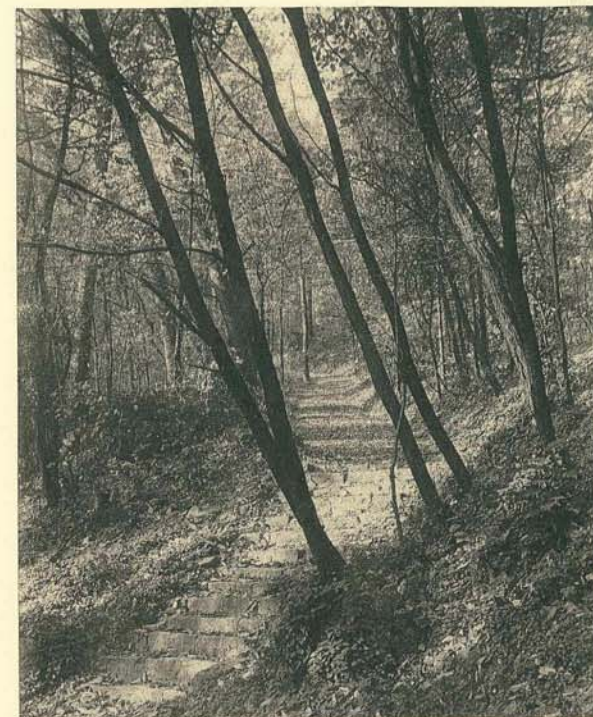
6. Stone steps leading to woodland path from Uppill Drive, Iroquois Park. (University of Louisville, Photographic Archives)

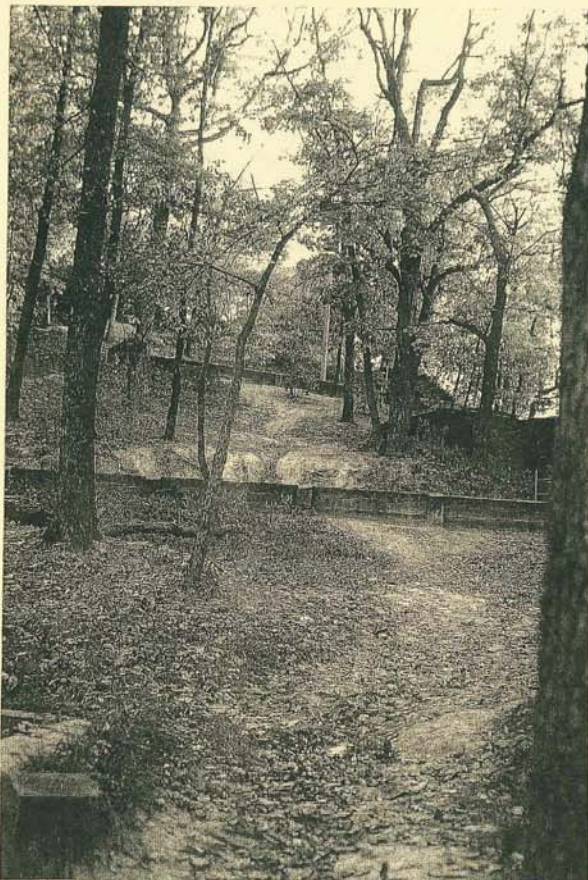
Erosion at steps to the Northern Overlook. (PDR Engineers, 1992)

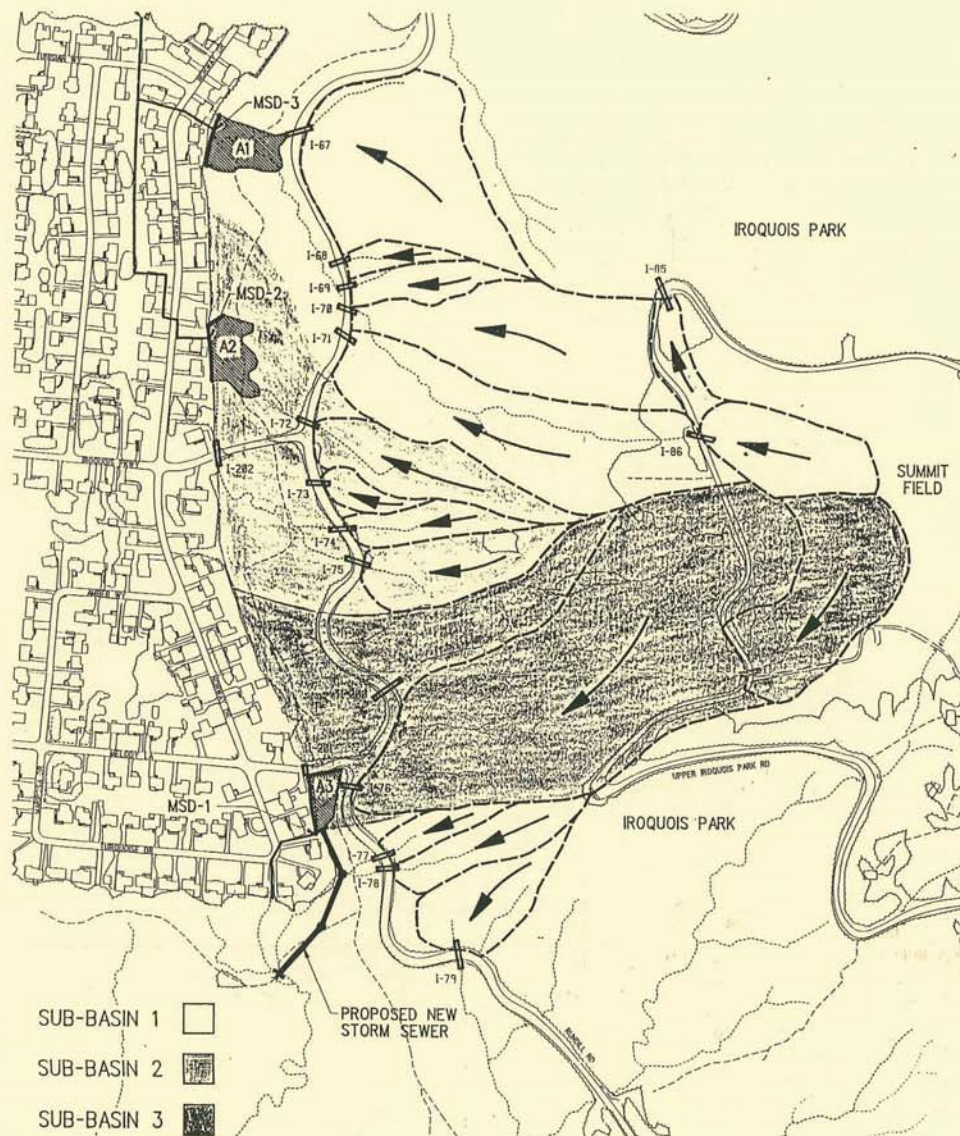
Plan showing western portion of Iroquois Park and culvert and inlet improvements required along Rundill Road. (PDR Engineers, Inc., 1993)

MSD and Metro Parks should work together to mitigate flooding of adjacent neighborhoods and reverse deterioration of the park, reconstructing a functional drainage system, including properly sized culverts and inlet/outlet structures. Drainage swales should be protected against erosion and cleared of silt and debris that hinder flow. Road shoulders should be frequently inspected for washouts and repaired when necessary.
