The Big Thompson Canyon Flood

A wall of water

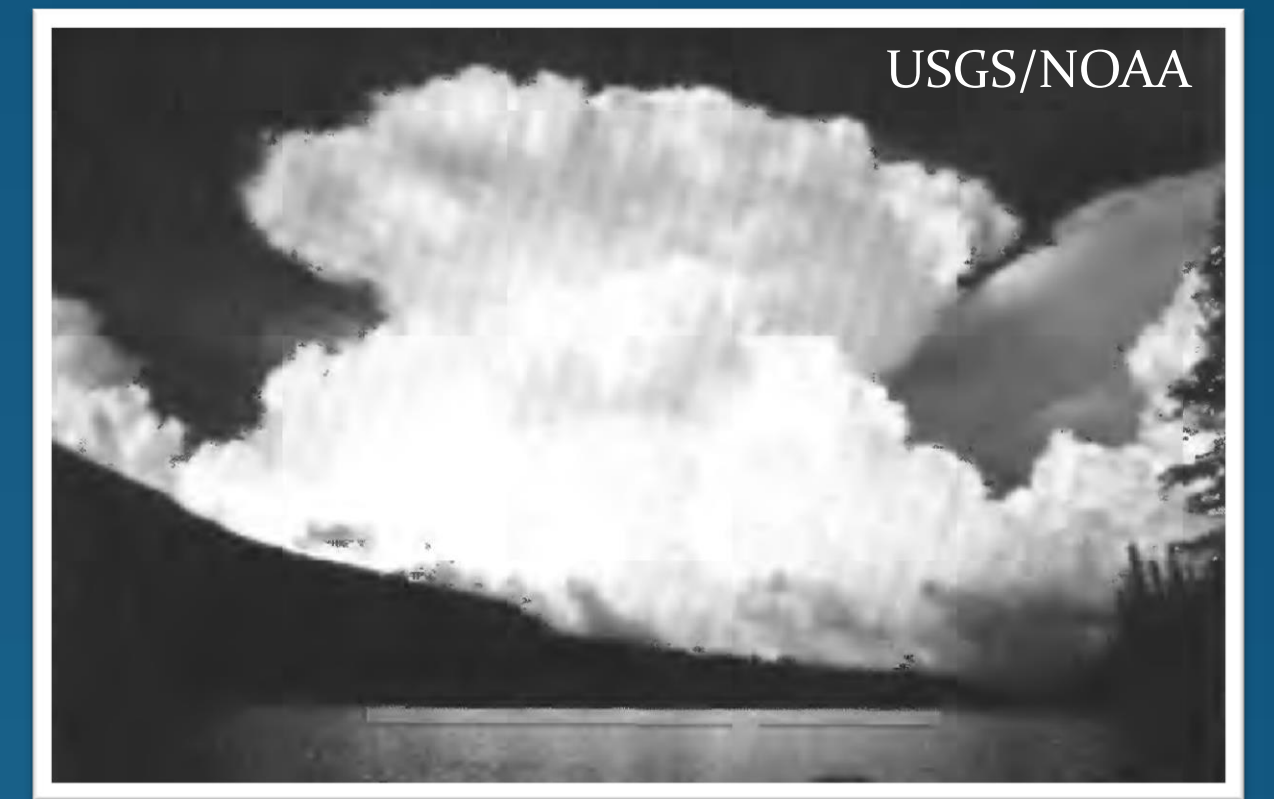
Photograph at 1830 MDT, July 31, 1976 of a storm cell from the same storm system and to the south of the Big Thompson storm.

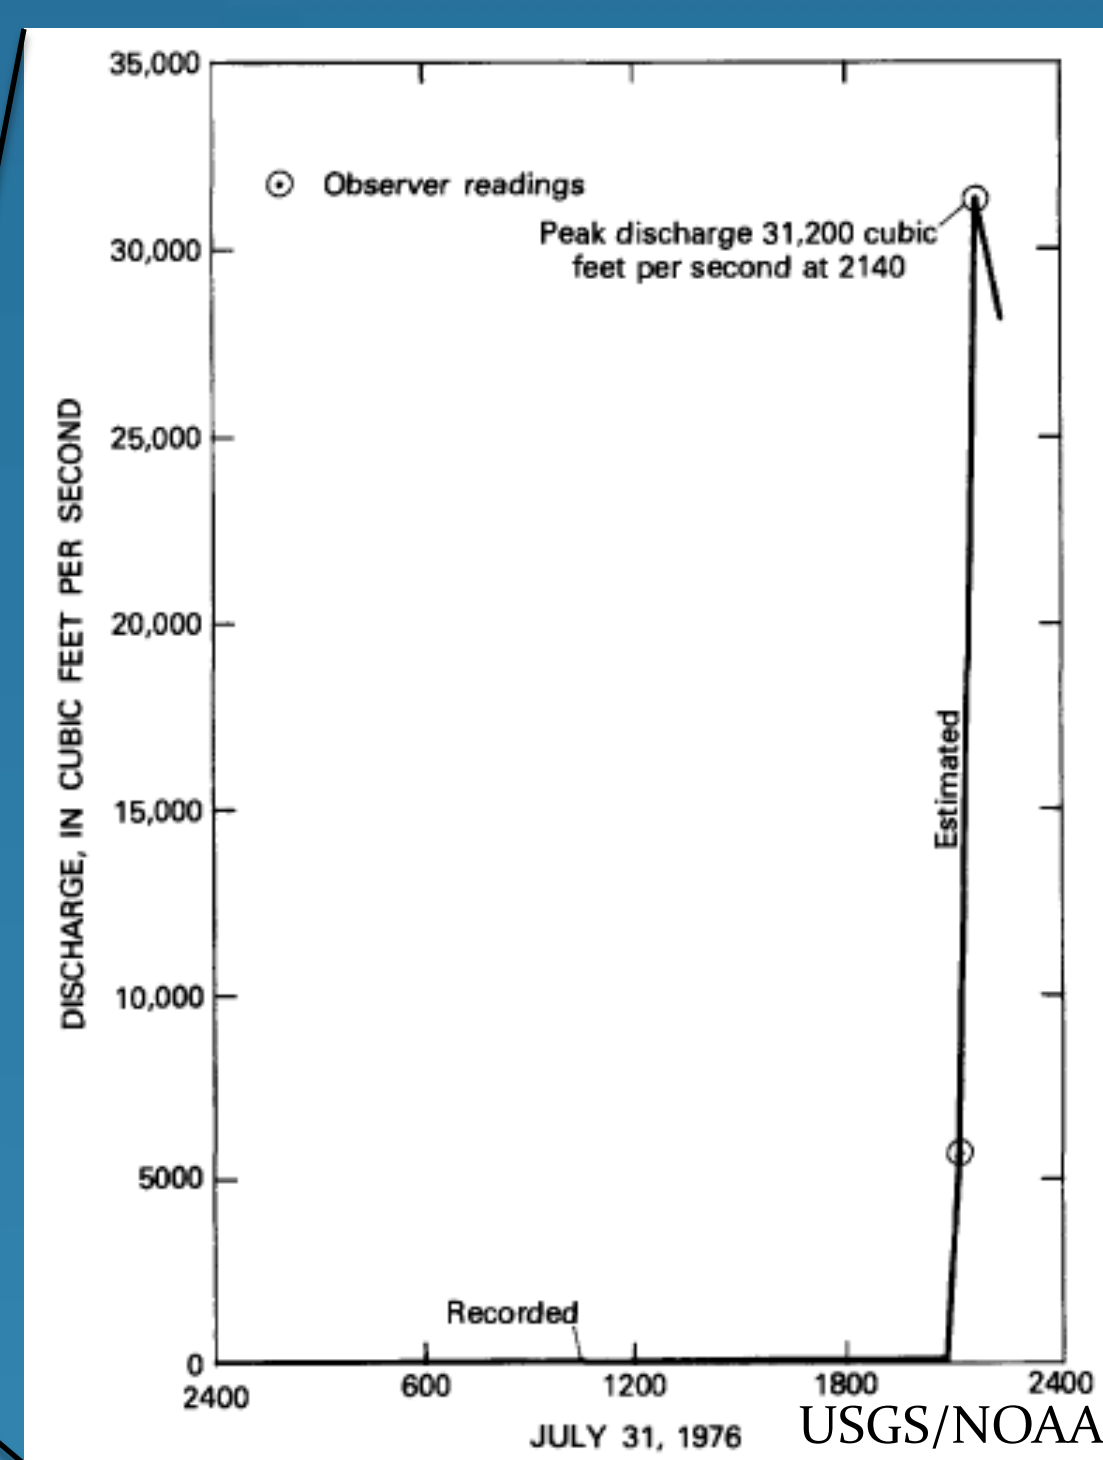
Estimated discharge at Drake.

As much of the rain fell on steep canyon walls with thin soil, runoff collected and was dumped into the river at dramatic rates, causing a surging flood wave. Near the town of Drake, a stream gage on the Big Thompson River was destroyed by the flood wave, with estimates indicating that discharge rose from virtually no flow to 31,200 cubic feet per second (cfs) in only 50 minutes. This shattered the previous recorded high of 8,000 cfs from the prior 89 years of gage measurements.

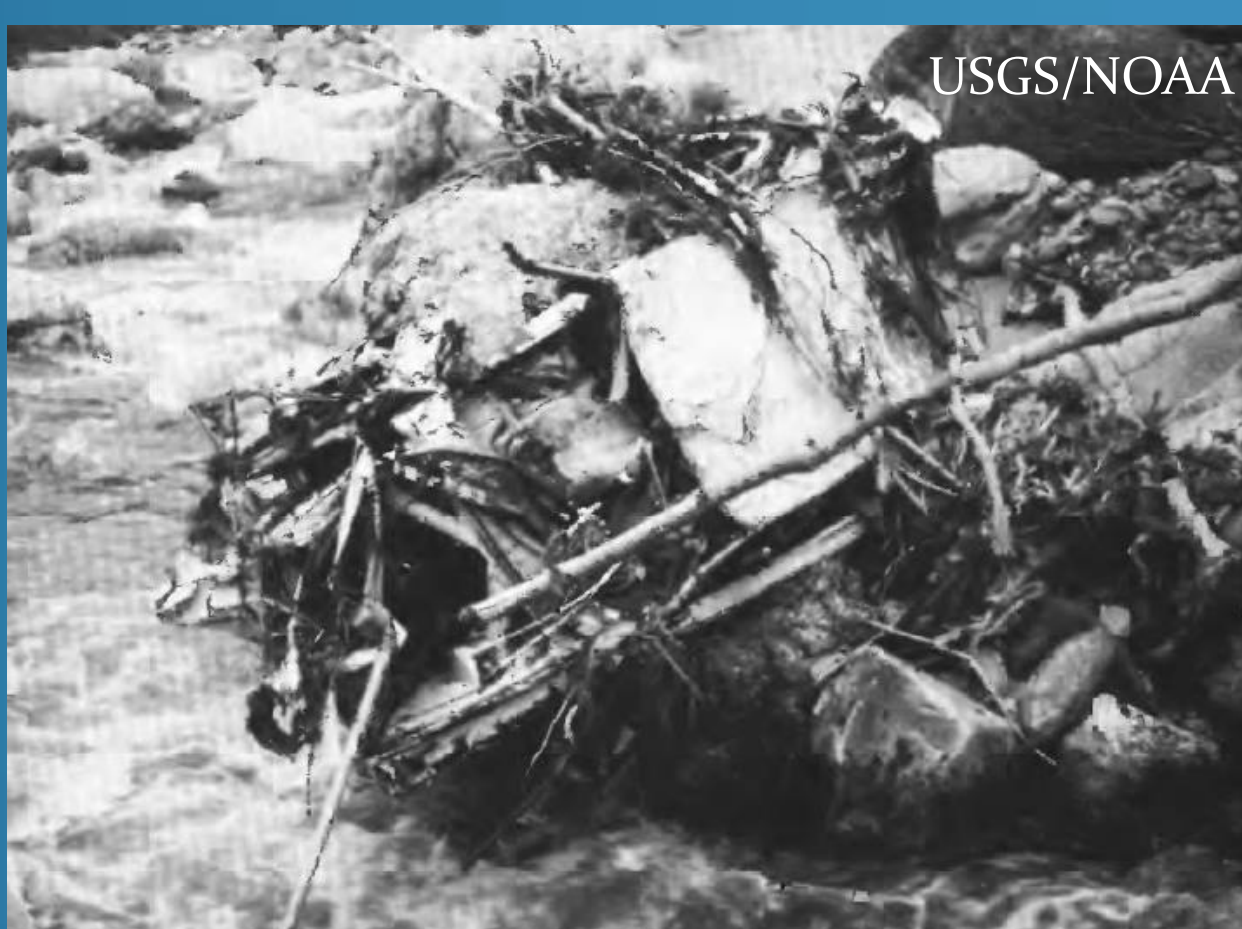
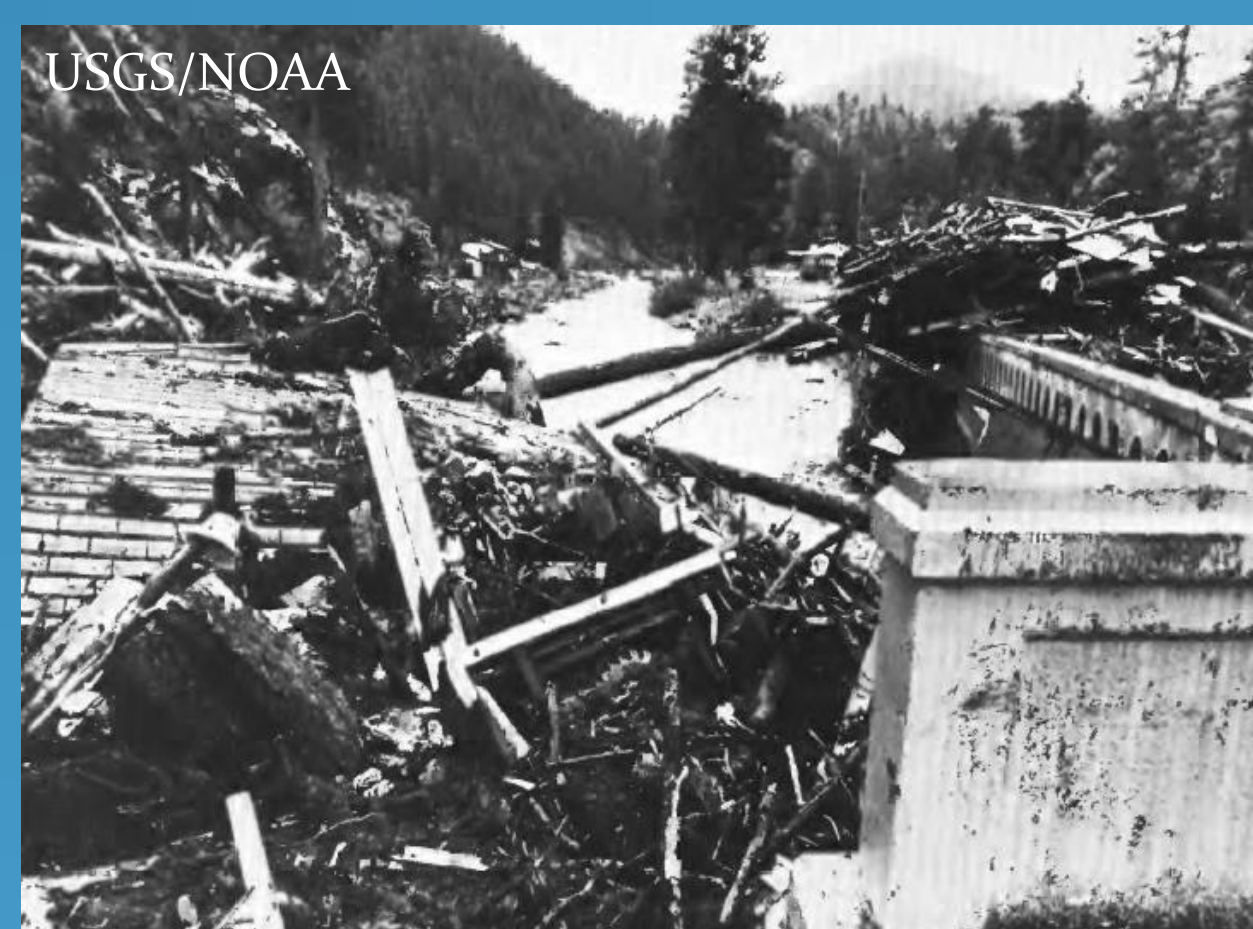
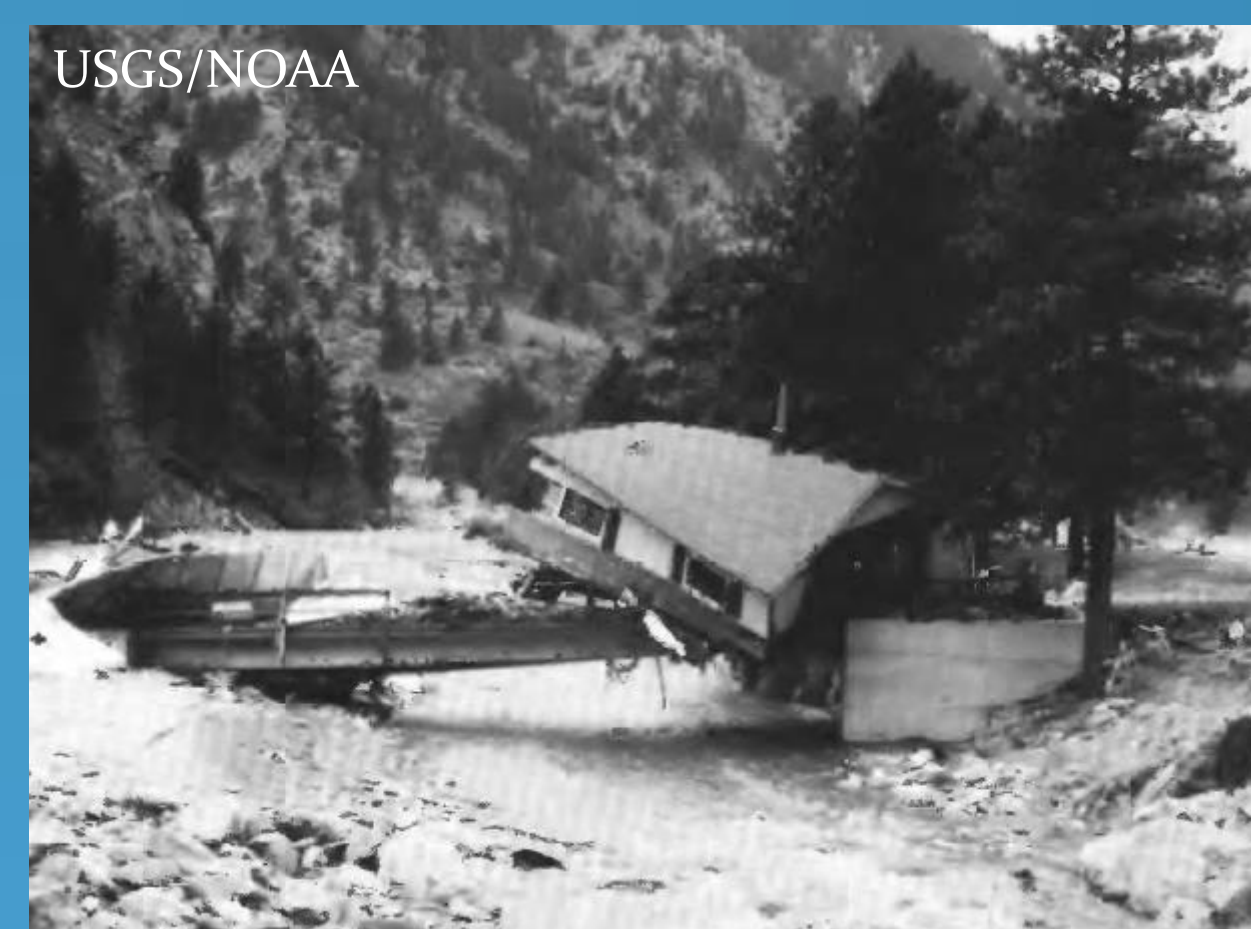
The Big Thompson flood left incredible damage behind – an estimated \$35 million dollars in 1977 dollars. Direct human impacts included the loss of over 140 lives, 250 reported injuries, and the helicopter evacuation of over 800 individuals. In addition, 418 homes and businesses were damaged along with 408 automobiles.
