SIXTH FIVE-YEAR REVIEW REPORT FOR LEE'S LANE LANDFILL SUPERFUND SITE JEFFERSON COUNTY, KENTUCKY

AUGUST 2018

U.S. Environmental Protection Agency Region 4 Atlanta, Georgia

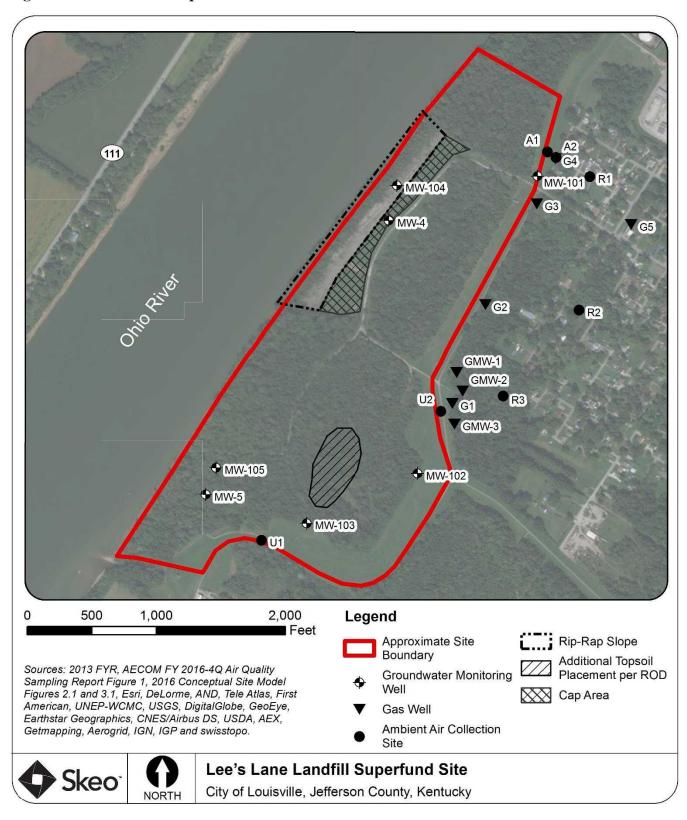
Figure 3: Detailed Site Map

MSD monitors ambient air twice per year at the locations shown on Figure 3. Table 6.3 in the CSM summarizes ambient air monitoring from 2012 to 2015. Carbon tetrachloride exceeded the EPA's RSL in April 2015 at air monitoring station U1. No other contaminants that were measured and have RSLs

MSD monitors soil gas twice per year at the locations shown on Figure 3. Table 6.2 in the CSM summarizes volatile organic compound (VOC) results for gas probes from September 2012 to April 2015. Chloroform exceeded the EPA's soil gas RSL during every event at locations G-1 and G-4. Carbon tetrachloride exceeded the EPA's RSL during every event at location G-4. Chloroform and tetrachloroethene exceeded the EPA's RSL sporadically during this time at location GMW-1. Tetrachloroethene exceeded EPA's RSL in 2012 at location GMW-2. Table 6.7 in the CSM summarizes carbon tetrachloride results for gas probes. Between 2012 and 2015, four probes exceeded RSLs at least once. The maximum exceedance during this period was 15,727 micrograms per meter cubed (μg m³) at G-4R in fall of 2013. April 2016 to October 2017 soil gas summaries were reviewed using the semiannual reports. No exceedances were observed during this time for the chemicals that are reported on.

In 2014, KDEP installed five new groundwater monitoring wells (MW-101 through MW-105). The Site now has seven groundwater monitoring wells (see Figure 3). MW-4 and MW-5 are adjacent to MW-104 and MW-105, respectively. MW-4 and MW-5 are screened in the deeper part of the aquifer; MW-104 and MW-105 are screened in the upper part of the same aquifer.

KDEP's 2016 Groundwater Report indicated that groundwater monitoring wells MW-102 and MW-103 continue to off-gas VOCs at levels of 100 percent of the LEL, thus making the use of electronic instruments down the monitoring well hole unsafe. The 2017 Groundwater Report indicates that low-flow sampling techniques would be accomplished using a bladder pump to avoid the possibility of igniting explosive gasses and to ensure the water was representative of actual groundwater conditions before sampling.

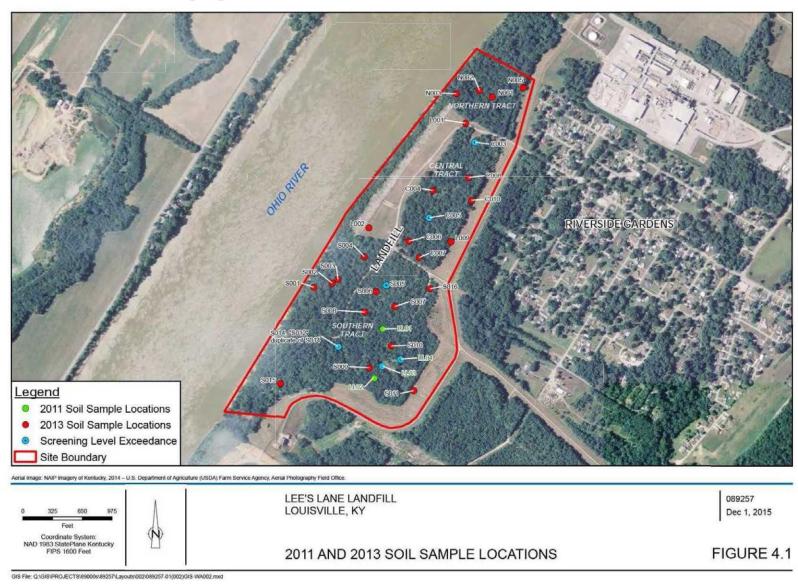
Figure D-1: 2011 and 2013 Soil Sampling Locations¹

In early April 2011, the EPA collected soil samples from four on-site locations to determine if hazardous constituents were present at levels exceeding EPA regional screening levels (RSLs) for residential soils. All reported arsenic values exceeded the residential RSL for arsenic (0.39 milligrams per kilogram, or mg kg). The range of detections for arsenic was 2.9 mg kg to 4.5 mg kg. The report stated that the detected arsenic concentration range is typical for soils derived from weathered sedimentary rock and is not thought to be indicative of contamination at the Site. Three of the four locations had contamination above residential RSLs of other contaminants. The EPA concluded that more sampling is necessary to identify remaining contamination.
