# **JEFFERSONVILLE HOUSING INVENTORY STUDY**

**JEFFERSONVILLE, INDIANA**

**Center for Environmental Policy and Management  
School of Urban and Public Affairs  
The University of Louisville**

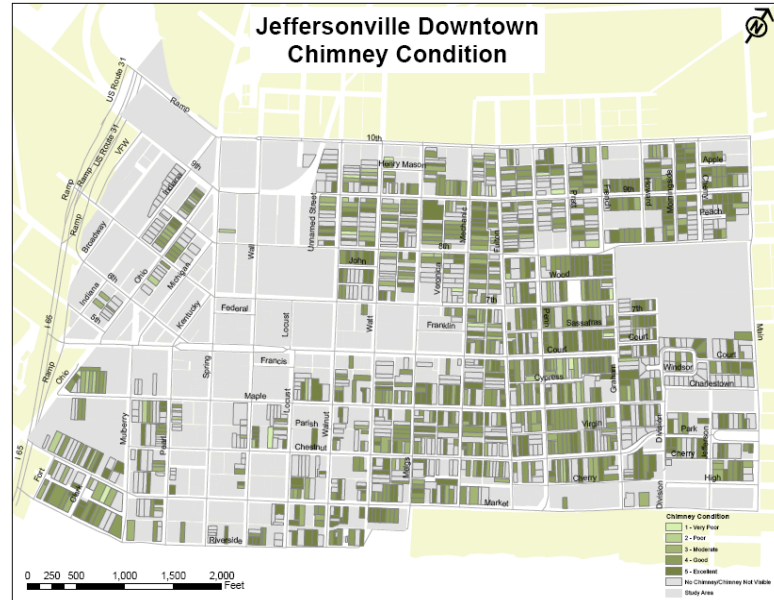
**Map 10: Individual Property Chimney Condition**

About half of the chimneys in the study area are either in excellent (24%) or good condition (23%). 41% of houses did not have a visible chimney, and 12% of chimneys were in fair to very poor condition. Chimneys in the northern portion of the study area are generally in better condition.

Chimney	Number	Percent
5=Excellent	381	24%
4=Good	371	23%
3=Moderate	150	9%
2= Poor	35	2%
1=Very Poor	15	1%
None/Not Visible	660	41%
<b>Total</b>	<b>1,612</b>	
<b>Average</b>	<b>4.12</b>

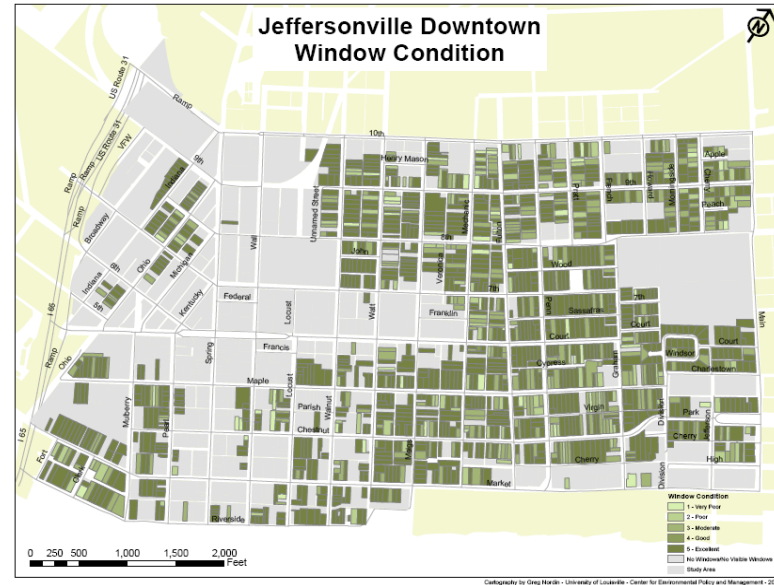
**Map 14: Individual Property Window Condition**

About half (48%) of the houses in the study area had windows in excellent condition, followed by 22% in good condition, 18% in fair condition, and the remaining 11% in poor or very poor condition. Two houses had no visible windows from the street. There are several blocks where all of the houses have excellent window condition, and few blocks where there is a majority of houses with poor window condition. Windows in poor condition appear to be somewhat isolated rather than clustered together in specific areas.

Windows	Number	Percent
5=Excellent	777	48%
4=Good	362	22%
3=Moderate	291	18%
2= Poor	120	7%
1=Very Poor	60	4%
None/Not Visible	2	<1%
Total	1,612	
Average	4.04

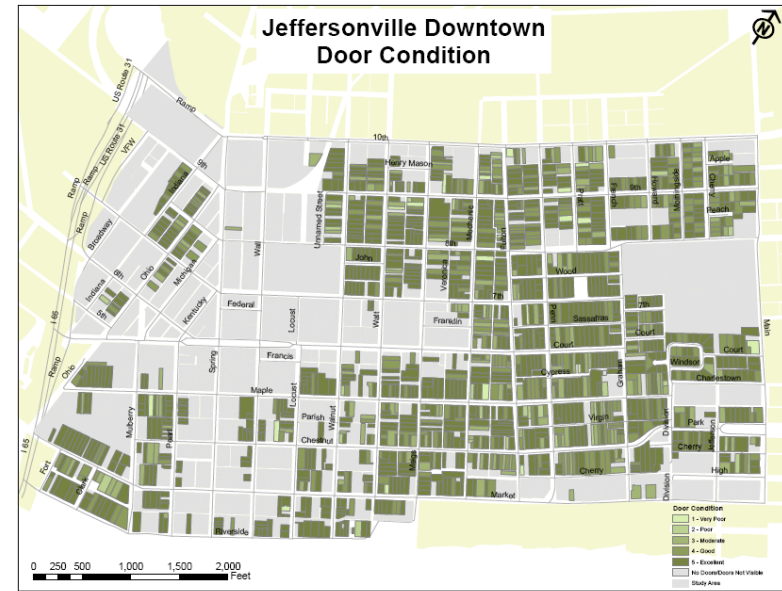
Map 15: Individual Property Door Condition

The majority of houses in the study area have doors in excellent condition (65%), followed by 20% in good condition and the remaining 14% in fair to very poor condition. Two houses had no visible doors from the street. Houses with doors in poor or very poor condition appear to be isolated and not clustered together in specific areas.

Doors	Number	Percent
5=Excellent	1,050	65%
4=Good	321	20%
3=Moderate	183	11%
2= Poor	35	2%
1=Very Poor	21	1%
None/Not Visible	2	<1%
Total	1,612	
Average	4.46
