THE GREAT MIDWEST FLOOD OF 1993

Synopsis:

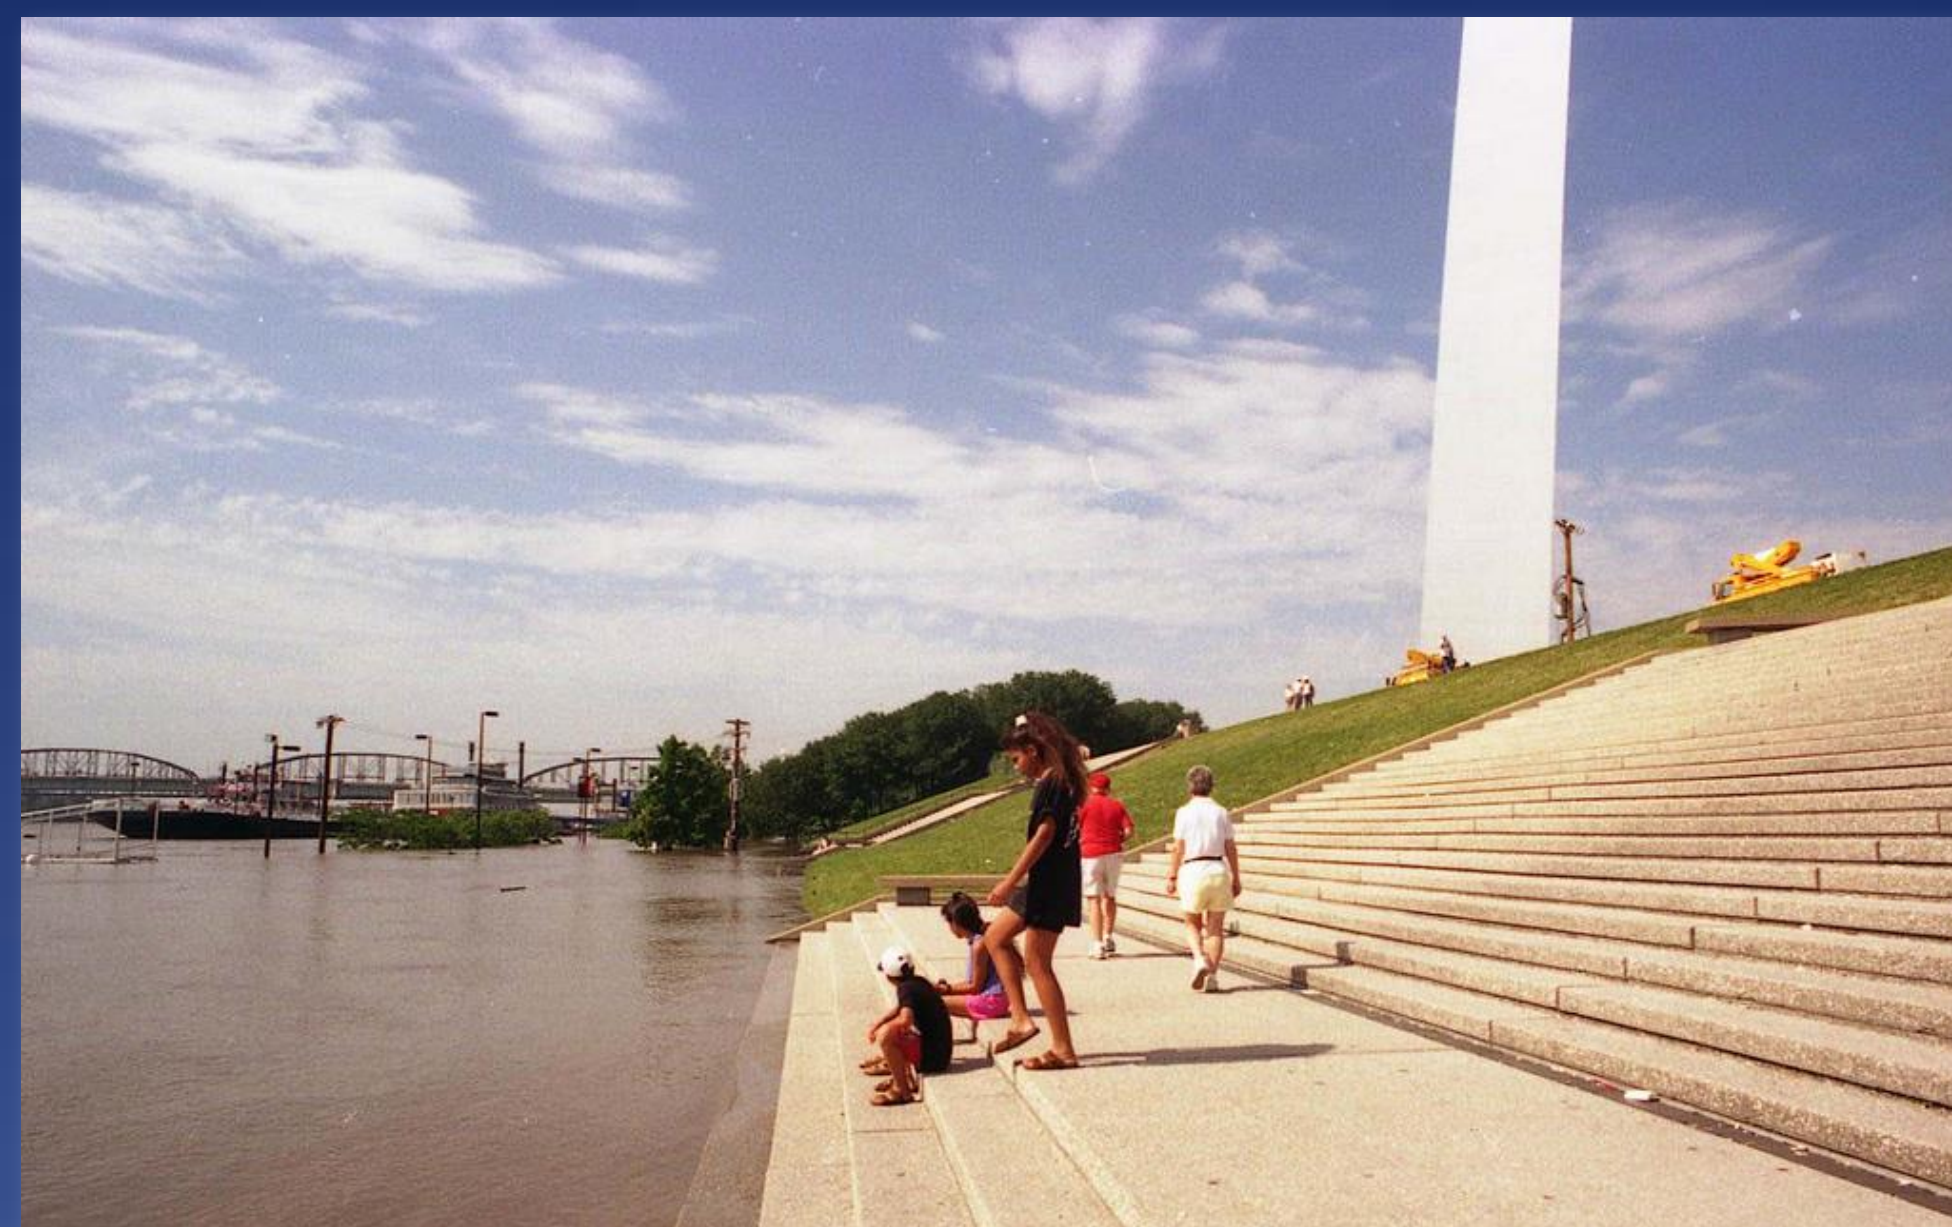
Left: River water up to the steps of the St. Louis Arch.
Center: Water washed out innumerable roadways, here U.S. 94 in Jefferson City, MO.
Below Left: Flood waters reached record levels.

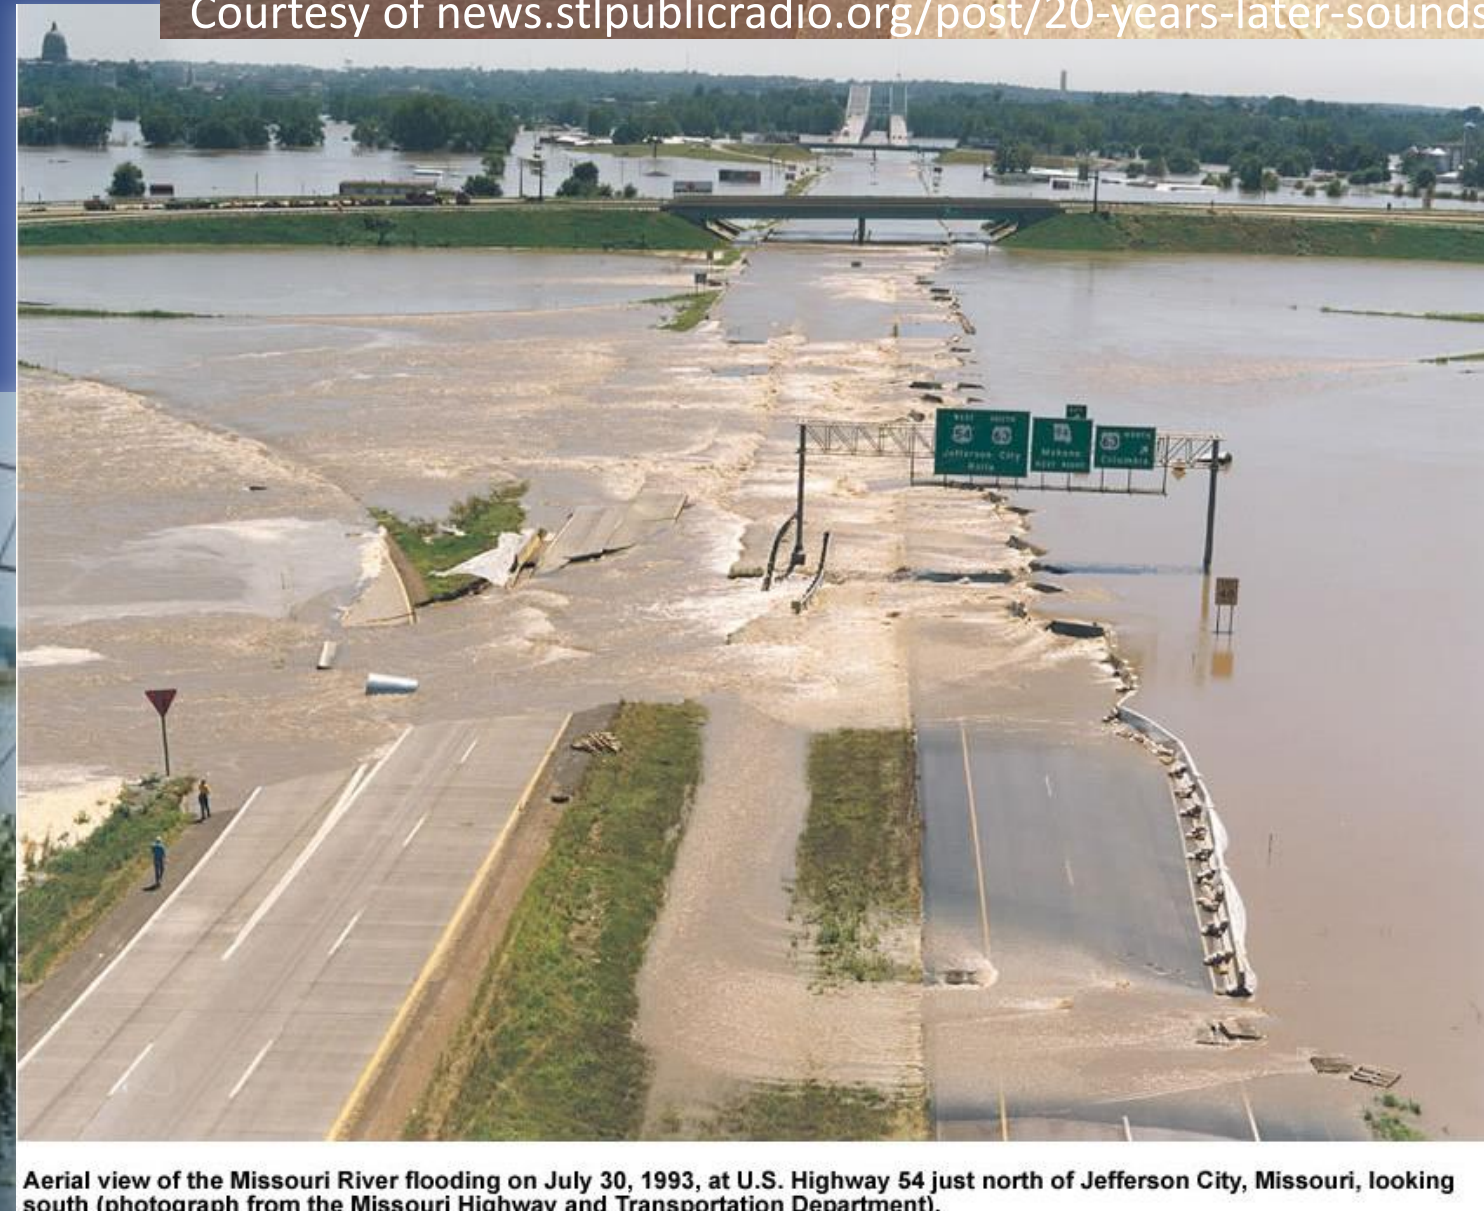
Aerial view of the Missouri River flooding on July 30, 1993, at U.S. Highway 54 just north of Jefferson City, Missouri, looking south (photograph from the Missouri Highway and Transportation Department).

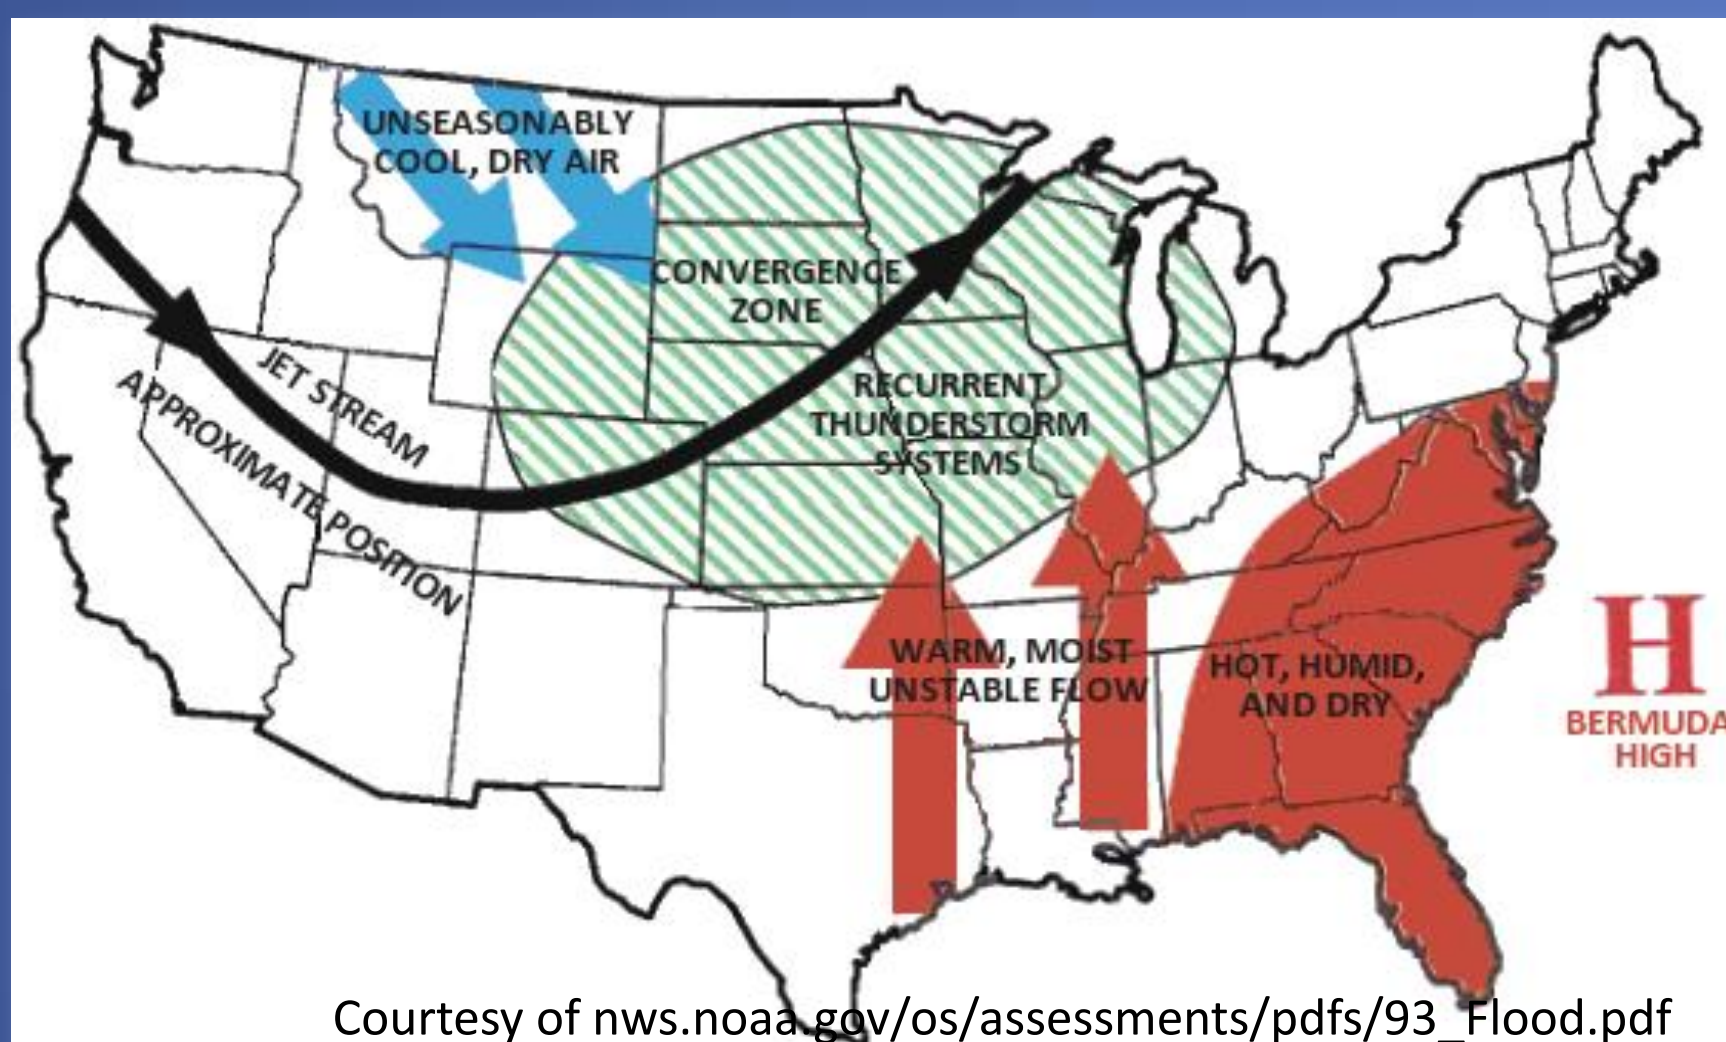
As depicted at left, the average position of the jet stream showed a trough over the Rockies with southwest flow across the Plains. Persistent East Coast high pressure blocked and stalled a low pressure frontal system in the Midwest. A continuous southerly flow between the high and low brought copious Gulf of Mexico moisture northward that fed the development of numerous convective complexes within the “convergence zone/recurrent thunderstorm systems.” Many of the storms occurred in the unseasonably cool air north of the front. The second image shows rainfall totals that occurred in this pattern over a 92-day period, ranging from 12-37 inches.
